### District of Summerland

#### Thirsk Dam Inspection Spillway Piezometer Data Review

August 2016

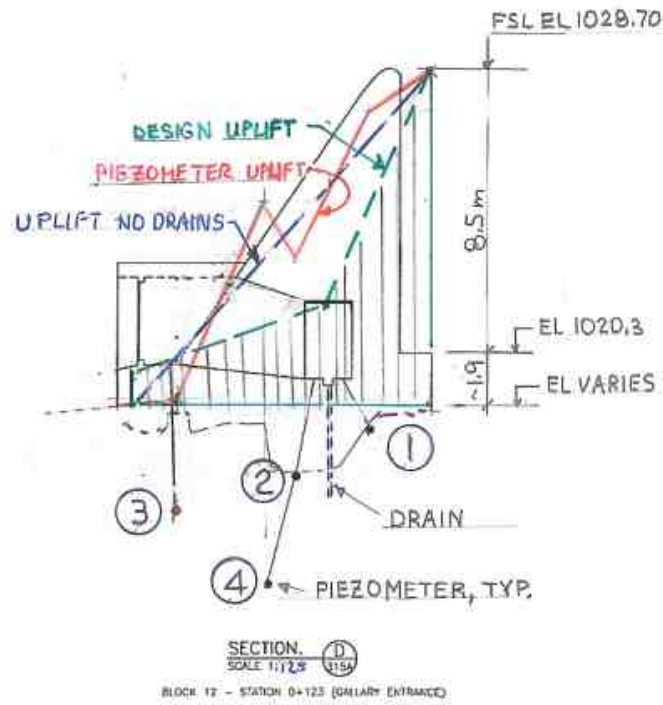
Figure 3-1 – Block 12 – Hydrostatic Uplift

- The hydrostatic uplift under Block #12 is significantly greater than the design uplift. In fact, it appears that the drains and grout curtain are ineffective under Block #12 at reducing the hydrostatic uplift.
- The hydrostatic uplift under Block #14, although slightly different in shape is about the same magnitude as the design uplift.

Increased hydrostatic uplift under the base of the blocks reduces the block stability. Therefore, we re-calculated the stability of Block #12 based on the increased hydrostatic uplift.

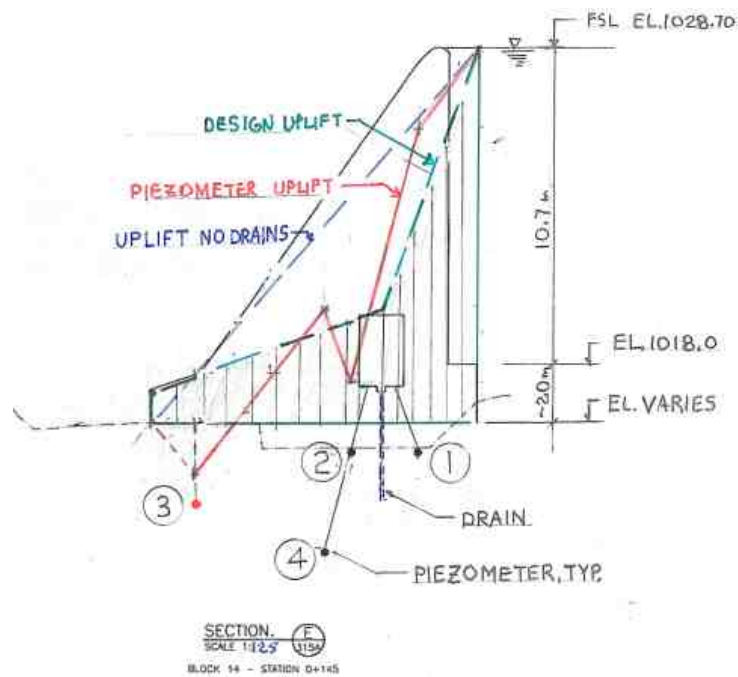
Figure 3-2 – Block 14 – Hydrostatic Uplift

The highest block, Block #14, has drains that are working effectively and the stability of this block meets the original design assumptions (i.e. it is stable for the usual hydrostatic condition with no anchors and the other load conditions with anchors).

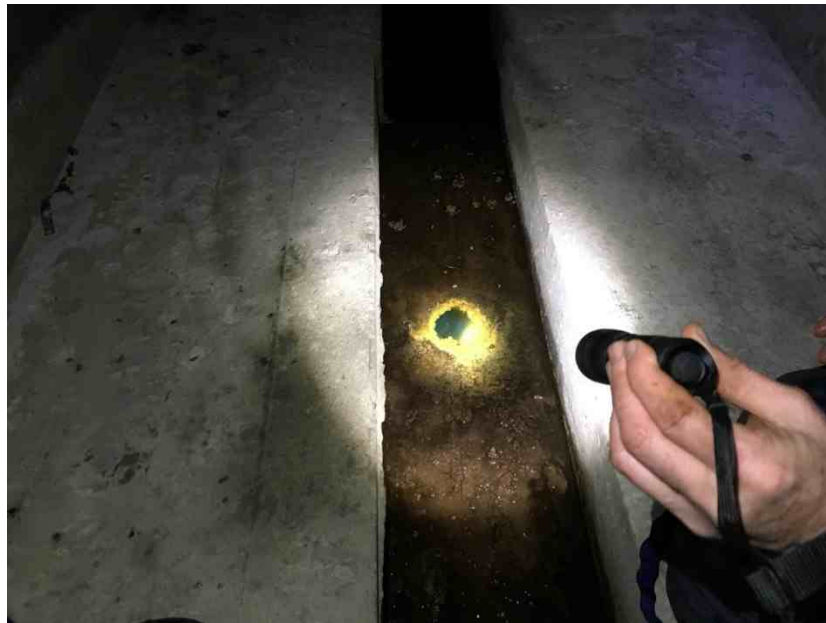
The drains all appeared to be functioning, although it was noted that all had small amounts of sediment on the sides of the drain holes. We recommend cleaning them as part of a 5 year maintenance cycle.

**Photo 5**  
**Spillway Drain in Gallery**

1. The District conduct anchor lift-off tests to confirm that the rock anchors are performing as designed. These tests would be supervised and evaluated by a Dam Safety Engineer.
2. The District continue to monitor the piezometers and report any anomalies to a Dam Safety Engineer.
3. The District measure and record the flow of water from the drains annually; particularly when the lake level is at or near full service level. Report any significant changes in drainage flow to a Dam Safety Engineer.
4. The District clean out the drains in the inspection gallery at 5 year intervals.

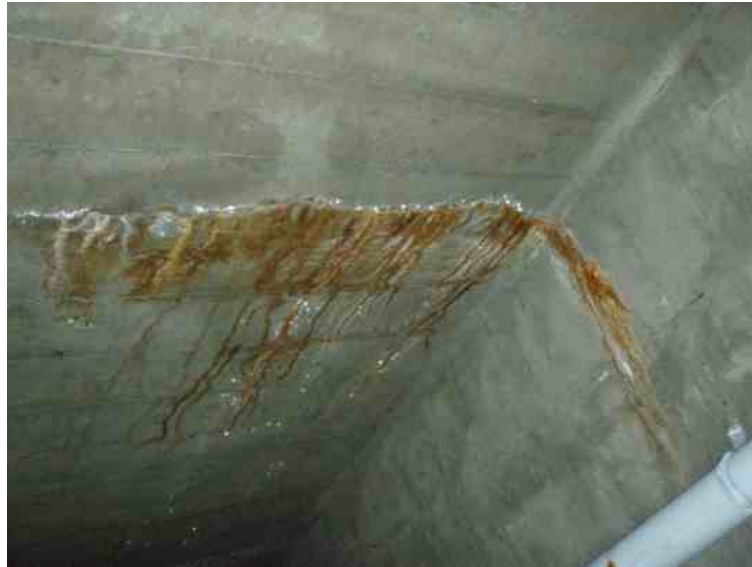
A few hairline cracks with efflorescence and minor weeping were observed in the upstream face of the gallery, however none showed any measureable leakage. None of the cracks observed impact the stability

**Photo 6**  
**Block 12 – Weep on Upstream Face**

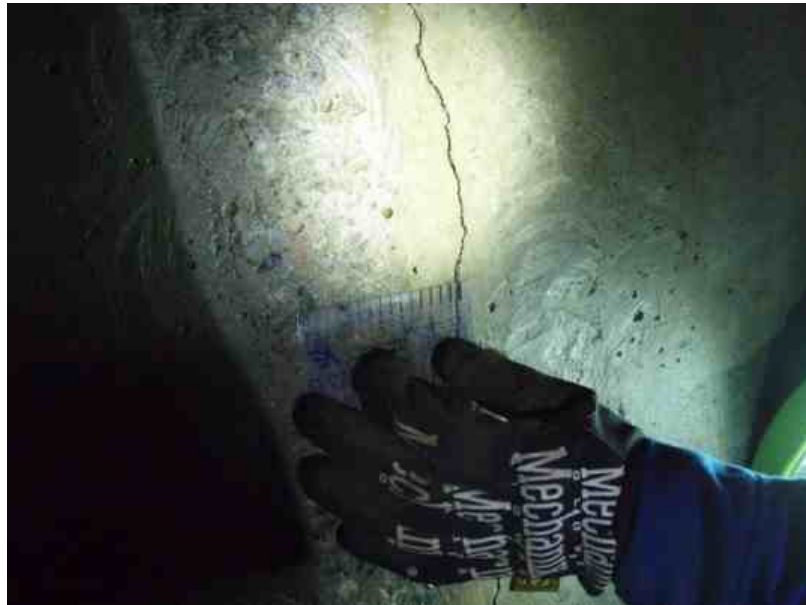
of the dam. The contraction joints were inspected between blocks and we measured the joint width as approximately 1.0 mm. This indicated that the joints are functioning as intended to relieve thermal and shrinkage stresses. There was no leakage observed in the contraction joints within the gallery, indicating that the water-stops between the blocks were functioning as designed.

**Photo 7**  
**Block 12-13 Contraction Joint**

| Item | Description | Depth Measurement from Base (m) |
|---|---|---|
| Joint 12-13 | Crack gauge used – 1.5-2mm crack – weeping.<br>On curve up – crack<br>End – Crack + condensation | |

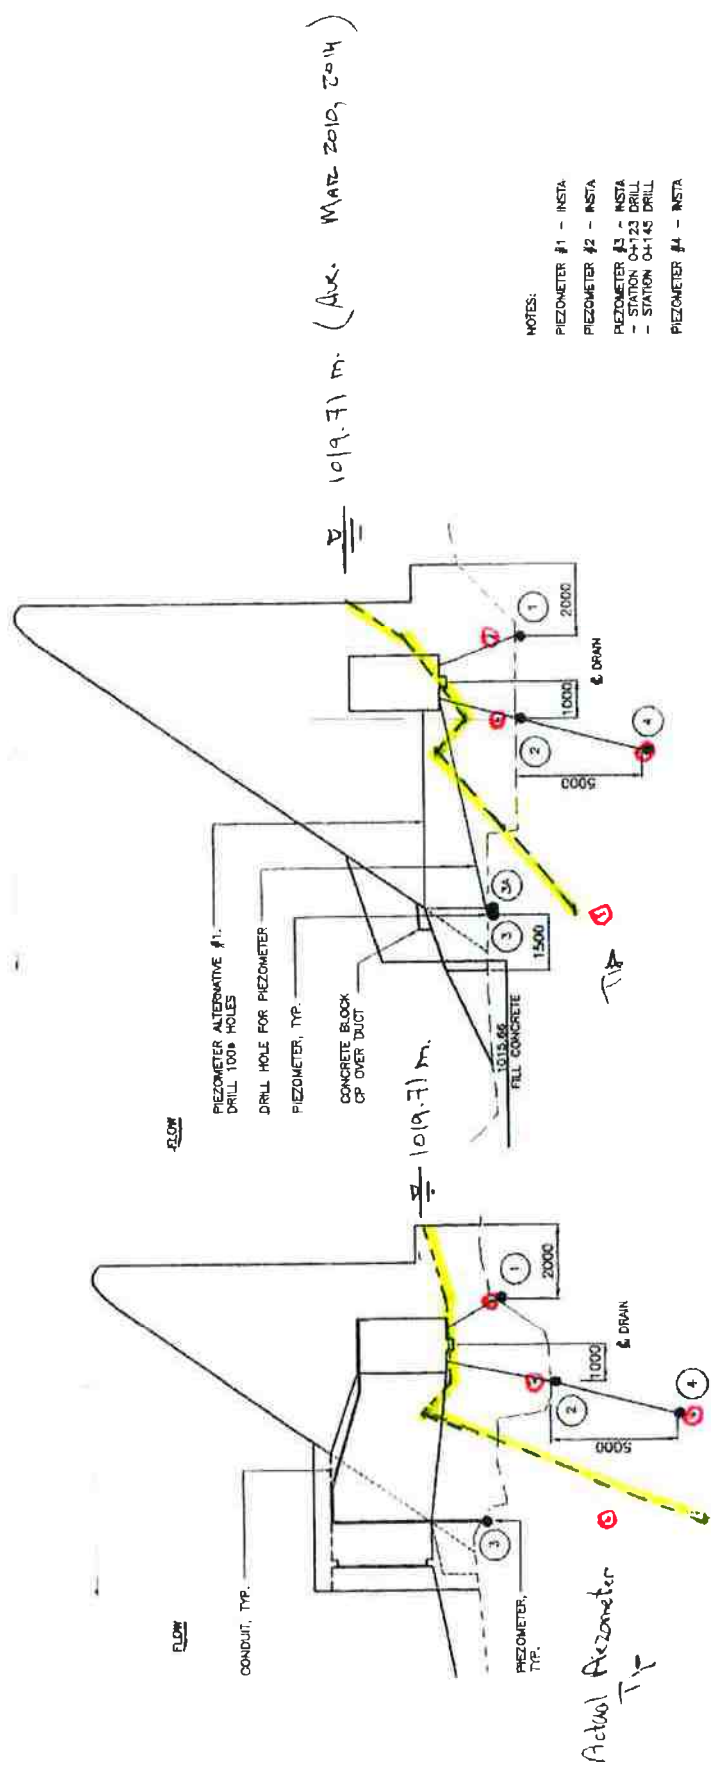
- Under the high reservoir storage condition, the phreatic surface at Piezometer No. 2 (Block 12) is about 3.5 m higher than the gallery drain and about 5.0 m higher at Piezometer No. 4. This would suggest that significant seepage water would be flowing through the drain hole system beneath the gallery.

SECTION D  
SCALE 1:100  
BLOCK 12 - STATION 0+123 (E ENTRANCE)

SECTION E  
SCALE 1:100  
BLOCK 14 - STATION 0+147
