PERPETUAL SLIDE SUMMERLAND, BRITISH COLUMBIA

Geotechnical and Hydrogeological Study

Report Number: 1417553-001-R-Rev1

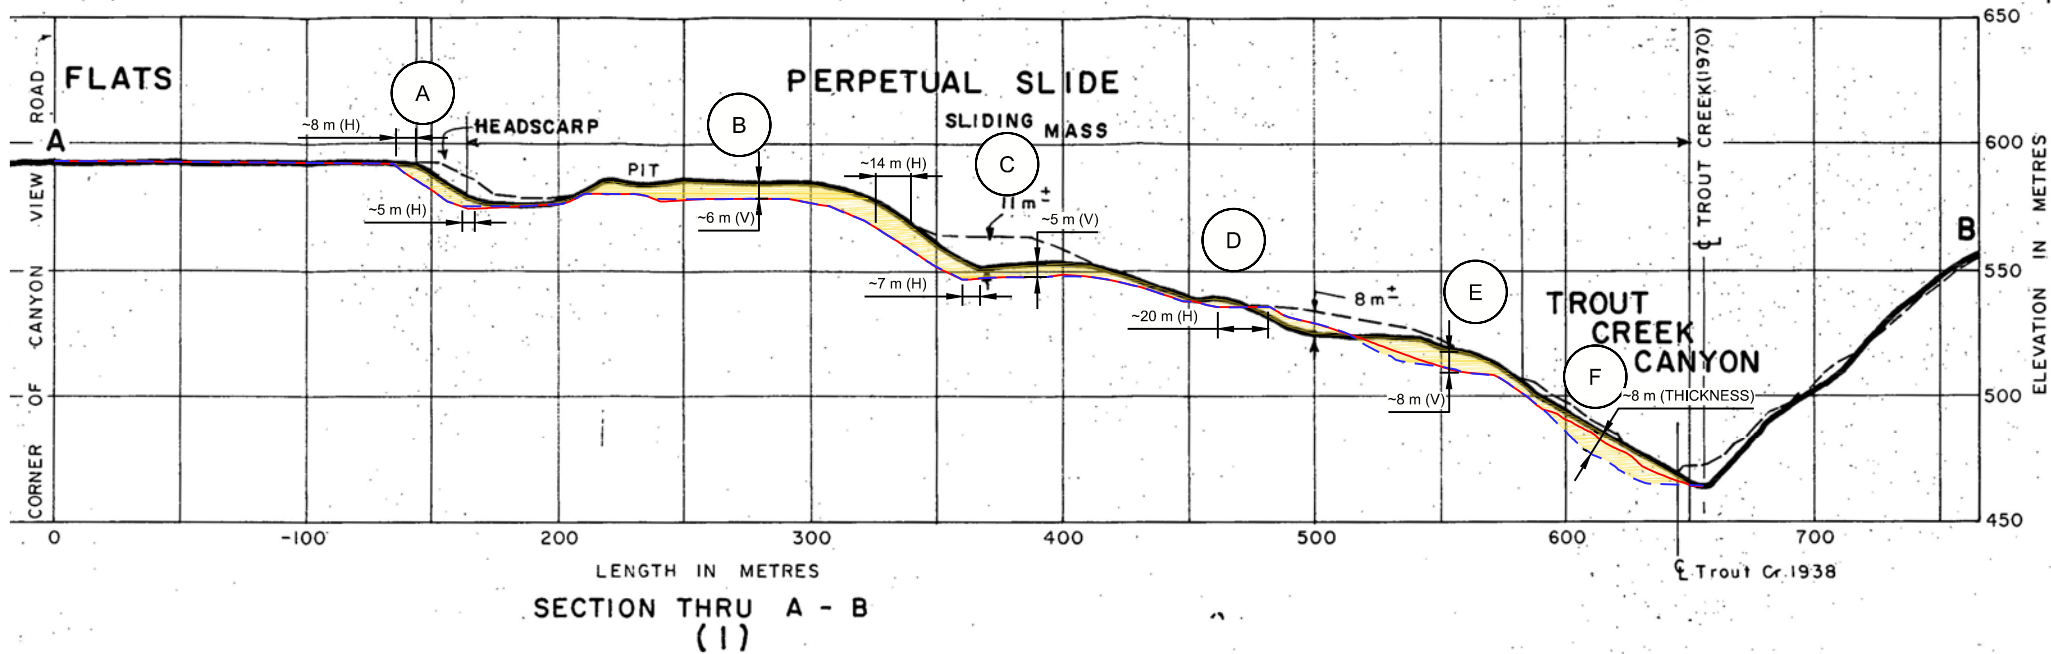
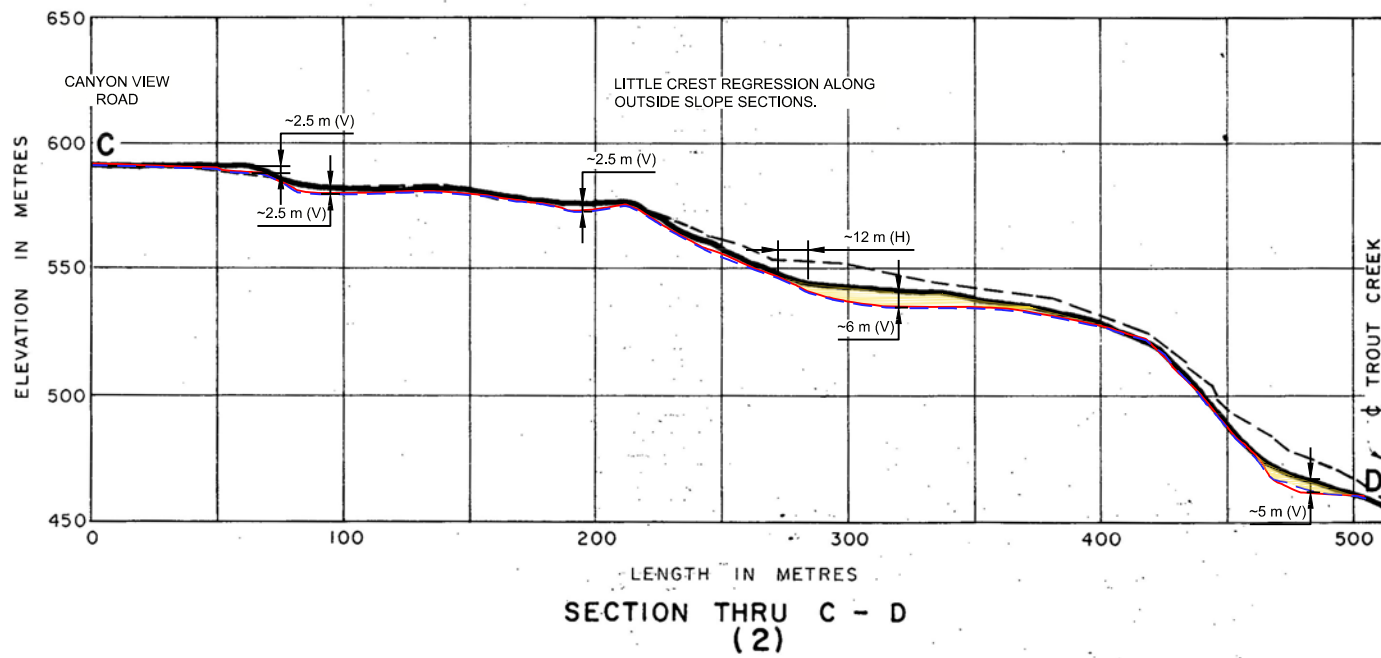
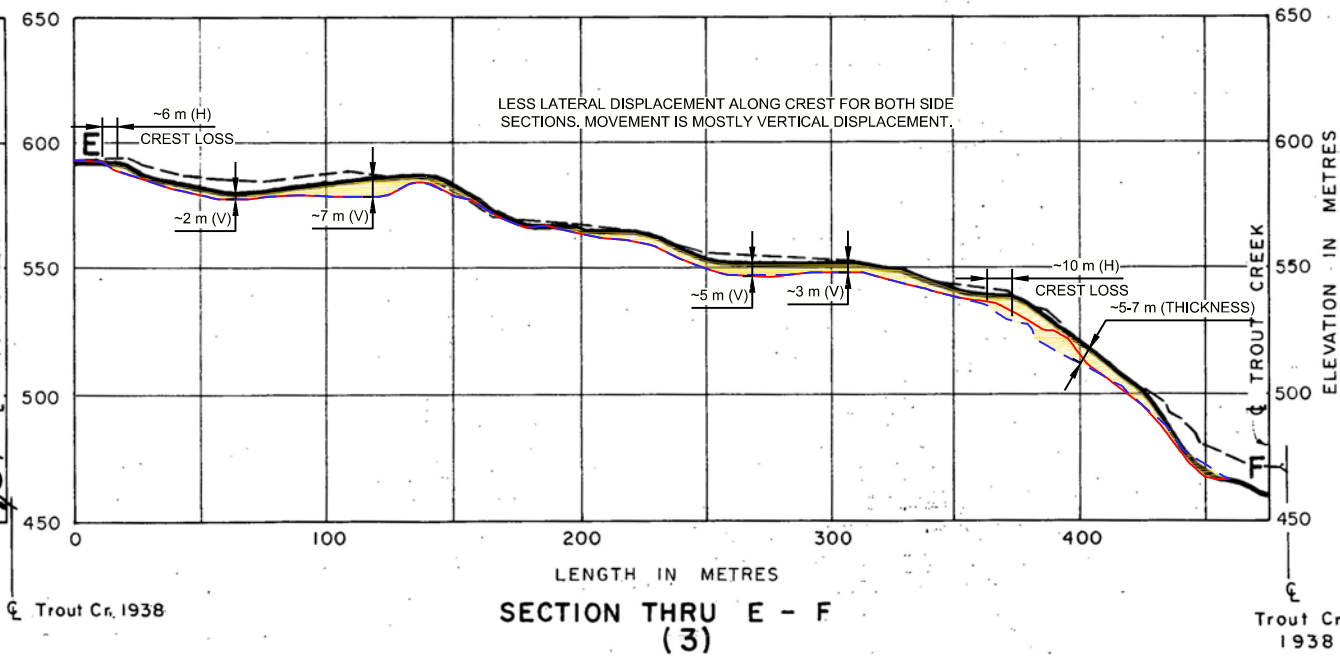
Using the 2005 and 2015 topography provided by DoS, slide profiles were also prepared from 3D surface models and compared using the same sections that were presented in Riglin’s Figure 1-2c. Calculations using average end areas for these sections indicate that the volume loss between 1970 and 2012 is very similar at about 15,700 m³ per year. It should be noted that this volume was calculated using the same profile length that extends between the head scarp down to the crest of the Trout Creek canyon and does not take into account for different levels of accuracy in the preparation of the topographic plans between the earlier and later years. The difference in the slide surfaces between each comparison year is shown by the shaded areas for each section on Figure 3.

Reference Label	Remarks (1970 to 2012)
A	Head scarp progressed by about 8 m with loss of material along entire slope face
B	Middle bench dropped by about 6 m with downslope face loss of about 14 m thickness
C	Graben below toe of middle bench has dropped by about 5 m with horizontal toe loss of about 7 m
D	Fresh scarps along bottom treeline has advanced downslope by about 20 m
E	Crest of canyon slope has dropped by about 8 m
F	Steep canyon face has regressed into the slope by about 15 m with a corresponding material thickness loss of about 8 m

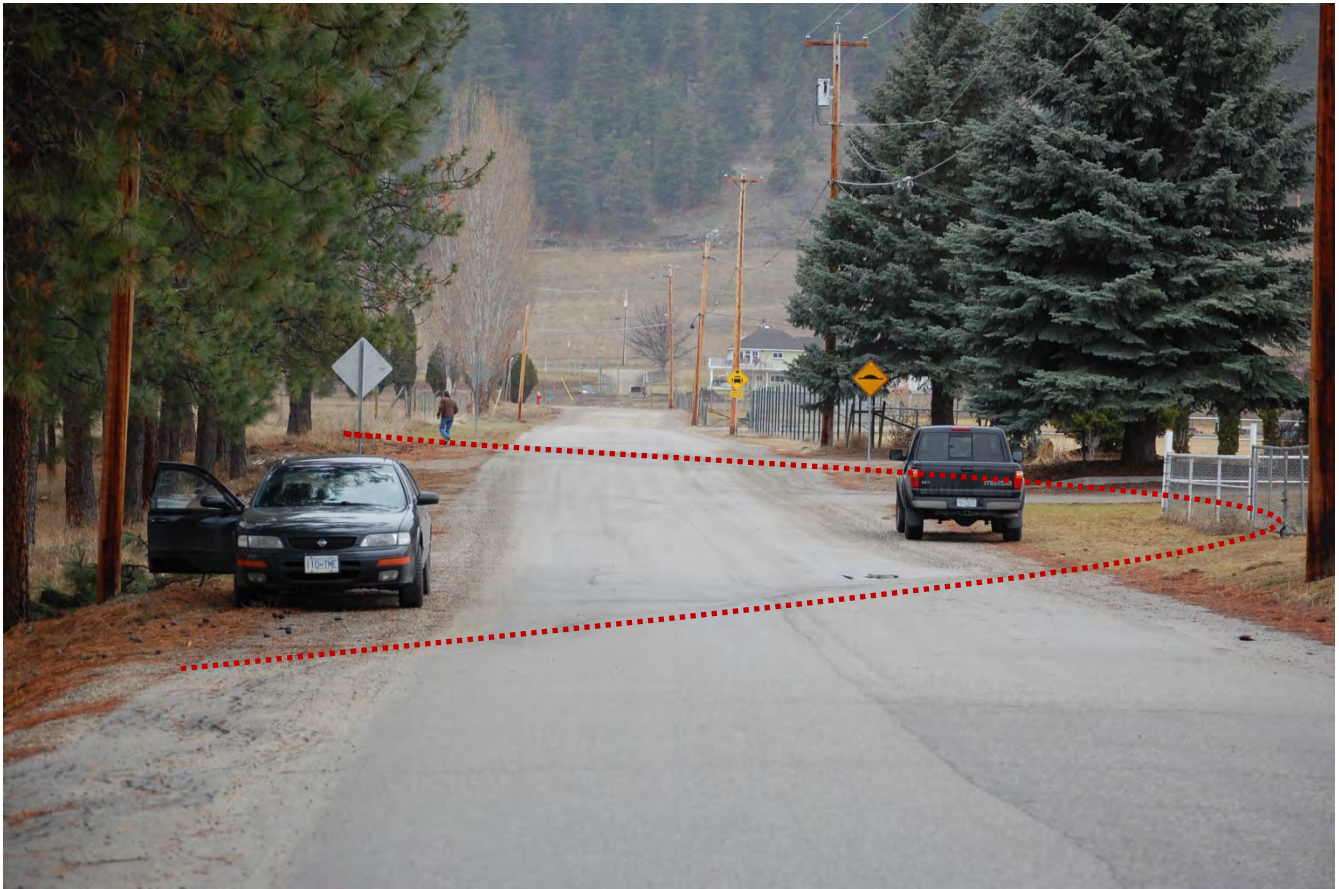
GPS Reference Locations	General Description of Site Features
TC1, TC2	<p>Localized roadway depression (dip) with patched pavement cracks at the east and west ends of Canyon View Road over a distance of about 95 m along the south edge of pavement (<i>Photograph 3801</i>).</p> <p>Water line breaks occurred in the 250 mm diameter pipe at each end of the road dip in 2012.</p> <p>A survey shows subsidence of up to about 52 cm has occurred along the outside south lane relative to its estimated original profile.</p> <p>A second crescent shaped crack has developed inside (south) of the larger outer crack within the last year or so (<i>Photograph 3809</i>). It is not known if this feature is associated with gradual post-break subsidence within the water line trench as a result of earlier water line breaks.</p> <p>The overall area of subsidence extends to a distance of about 5 m inside the property at 10920 Canyon View Road.</p>

Photograph 3801: Looking west along abrupt roadway depression (dip) that extends across both lanes and to about 5 m into the north property at 10920 Canyon View Road.

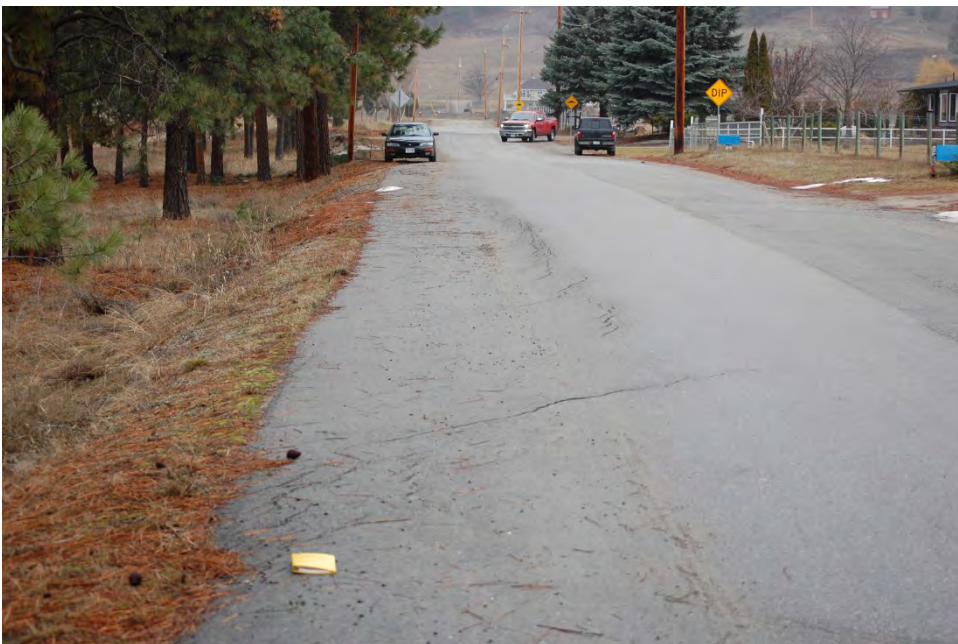
Photograph 3818: Looking west along south outside wheel path with numerous pavement cracks along section of embankment fill that occur in a repeating series having a diagonal pattern.

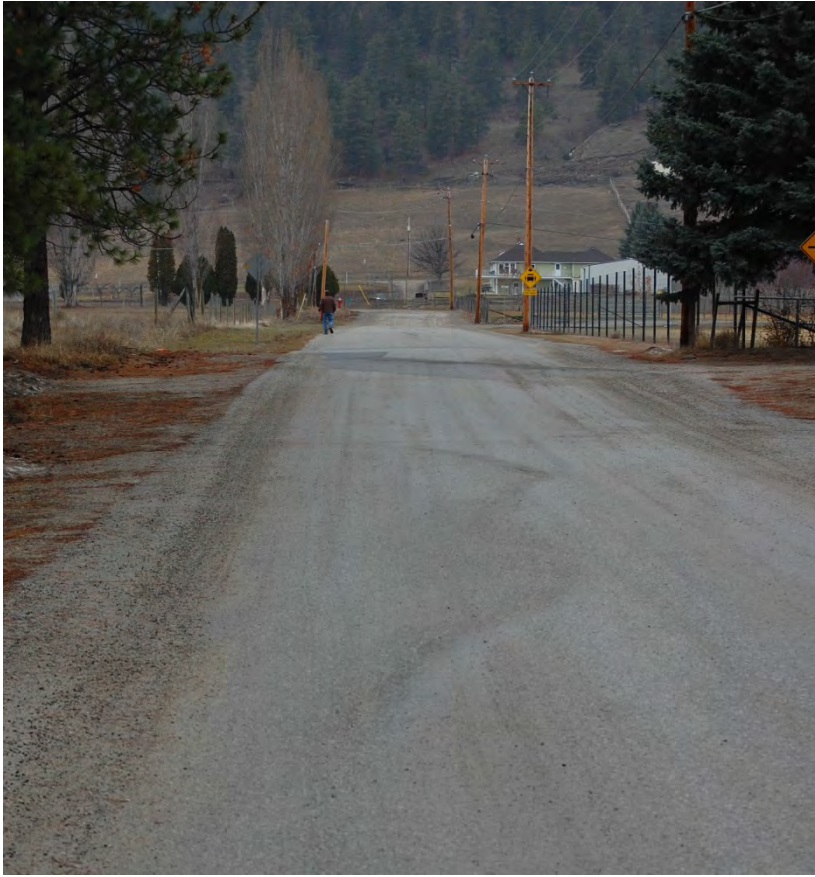
Photograph 3809: Looking west along Canyon View Road at inside crescent shaped crack that extends to about the roadway centre line. This feature has developed within the past year or so. The crack feature is about 25 m in length and has an abrupt drop of about 50 mm.

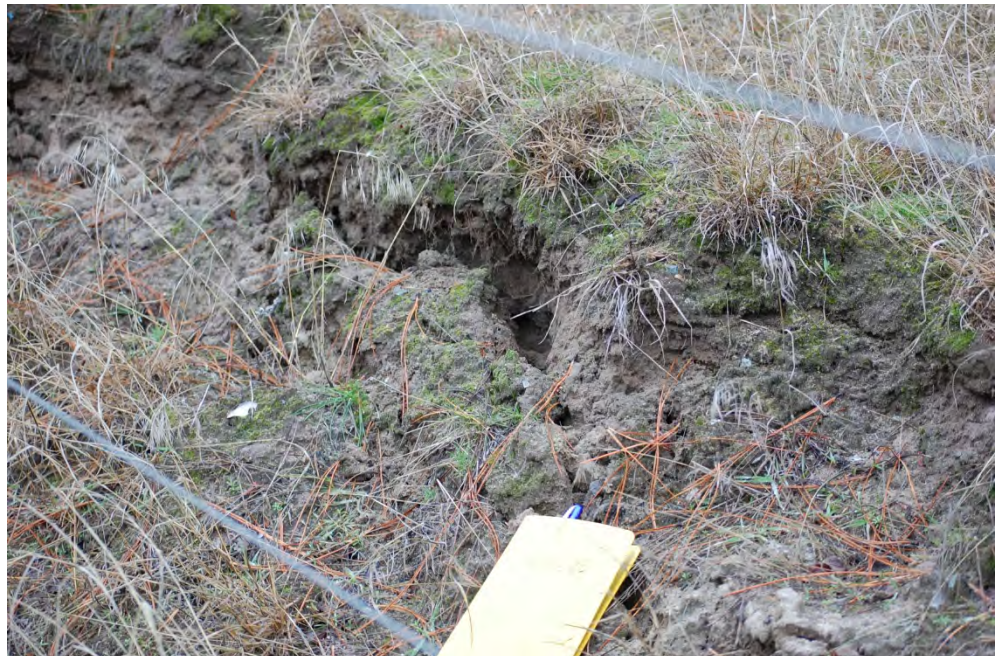
TC3, TC4	<p>Fresh tension crack development along slide head scarp where vertical and horizontal displacements extend up to about 10 to 15 cm within predominantly sand deposits (<i>Photograph 3837</i>).</p>

Photograph 3837: Looking southwest at fresh tension crack along slide head scarp where horizontal and vertical displacements of 10 to 15 cm exist within natural sand deposits.

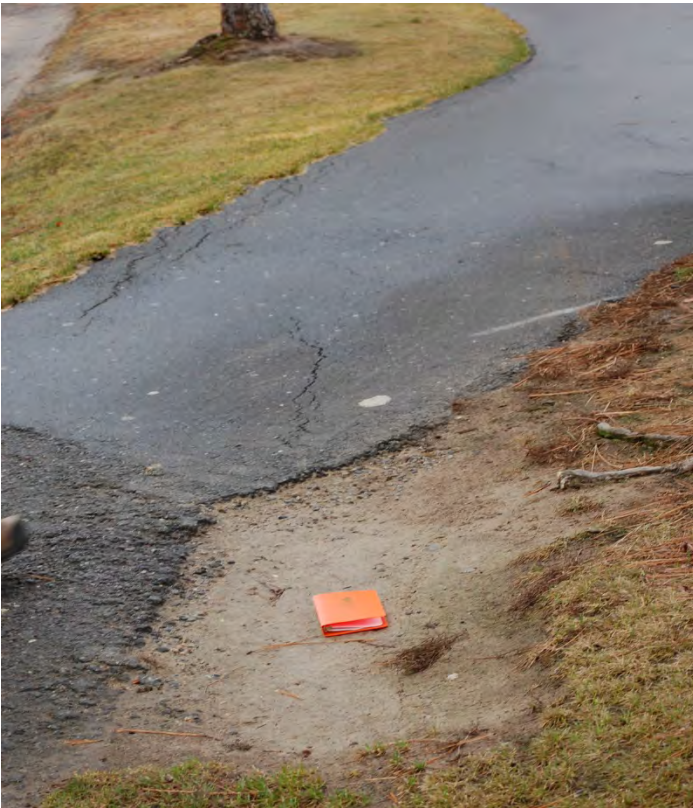
Photograph 3863: Looking south at pavement crack that runs across the golf course pathway and faintly continues across into the ground surface (right hand side of field book) where a 1 to 2 mm wide cracks runs parallel to the slide head scarp that is located about 10 m to the left of the photograph).

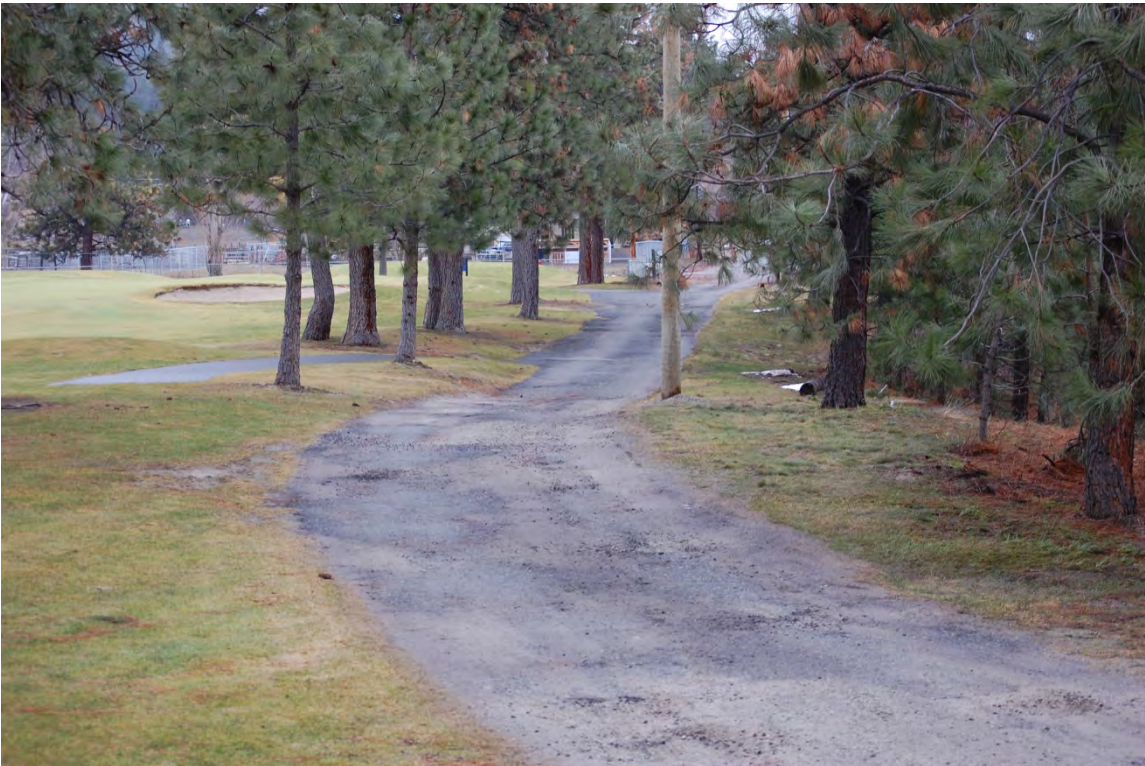
Photograph 3864: Looking north at localized depression along section of access road to the golf course maintenance yard. Piezometer/monument P1 is located about 10 m north of the narrow golf pathway (hidden behind larger trees) that runs to the left on the photograph.

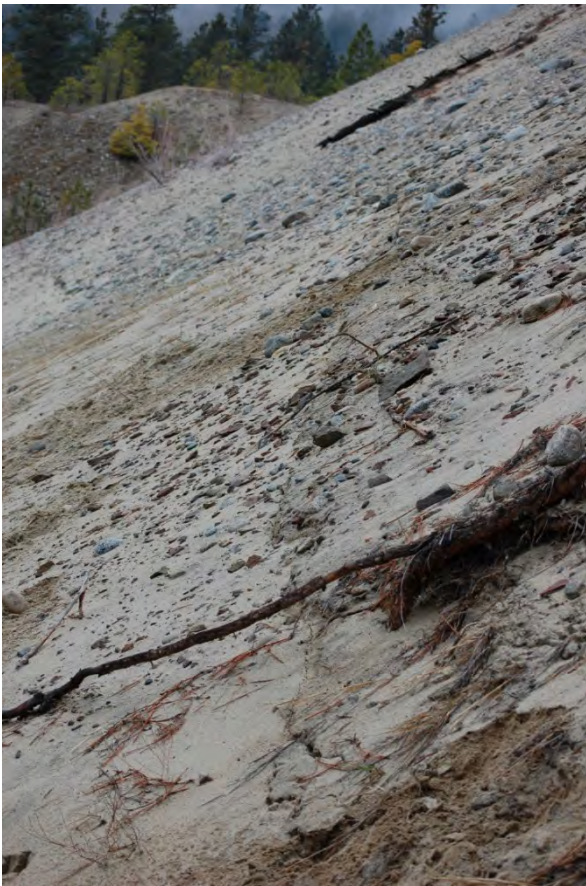
Photograph 3882 (left): Looking southwest along mid slope at recent tension crack (partially obscured by ravelled material) across sand and gravel face overlooking lower slide bench. Lack of grass, shrubs or small tree cover is indicative of ongoing ravelling from continuing creep movements.

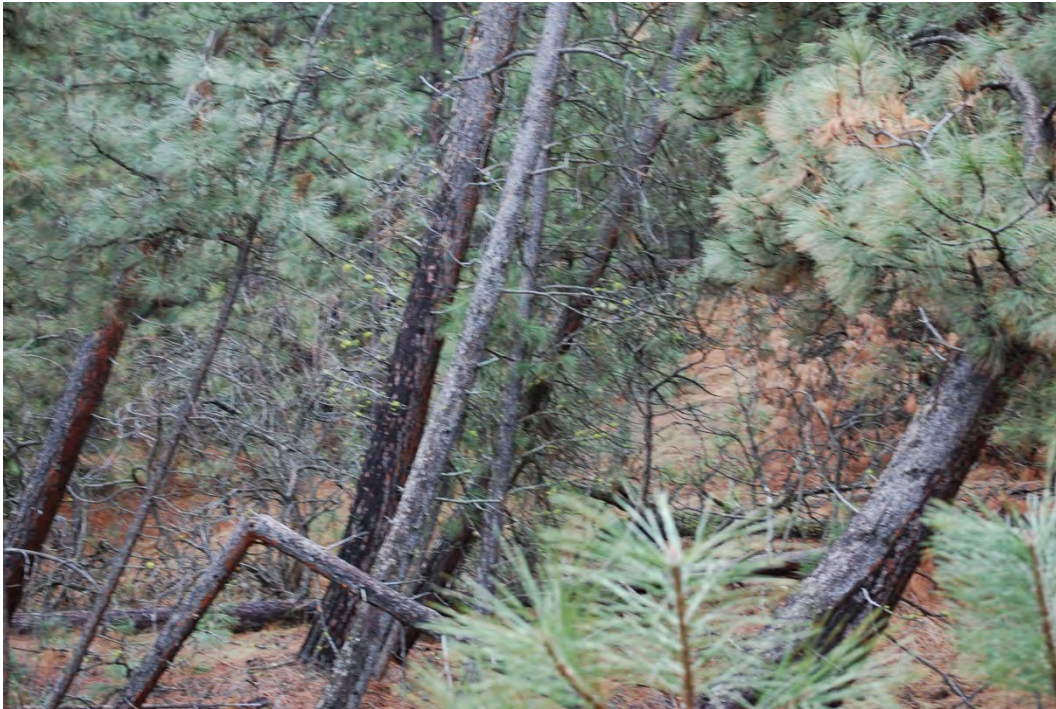
Photograph 3998: Looking west-northwest along crest of lower slide bench at rotational block failure where trees are leaning backwards into the slope, especially within graben areas. This area is located just upslope at the top left corner on the stitched photographs 3963-3965.

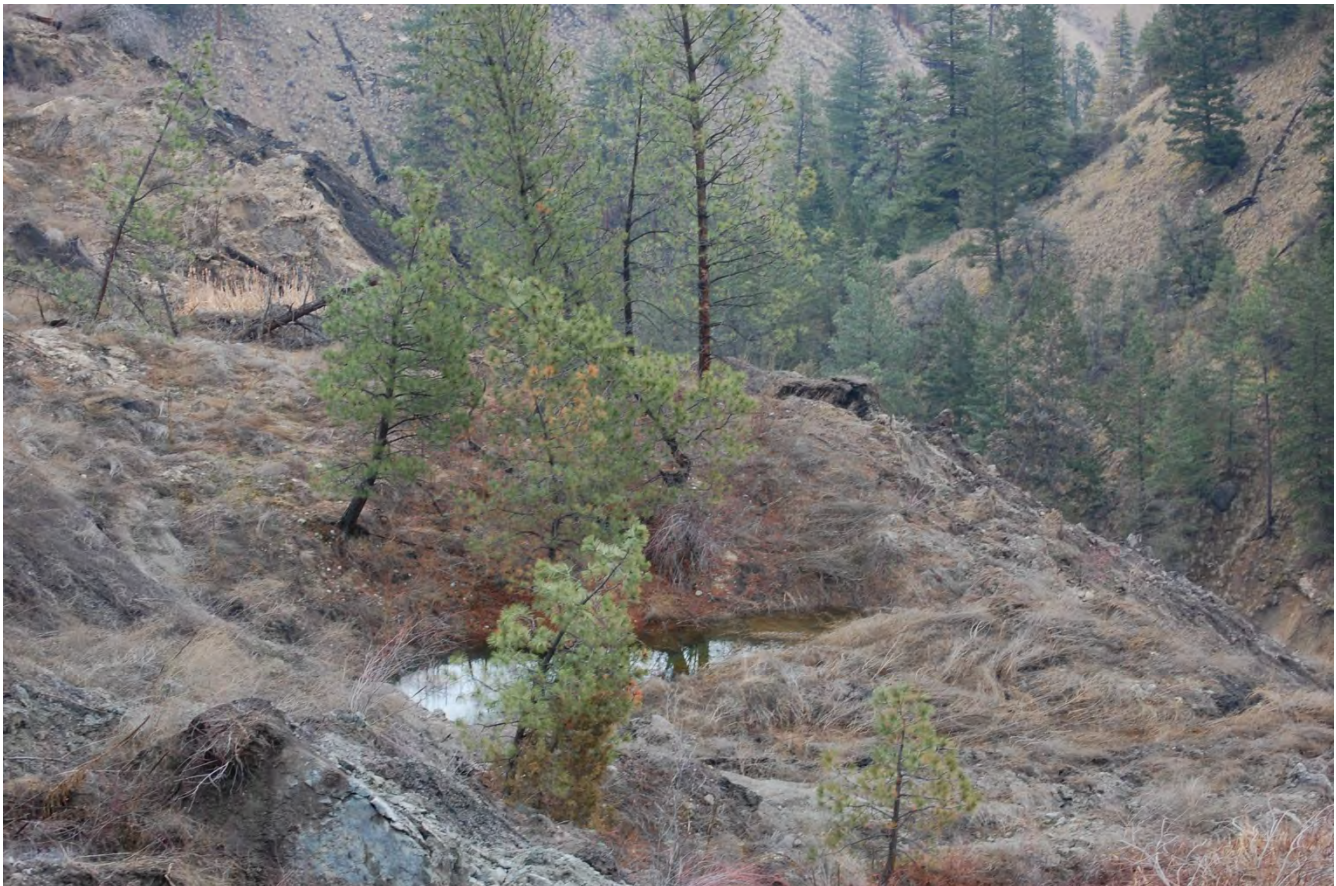
Photograph 3991: Looking southwest at large area of ponded groundwater seepage near middle of lower slide bench.

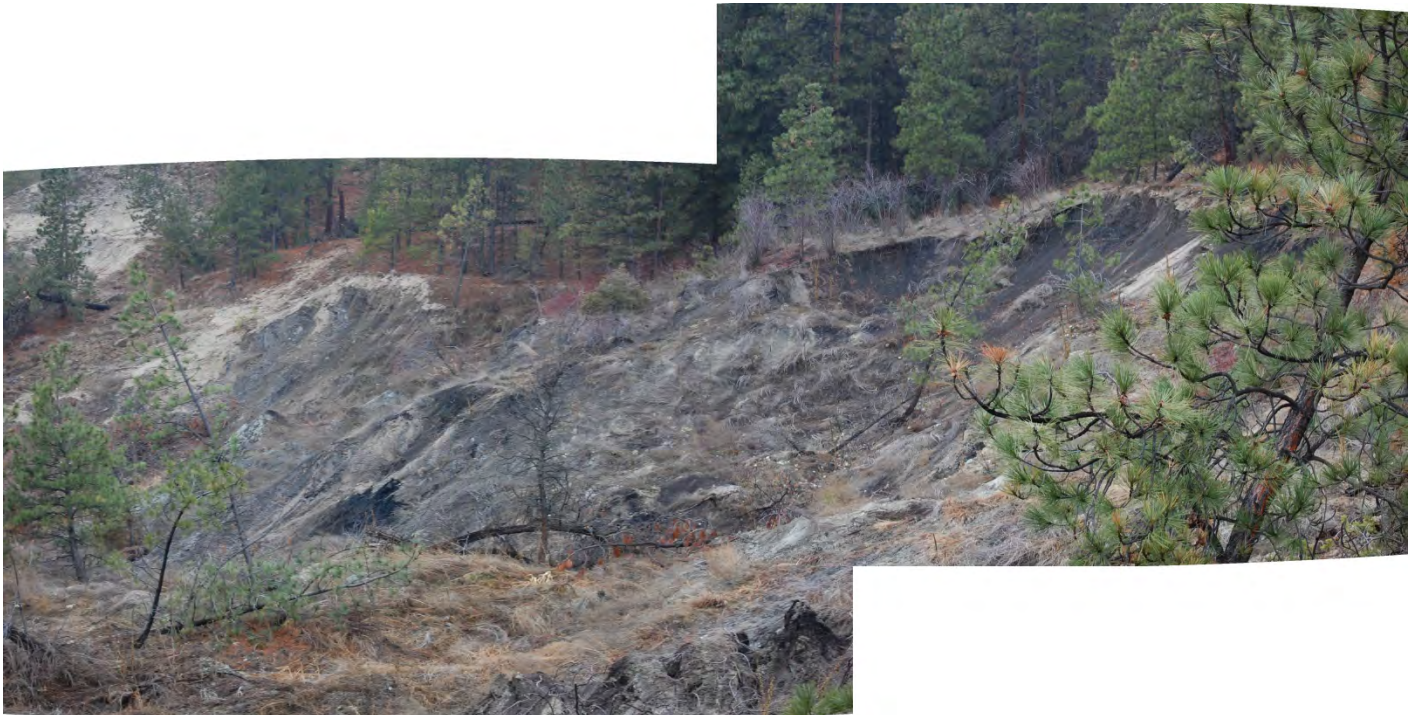
Stitched photographs 3940, 3942: Looking west-northwest along lower slide bench where significant slide activity is occurring. This area extends for a width of about 120 m towards the west slide flank.

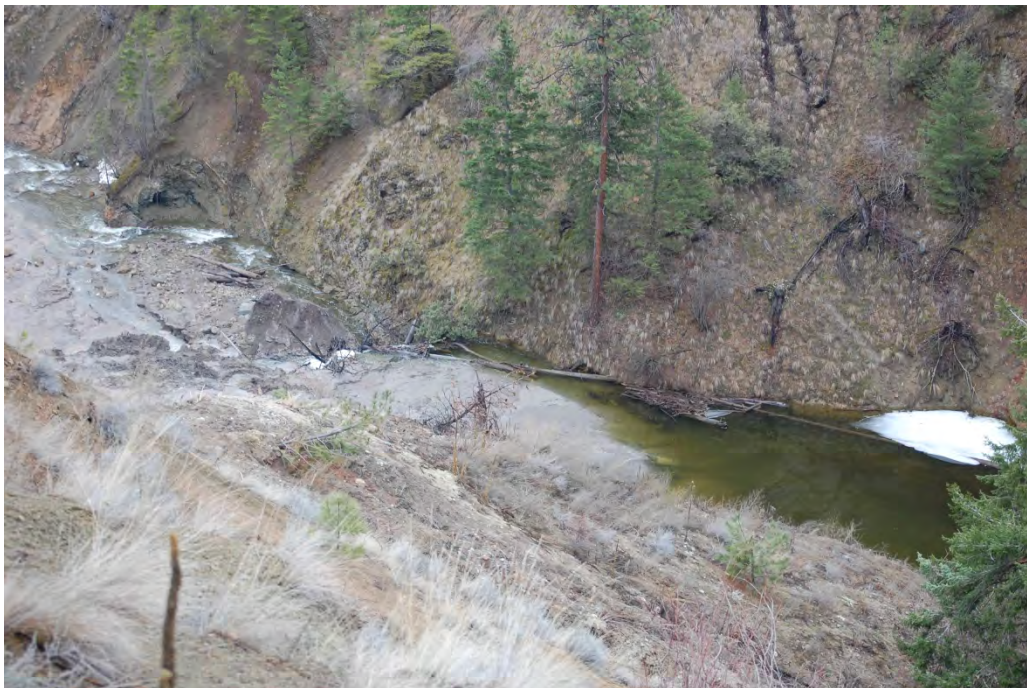
*Photograph 3994:
Looking south into
Trout Creek canyon from
GPS17 location at
channel flow
impingement caused by
accumulation of slide
debris resulting in the
backup of stream water
and pooling within the
channel.*
