# Technical Memorandum

| <b>Re:</b> | Preliminary Slope Hazard Assessment, Callan Rd and Bridgeman Rd<br>Summerland, BC |
| <b>Project No.</b> | 2605393 |

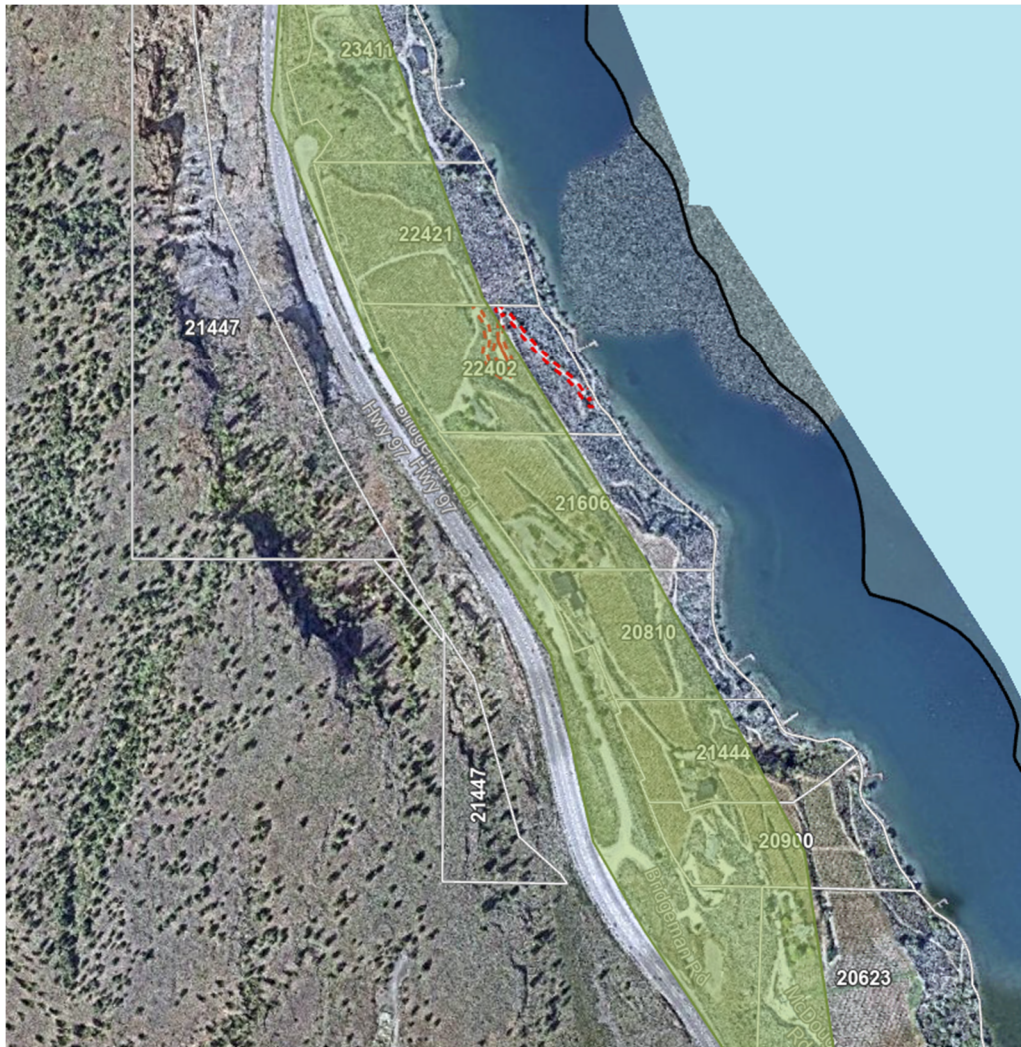
**Figure 2 – Bridgeman Rd Properties. Properties not considered at increased risk from slope hazards (Green). Approximate Photo locations in pink. Imagery from DoS Spatial Viewer August 20, 2026.**

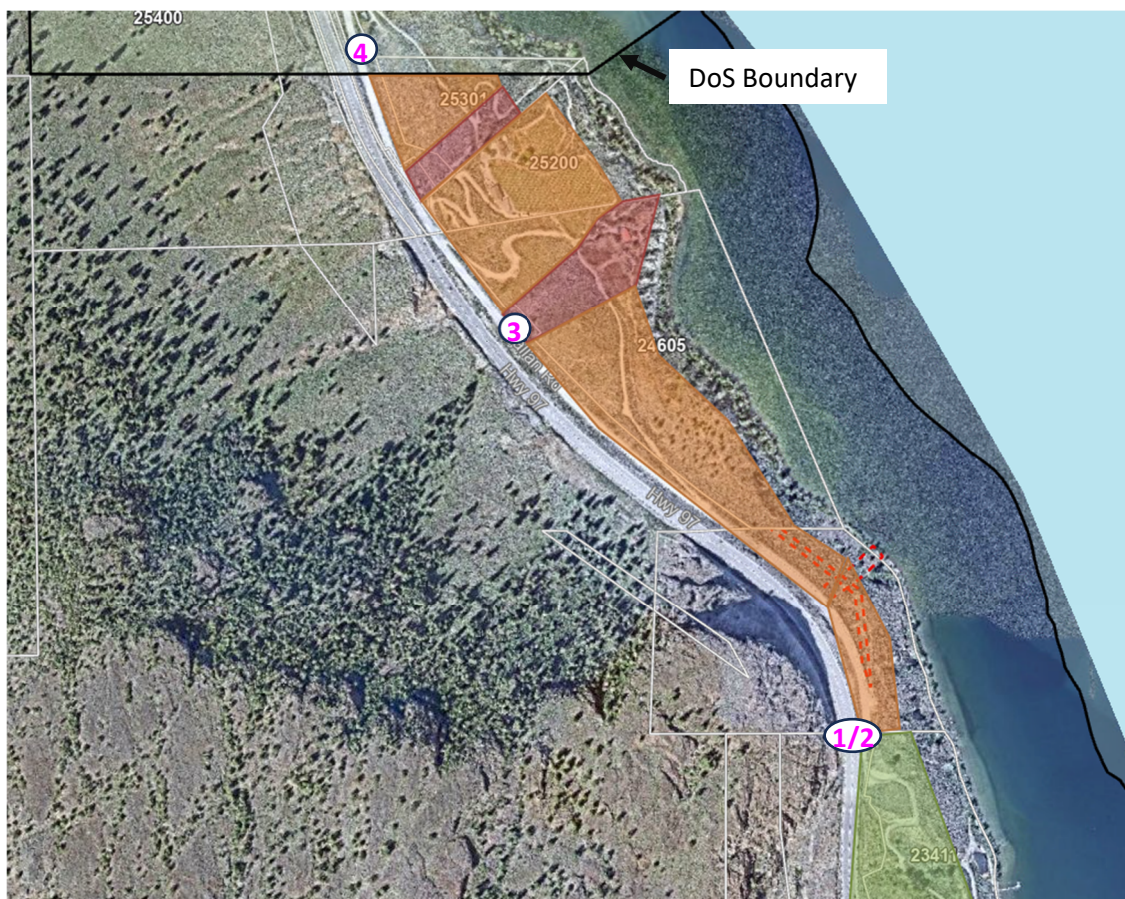
**Figure 3 - Callan Rd Properties Potentially Impacted by Post-Wildfire Slope Hazards (Red and Orange). Properties not considered at increased risk from slope hazards (green). Approximate Photo locations in pink. Imagery from DoS Spatial Viewer August 20, 2026.**

For the purposes of the initial assessment and re-entry criteria development it is Terrane's recommendation that homes immediately downhill of fire impacted slopes, or downslope of fire impacted drainages, are evacuated if the Zone 5 precipitation criteria are met (Table 1). Impacted properties in the Cartwright neighbourhood are shown in Figures 2, 3, and 4, below. Red areas have a higher risk of long term impacts due to slope height and or/grade, runoff channels, or known historic drainages.

- Impacted properties should remain evacuated until 24 hours after the end of the rain event for 1 hour, 12 hour, and 24 hour criteria, or 48 hours after the end of the rainfall event if the 48 hour criteria is exceeded (see Table 1), or after an assessment by a qualified professional engineer.
- A rainfall gauge with remote monitoring and alarm capabilities should be placed within 2.5 km and 150 m of elevation of the impacted areas. If remote monitoring is not available, then the gauge should be checked hourly during significant rainfall. Snowmelt is not included in the criteria detailed in this memo.

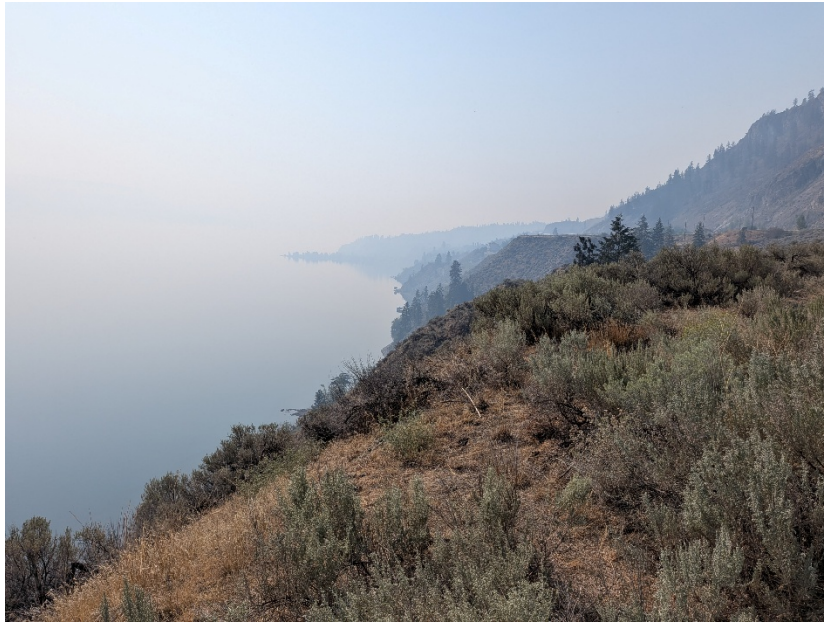
- Bridgeman Rd appeared to be unaffected by the wildfire. Burnt areas were noted on the west (high) side of Highway 97, but potential debris is unlikely to affect properties on the low (east) side. There are no homes on the west side of Highway 97 in the Bridgeman Rd area (Photo 1).
- Callan Rd had extensive impacted areas both above and below Highway 97. Only the portion of Callan Rd within the DoS (south and east of the Hwy 97 intersection) are included in this memorandum.
- Fire intensity in the impacted area of Callan Rd varied (Photos 2-5).
- Two existing gullies were noted in the burned area, with one potential runout zone impacting a house and buildings on 24605 Callan Rd (Photo 4).

Photo 1. From the south end of Callan Rd, looking south toward Bridgeman Rd. No significant burn impact on the east of Hwy 87 from this point south.

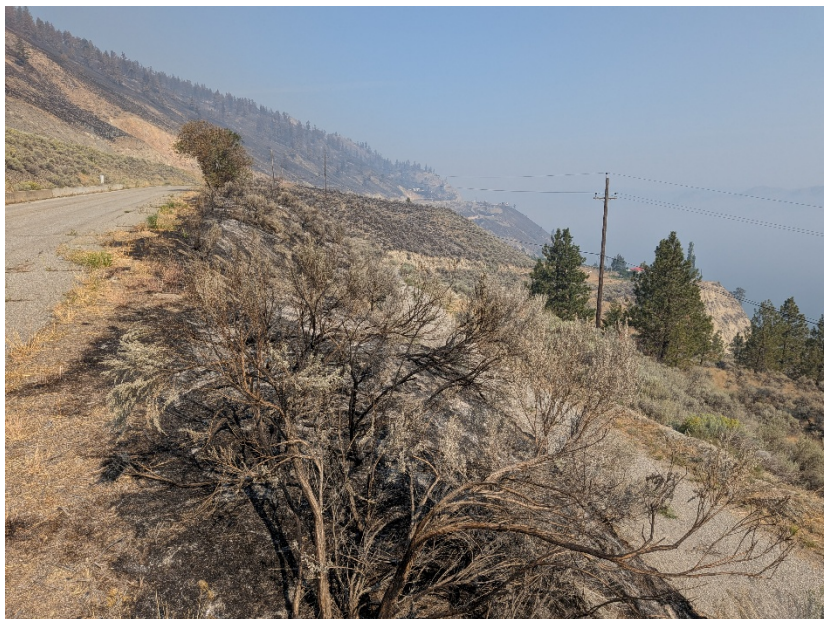
Photo 2. South end of Callan Rd, looking north. Beginning of burn area.

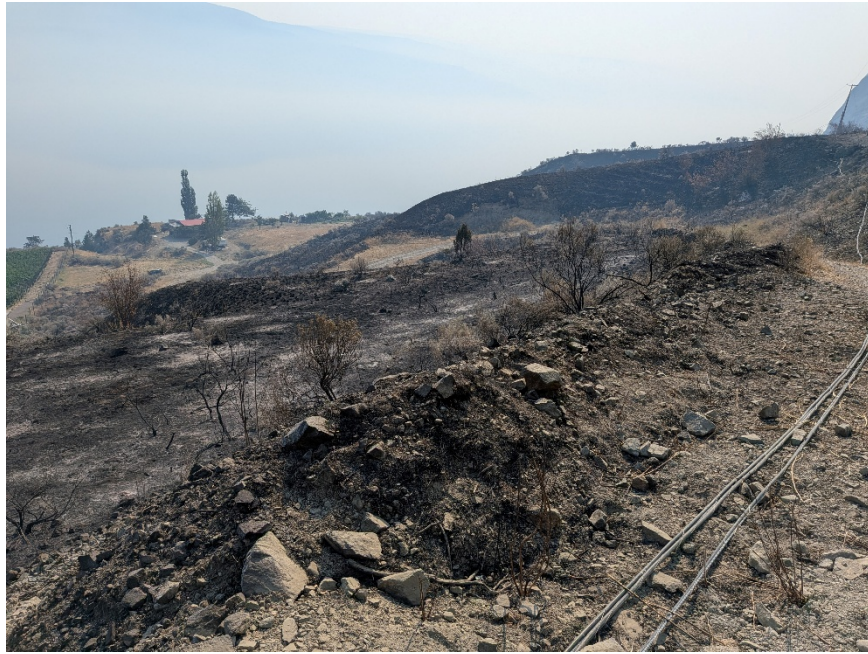
Photo 3. Callan Rd intersection looking southeast.

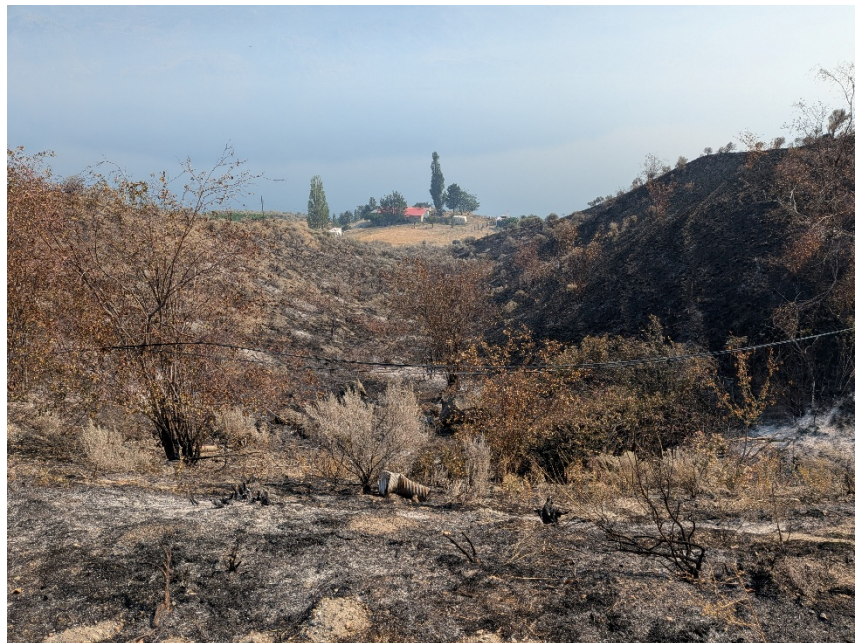
Photo 4. From Callan Rd looking east down a burned gully at 24605 Callan Rd.
