# Technical Memorandum

| <b>Re:</b> | Preliminary Slope Hazard Assessment, Cartwright, Rev 1<br>Summerland, BC |

**Photographs – TGI 1-9**

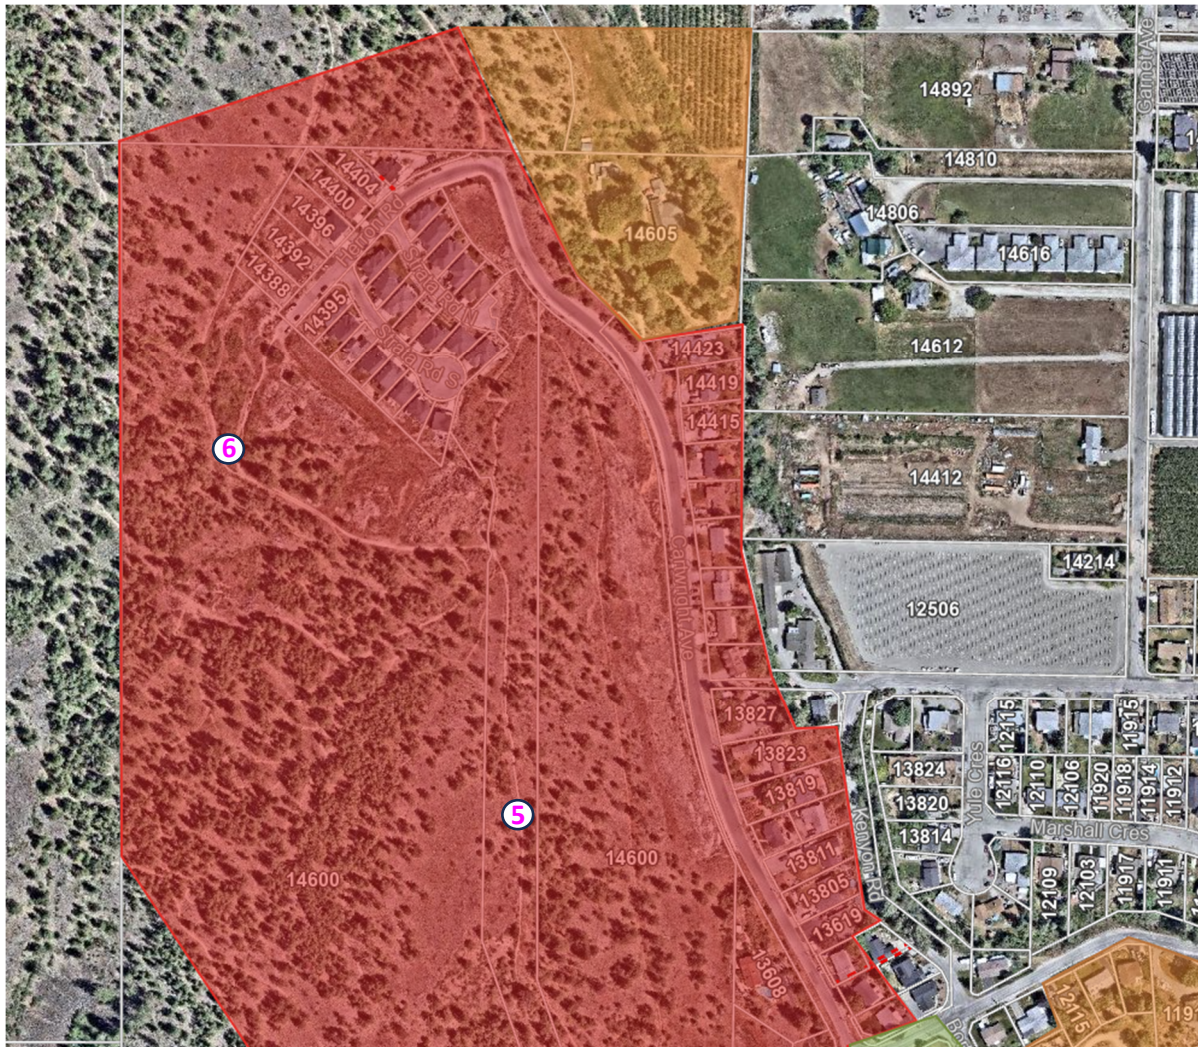
**Figure 2 – Cartwright Properties Potentially Impacted by Post-Wildfire Slope Hazards (Red and Orange). Properties not considered at increased risk from slope hazards (Green). Approximate Photo locations in pink. Imagery from DoS Spatial Viewer August 17, 2026.**

For the purposes of the initial assessment and re-entry criteria development it is Terrane's recommendation that homes immediately downhill of fire impacted slopes, or downslope of fire impacted drainages, are evacuated if the Zone 5 precipitation criteria are met (Table 1). Impacted properties in the Cartwright neighbourhood are shown in Figures 2, 3, and 4, below. Red areas have a higher risk of long term impacts due to slope height and or/grade, runoff channels, or known historic drainages.

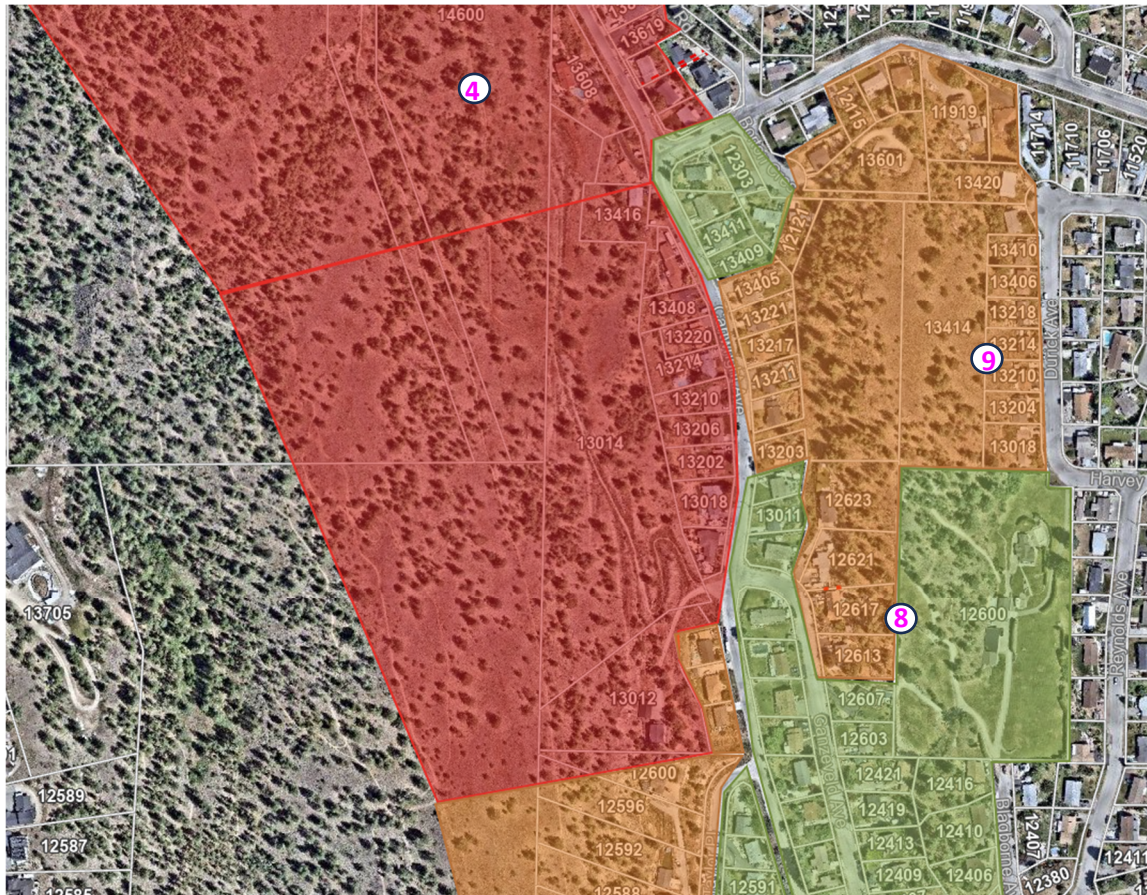
- Properties on the west side of Durick Ave, a portion of Jubilee Rd W, Borton Cres, and the east side of Cartwright Ave are potentially impacted by the burned areas on Cartwright Mountain (See Figure 3) (Photos 9).

**Figure 3 - Cartwright Properties Potentially Impacted by Post-Wildfire Slope Hazards (Red and Orange). Properties not considered at increased risk from slope hazards (green). Approximate Photo locations in pink. Imagery from DoS Spatial Viewer August 17, 2026.**

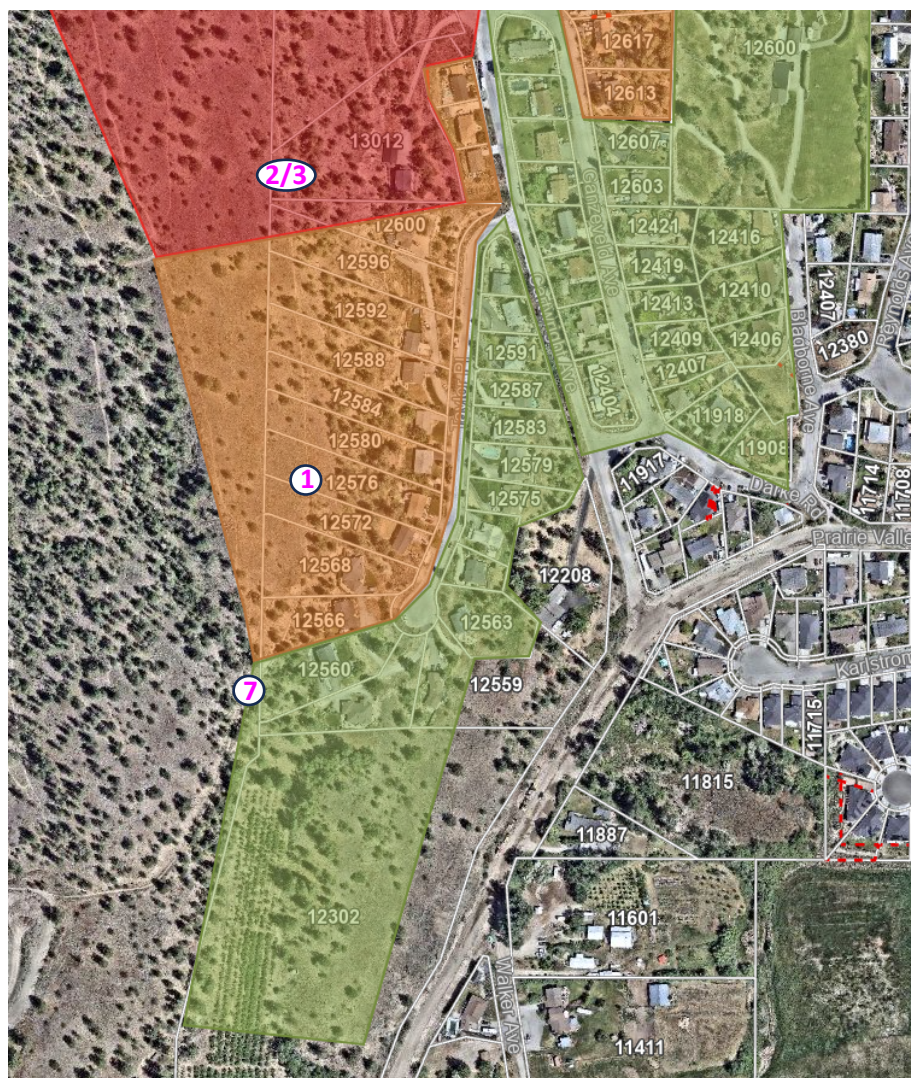
**Figure 4 - Cartwright Properties Potentially Impacted by Post-Wildfire Slope Hazards (Red and Orange). Properties not considered at increased risk from slope hazards (Green). Approximate Photo locations in pink. Imagery from DoS Spatial Viewer August 17, 2026.**

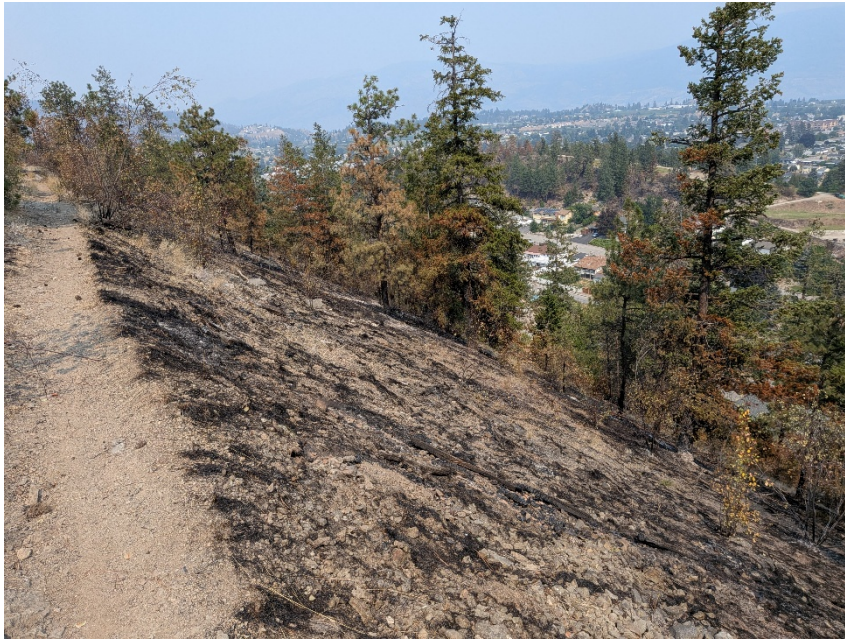
- The majority of the undeveloped area west of Carwright was impacted by the fire, and the burn appeared to be of varying intensity (Photos 1-4).
- In the area upslope of Carwright Ave and Herron Road fire intensity appeared to be higher, with many burned roots, little to no surviving vegetation, and multiple smoldering roots and voids (Photos 3-4).

Photo 1. Upslope (west) of Taylor Ave looking north.

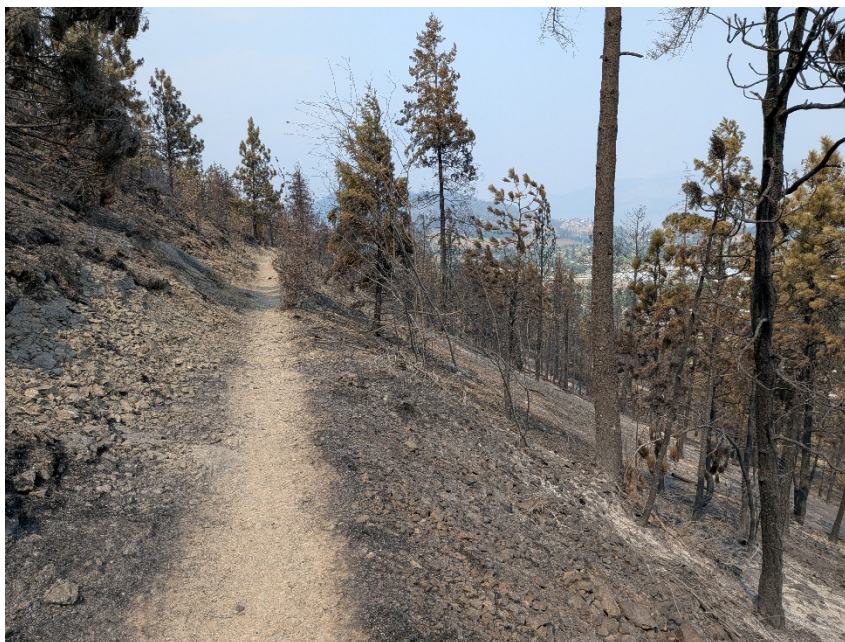
Photo 2. Upslope (west) of Cartwright Ave looking north.

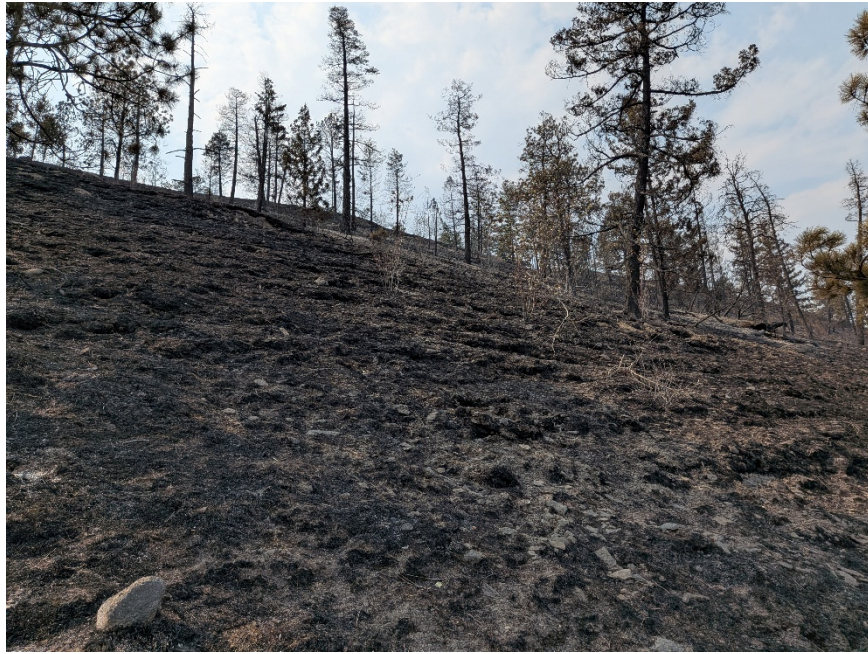
Photo 3. Upslope (west) of Cartwright Ave looking west.

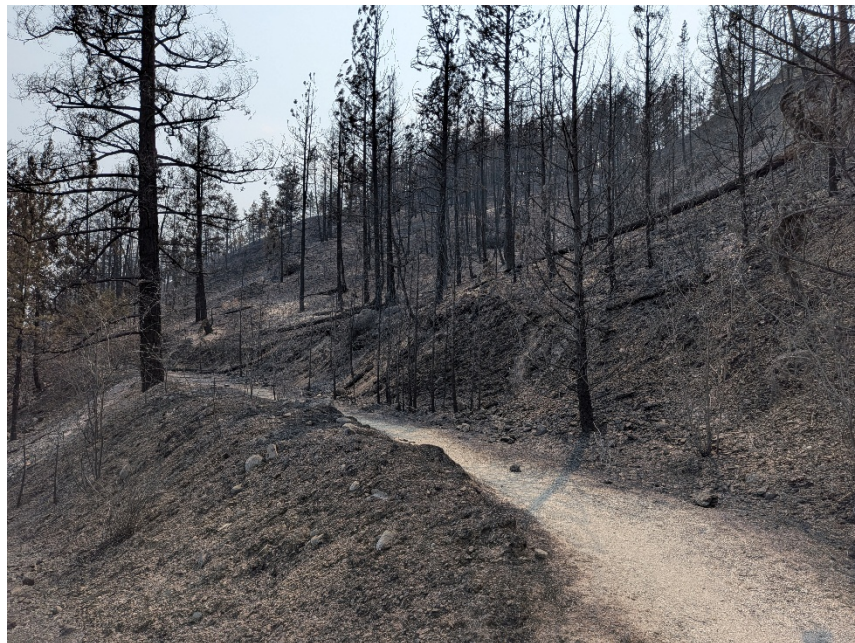
Photo 4. Upslope (west) of Cartwright Ave looking south.

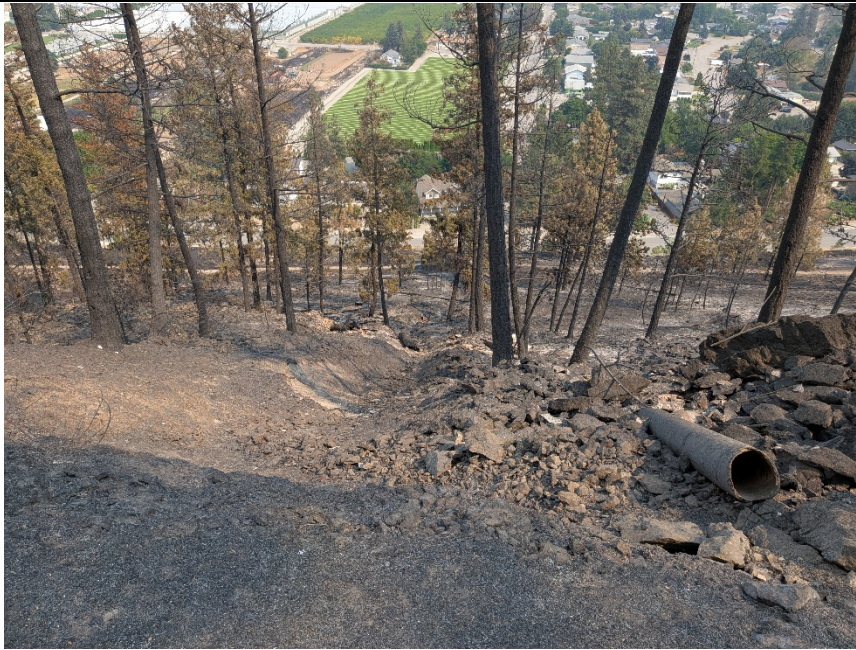
- The area above the northern portion of Carwright Ave had multiple pre-existing eroded runoff channels above and below the traversed trail (Photo 5).
- The area above Herron Rd and the strata properties at the north end of Cartwright Ave has a large runoff gully. This area has historically had significant water during periods of high groundwater, excessive rainfall, and snowmelt (Photo 6).

Photo 5. Slope uphill (west) of Cartwright Ave looking east, at pre-existing erosion channels.

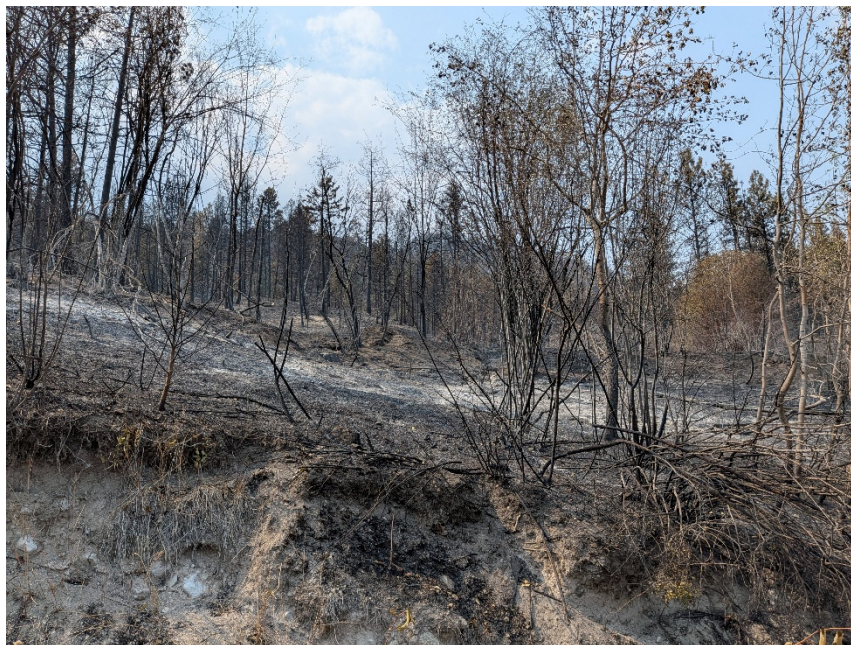
Photo 6. Slope uphill (west) of Herron Rd strata looking west, up the larger drainage.

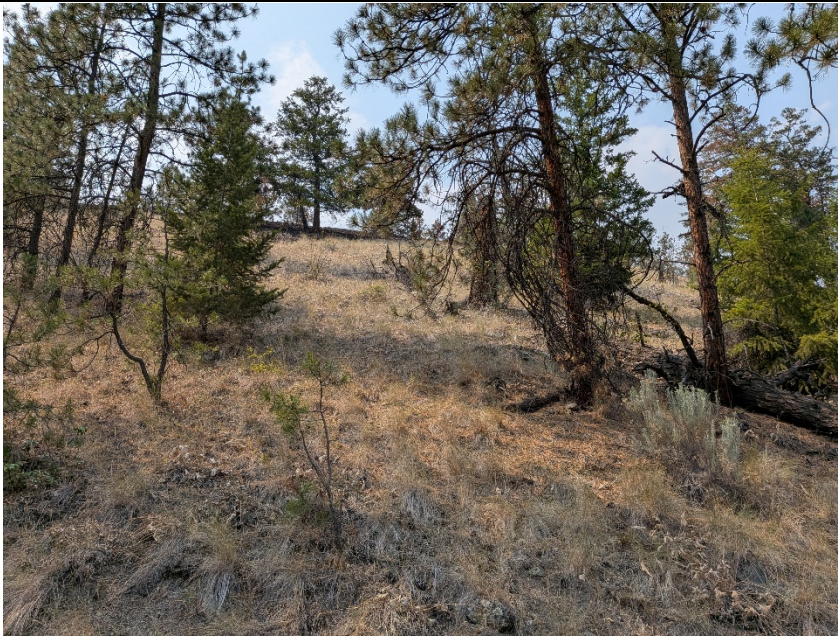
- The area above (west) and south of the southernmost properties on Taylor Place was unburnt (Photo 7)
- A portion of Cartwright Mountain, east of the main interface burn area, was also significantly impacted (Photo 8) A large, irrigated, property at 12600 Blagborne Ave was not significantly impacted.

Photo 7. Slope upslope (west) of the south end of Taylor Place, looking west.

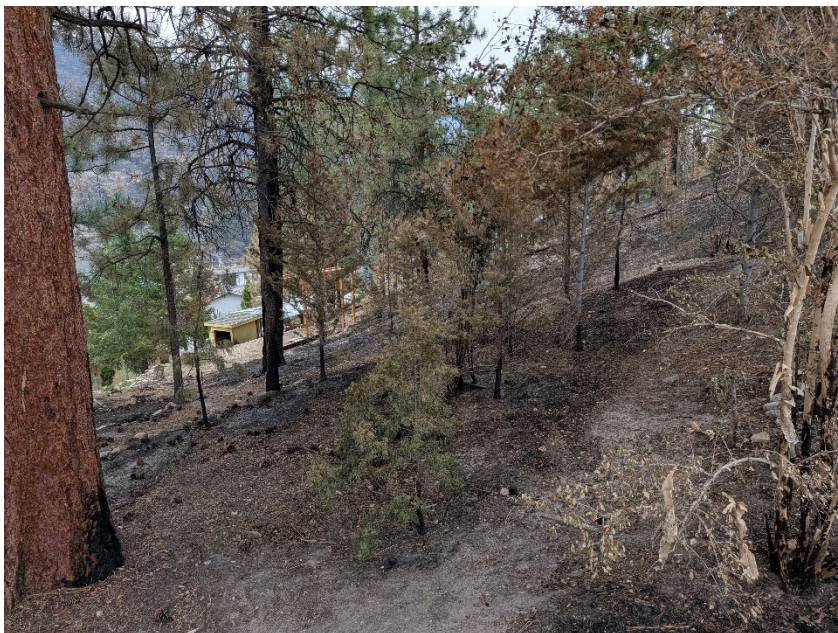
Photo 8. Slope upslope (east) of properties on the east side of Cartwright Ave, on Cartwright Mountain, looking northwest.

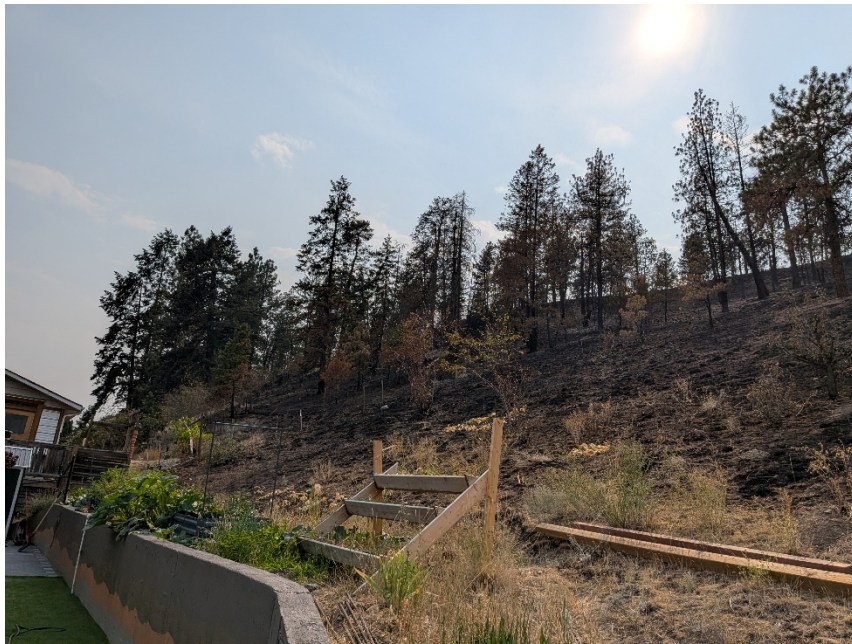
Photo 9. Slope upslope (west) of Durick Ave on Cartwright Mountain, looking southwest.
