# Technical Memorandum

| <b>Re:</b> | Preliminary Slope Hazard Assessment, Deer Ridge and Prairie Valley<br>Summerland, BC |
| <b>Project No.</b> | 2605393 |

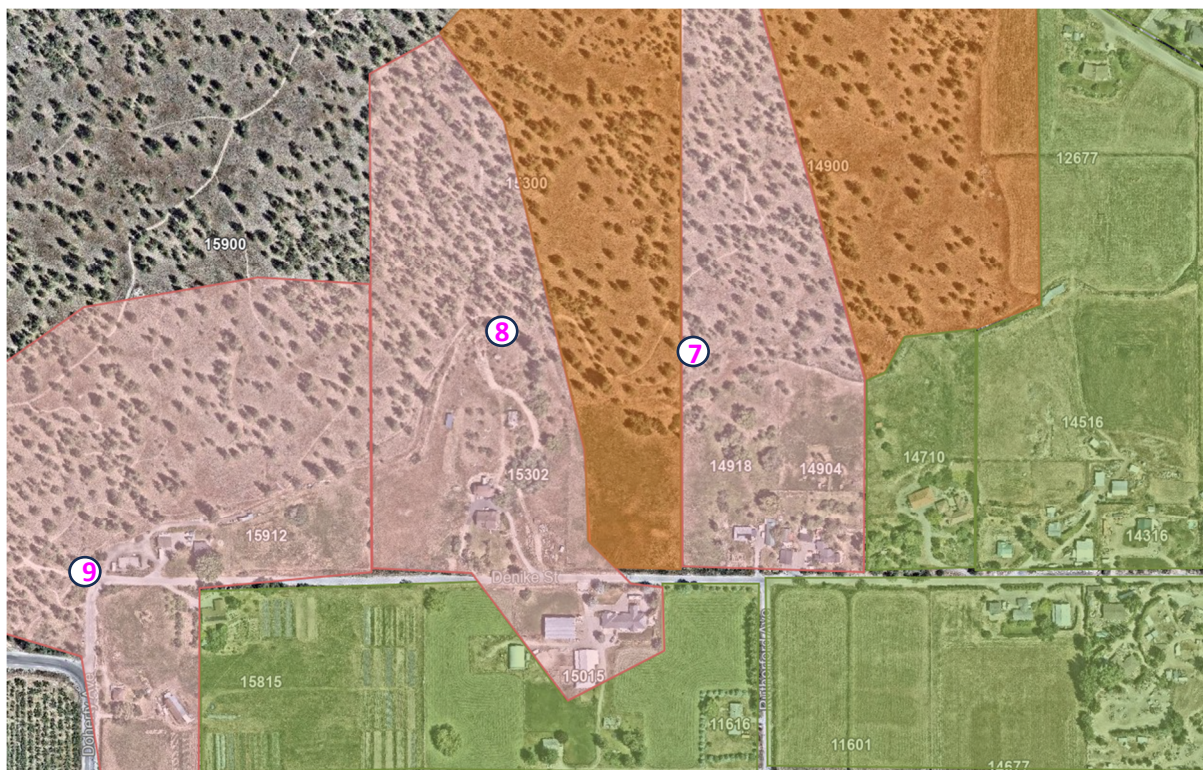
**Figure 4 – Prairie Valley North Properties Potentially Impacted by Post-Wildfire Slope Hazards (Red and Orange). Properties not considered at increased risk from slope hazards (Green). Approximate Photo locations in pink. Imagery from DoS Spatial Viewer August 20, 2026.**

For the purposes of the initial assessment and re-entry criteria development it is Terrane’s recommendation that homes immediately downhill of fire impacted slopes, or downslope of fire impacted drainages, are evacuated if the Zone 5 precipitation criteria are met (Table 1). Impacted properties in the Cartwright neighbourhood are shown in Figures 2, 3, and 4, below. Red areas have a higher risk of long term impacts due to slope height and or/grade, runoff channels, or known historic drainages.

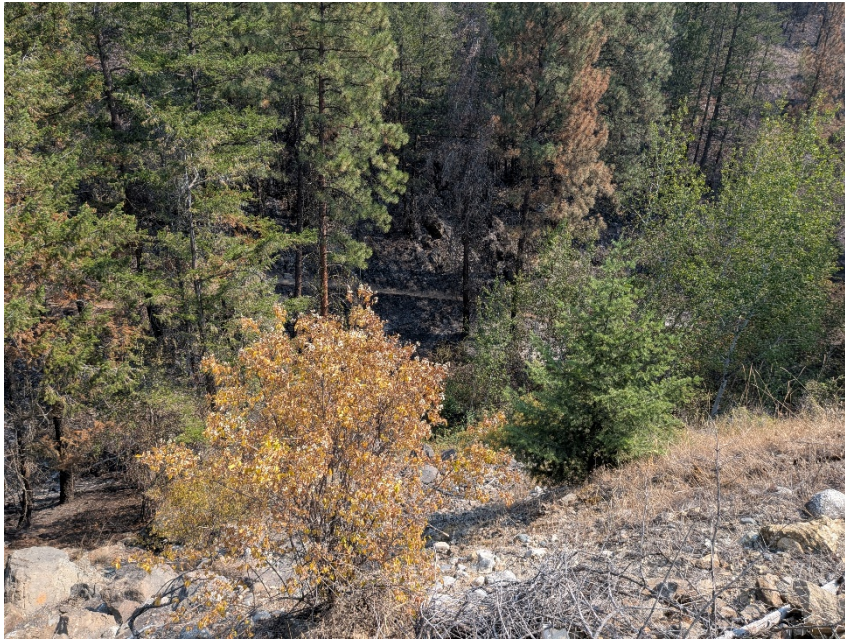
- The south portion of Deer Ridge, including all homes on Summergate Dr, Sunset Pl, Sunset Crt, and the majority of Morrow Ave were unburnt.
- The Summerland solar farm was not directly impacted by the wildfire, however the upper portion of the drainage in which it is situated was burnt, and therefore it may be impacted by wildfire related secondary hazards (Photo 1).

Photo 1. Looking down (east) into the gully which drains south to the solar farm.

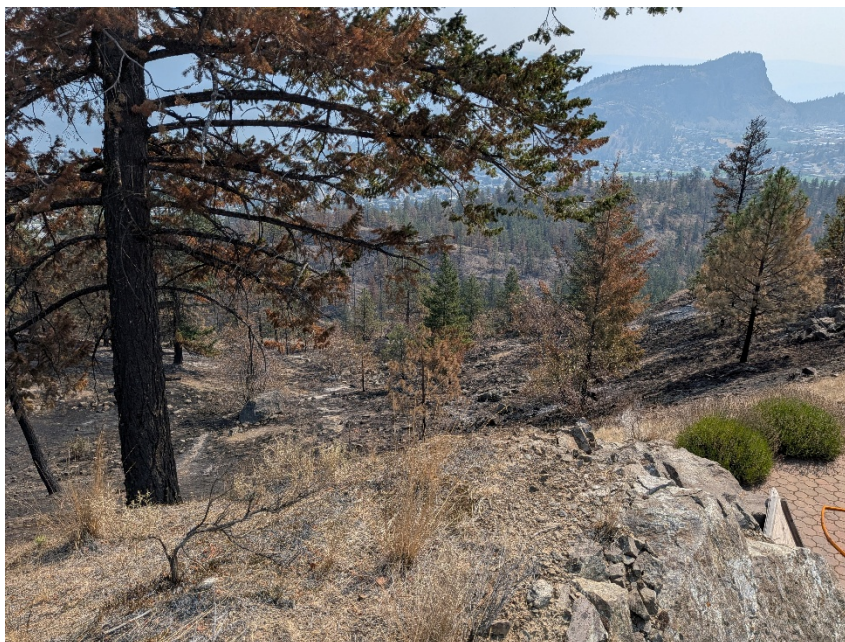
- On two properties at the east end of the Hermiston Dr (13455 and 13462) the dwellings are situated above the wildfire impacted slopes and gullies. However, other areas of the property including the driveways were impacted and may be impacted by future rain events (Photos 2 and 3).

Photo 2. Looking west from 13455 Hermiston Dr down a burn gully.

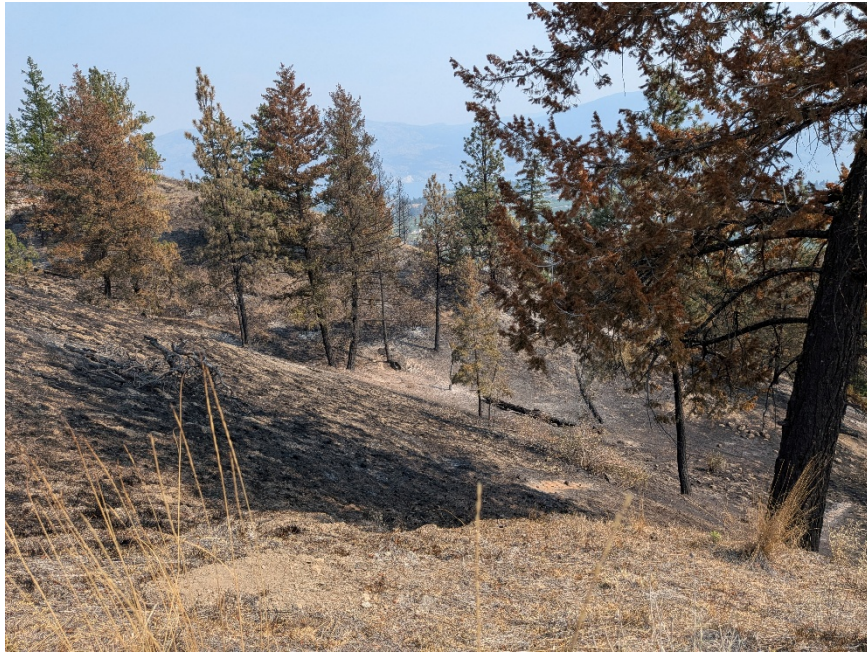
Photo 3. Burned slope below the house on 13462 Hermiston Dr looking west.

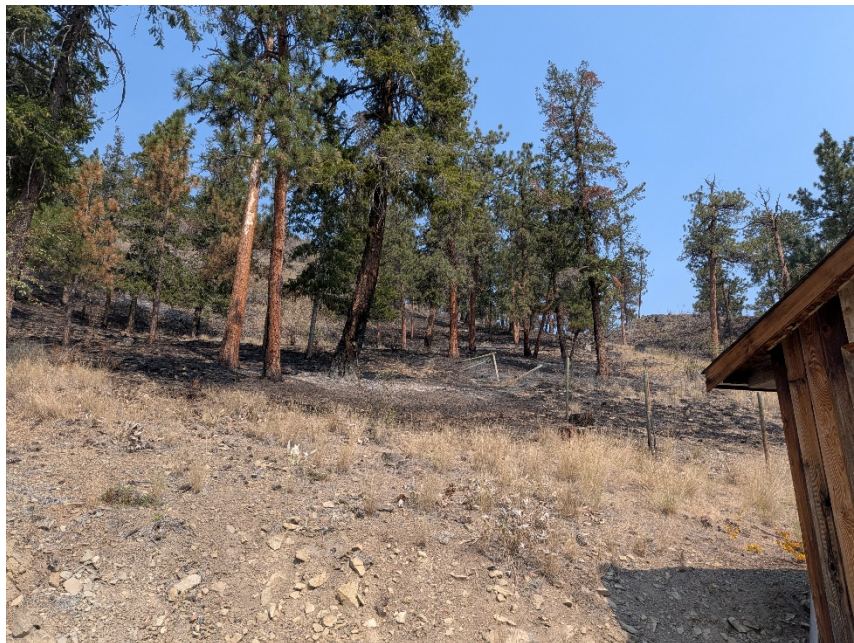
- In the area upslope (north) of Hermiston Dr slopes above the homes were burnt to varying degrees of intensity. Some areas appear to have drainages that may flow directly toward homes, however the catchment area of the drainages was not determined. (Photos 4-5).

Photo 4. Upslope (north) of Hermiston Dr looking north.

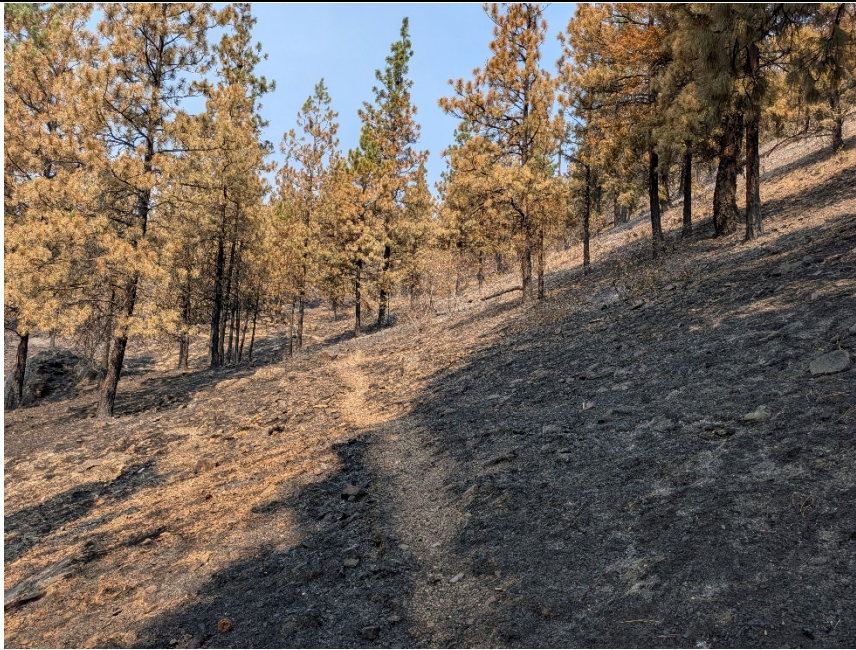
Photo 5. Slope uphill (west) of Hermiston Dr looking west.

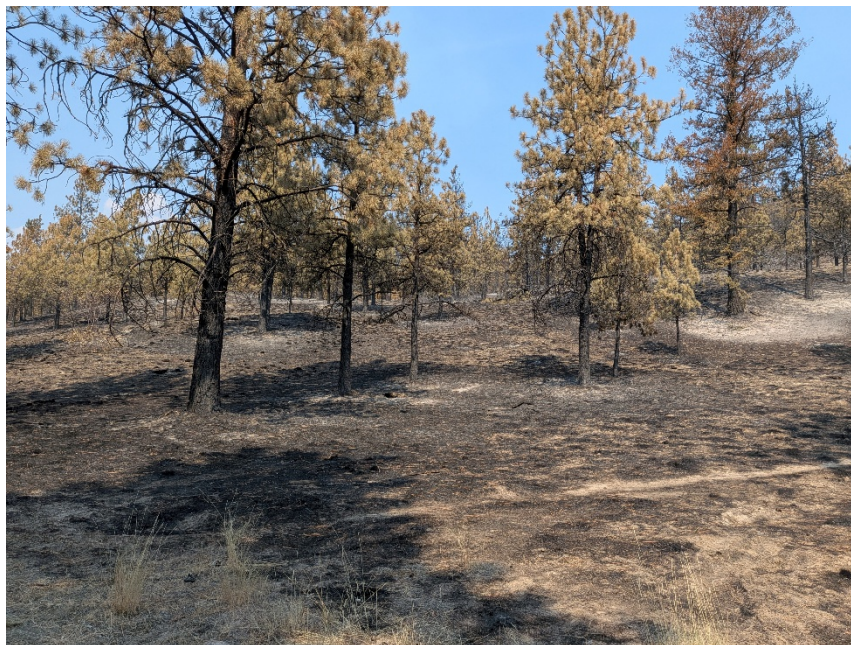
- The area upslope of properties on Denike St and Morrow Ave was impacted by the fire, however in areas outside of potential drainage paths the slope is not steep enough to cause hazards that would impact the homes below (Photo 6).

Photo 6. Slope uphill (north) of Denike St, west of McKlarty PI looking northwest.

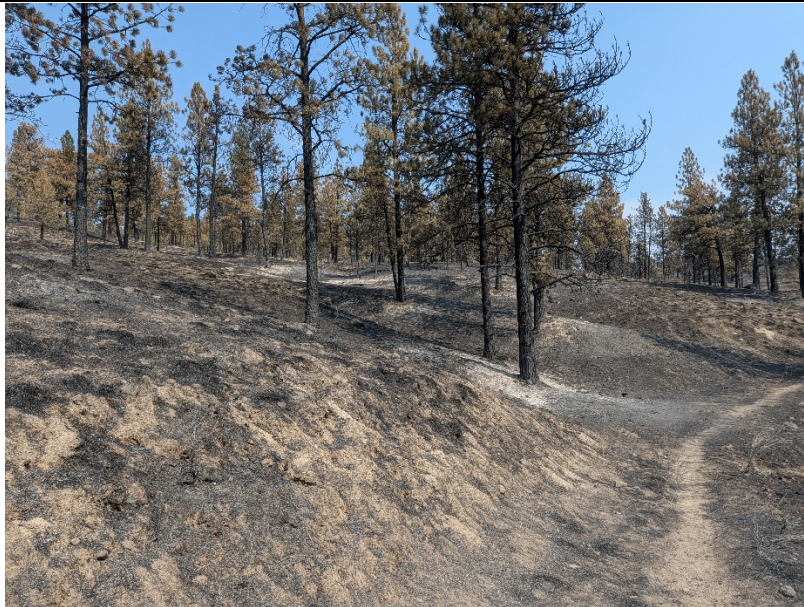
- A possible drainage path was noted above 14918 and 14904 Denike St which may pose potential debris flow/debris flood hazards post wildfire (Photo 7)
- A large gully which extends a significant way up the mountain was heavily burnt and extends through 15302 Denike St and has a possible runout zone into 15015 Denike St (Photo 8).

Photo 7. Slope upslope (north) of 14918 and 15904 Denike st, looking northeast at potential drainage paths.

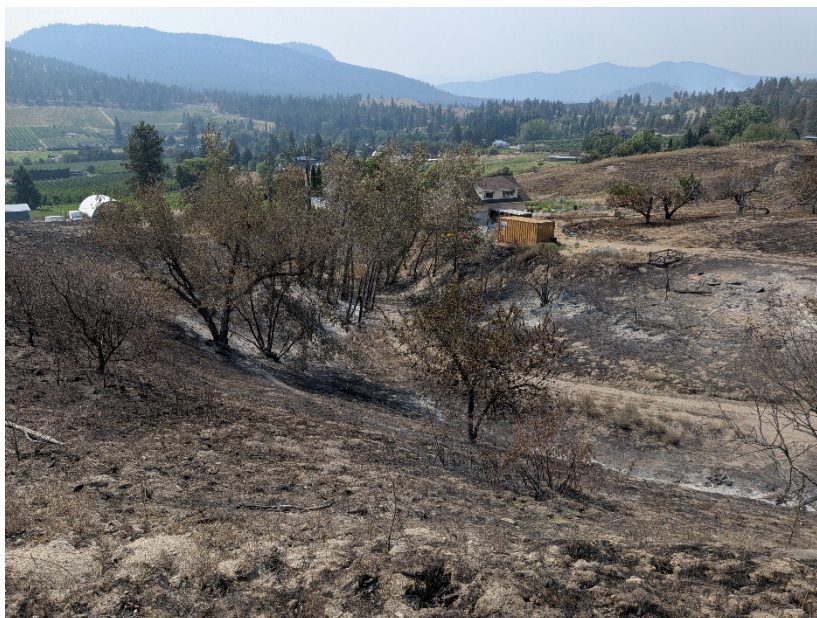
Photo 8. Looking down (southwest) the burnt gully towards 15304 (right) and 15015 (left) Denike St.

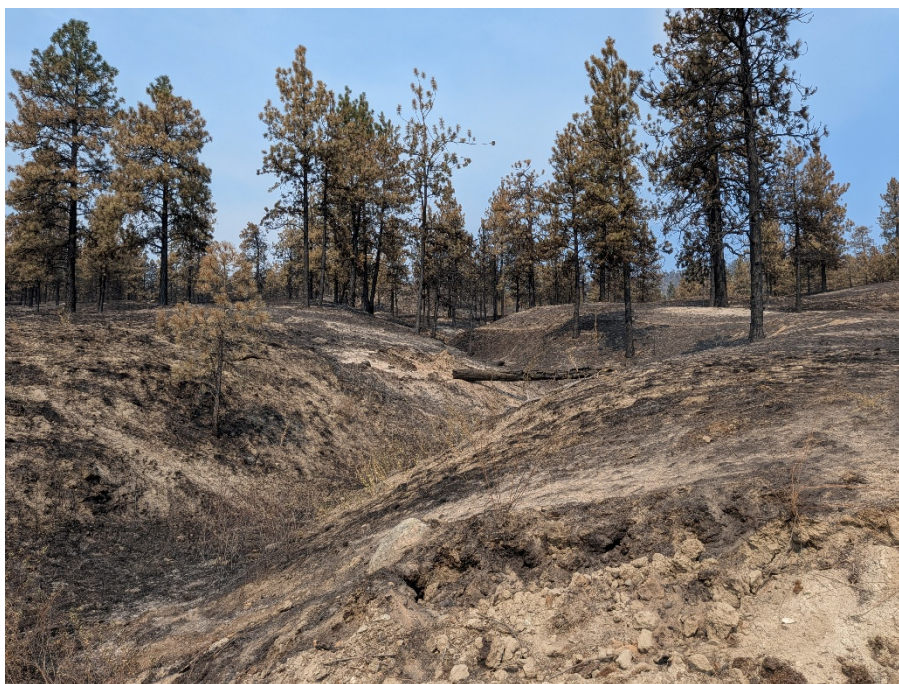
- The area upslope of 15912 and the west portion of 15815 Denike St has multiple burnt drainage paths which may pose potential debris flow/debris flood hazards. (Photo 9)

Photo 9. Gully upslope (northwest) of Denick St and Doherty Ave, looking northwest.
