# Technical Memorandum

| <b>Re:</b> | Preliminary Slope Hazard Assessment, Garnet Valley North<br>Summerland, BC |
| <b>Project No.</b> | 2605393 |

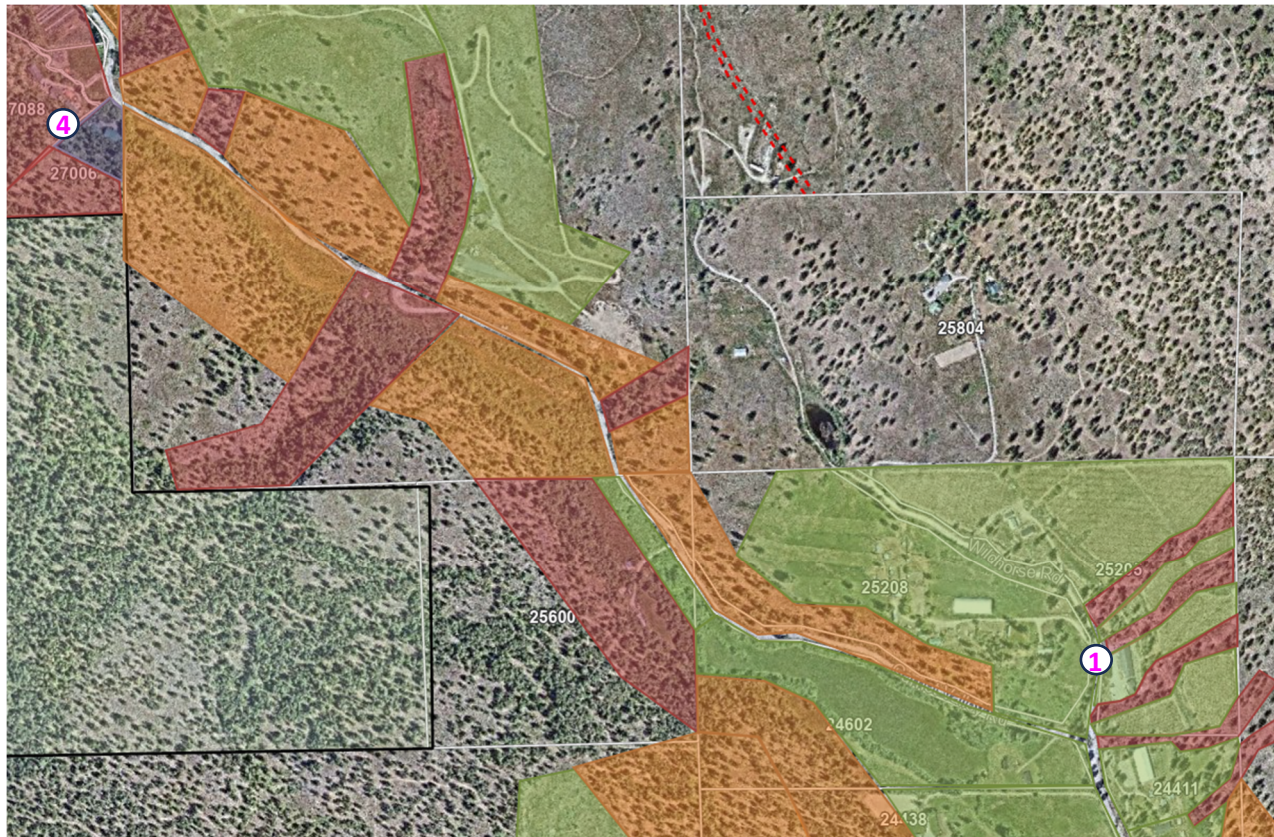
- 25600 Garnet Valley Rd
  - 27088 Garnet Valley Rd
  - 27218 Garnet Valley Rd
  - 28000 Garnet Valley Rd
  - 28214 Garnet Valley Rd
  - 28412 Garnet Valley Rd

- 28610 Garnet Valley Rd
  - 28818 Garnet Valley Rd
  - 28411 Garnet Valley Rd
  - 28808 Garnet Valley Rd
  - 28996 Garnet Valley Rd (trailer)
  - 28999 Garnet Valley Rd

- Buildings in orange potential slope hazard zones (Figures 2-3) include but may not be limited to:
  - 27413 Garnet Valley Rd
  - 28804 Garnet Valley Rd

**Figure 2 – Garnet Valley Properties Potentially Impacted by Post-Wildfire Slope Hazards (Red and Orange). Property unsafe prior to detailed geotechnical assessment (Purple). Areas not considered at increased risk from slope hazards (Green). Approximate Photo locations in pink. Imagery from DoS Spatial Viewer August 20, 2026.**

For the purposes of the initial assessment and re-entry criteria development it is Terrane’s recommendation that homes immediately downhill of fire impacted slopes, or downslope of fire impacted drainages, are evacuated if the Zone 5 precipitation criteria are met (Table 1). Impacted properties in the Garnet Valley neighbourhood are shown in Figures 2, 3, and 4, below. Red areas have a higher risk of long term impacts due to slope height and or/grade, runoff channels, or known historic drainages.

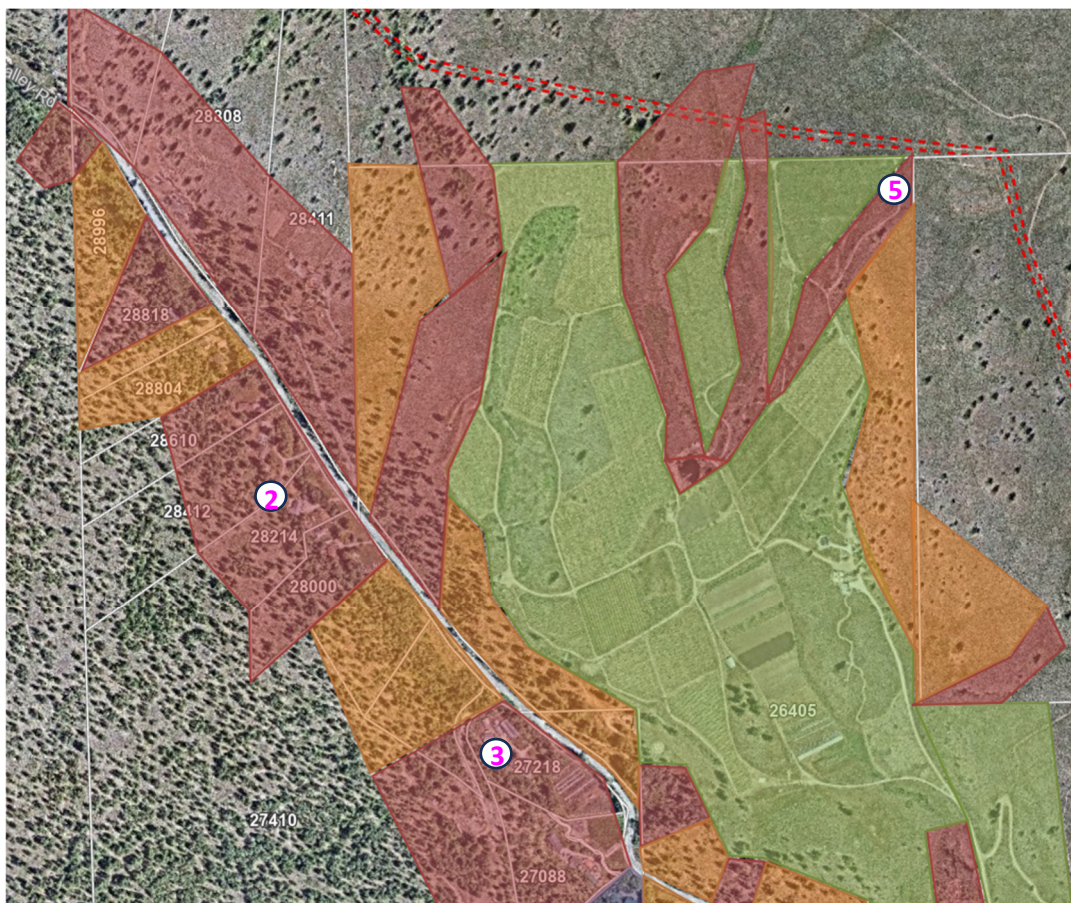
**Figure 3 – Garnet Valley Properties Potentially Impacted by Post-Wildfire Slope Hazards (Red and Orange). Properties not considered at increased risk from slope hazards (green). Approximate Photo locations in pink. Imagery from DoS Spatial Viewer August 20, 2026.**

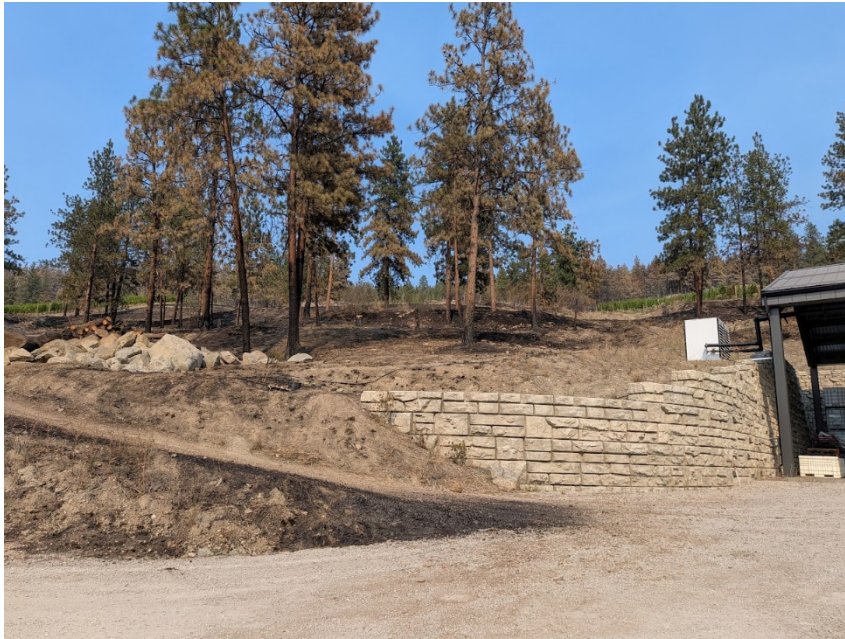
- Two properties on Wildhorse Rd (25205 and 25208) were included in the assessment. Some potential hazard zones on slopes and in gullies were noted, but no homes or habituated buildings were observed within. The crush pad on 25205 Wildhorse Rd may be within a runout zone and multiple large retaining walls in the winery area should be subject to a more detailed post wildfire inspection (Photo 1).

Photo 1. Burnt slope and gully above the crush pad on 25205 Wildhorse Rd looking east.

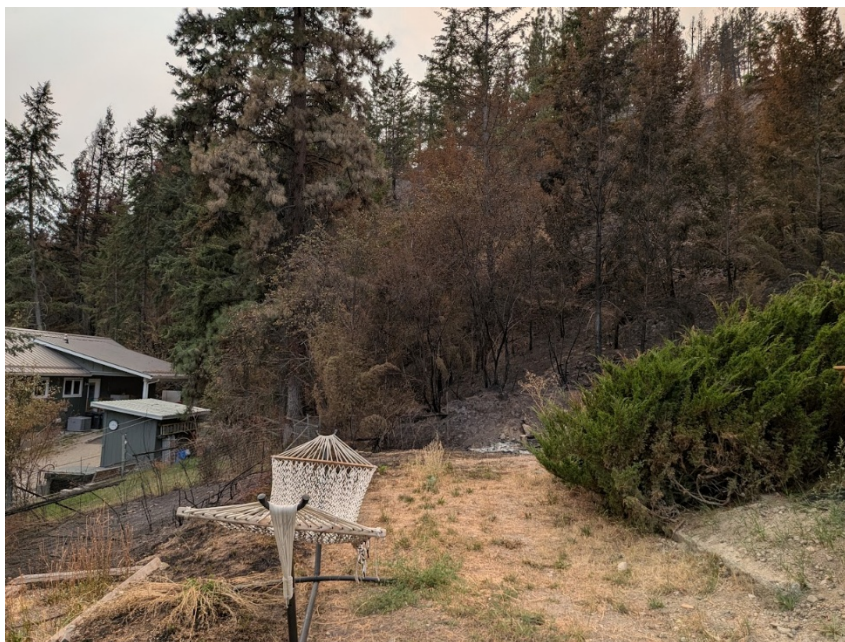
- 25804 Wildhorse Rd was not accessible at the time of the site assessment as there were down power lines.
- Homes and buildings on Garnet Valley Rd north of Wildhorse Rd which are close to the base of the slope and/or situated within the potential runout zones of burnt gullies and/or heavily burn steep slopes are at risk of potential post wildfire impacts (Photo 2-3). Buildings in red potential runout zones (Figures 2-3) include but may not be limited to:

Photo 2. Heavily burnt slope and gully above 28214 Garnet Valley Rd looking south.

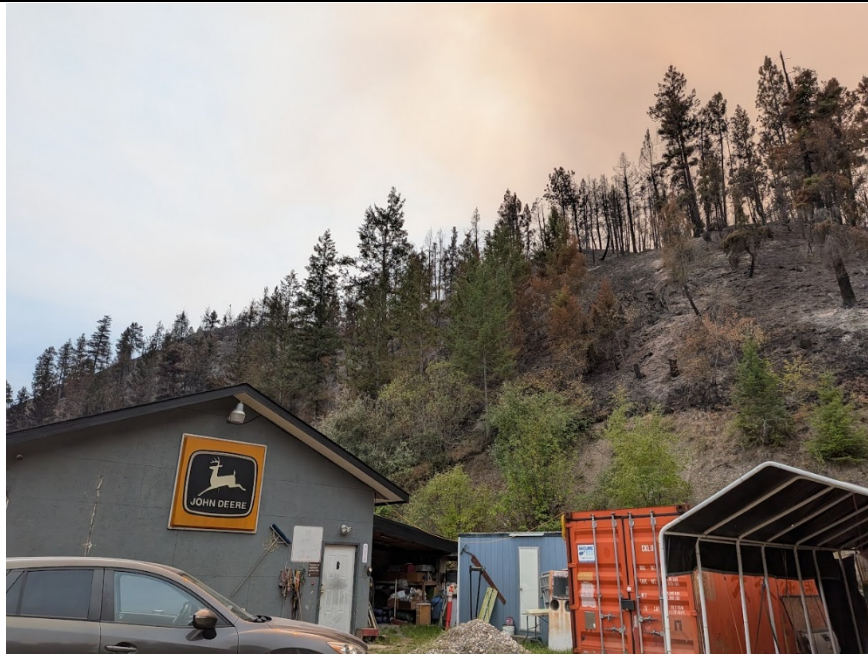
Photo 3. Burned slopes uphill of remaining buildings looking southwest.

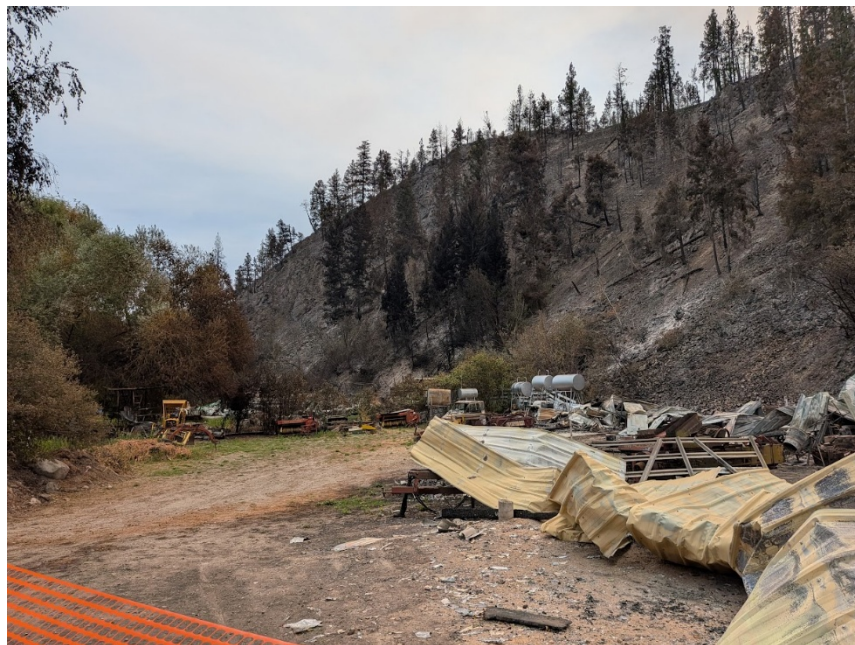
- The buildings at 27006 were damaged in the fire, however the slope immediately behind the building location appeared to have significant potential rockfall hazards, as well as having burned intensely. A detailed geotechnical slope stability assessment should be completed prior to reconstruction of any buildings (Photo 4).
- In other locations along Garnet Valley Rd burnt gullies may cause impacts to the road and properties in future, however no buildings are in the direct runout path (Photo 5)

Photo 4. Heavily burned steep slope above 27006 Garnet Valley Rd looking south.

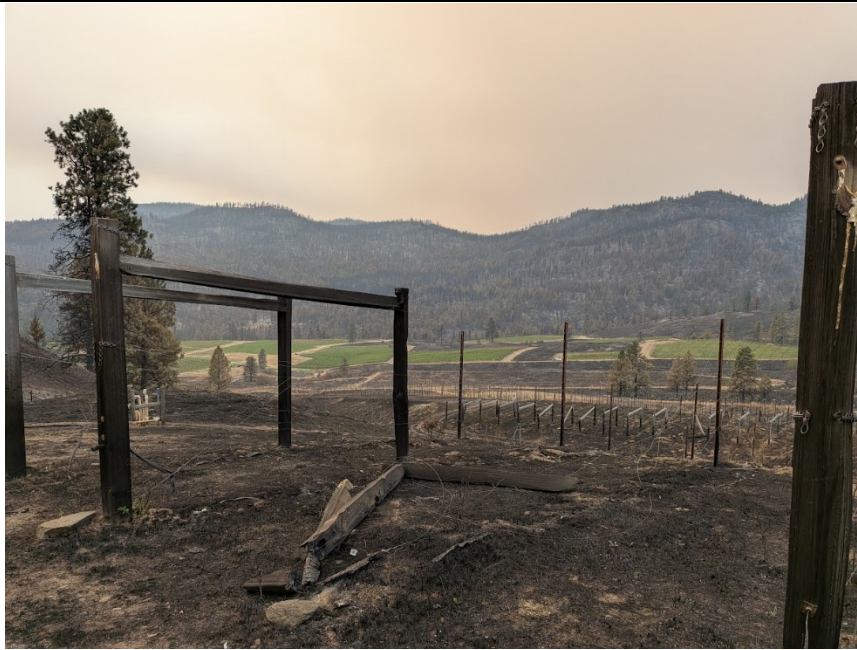
Photo 5. Burned slopes and drainages within 26405 Garnet Valley Rd looking west.
