# Technical Memorandum

| <b>Re:</b> | Preliminary Slope Hazard Assessment, Garnet Valley South<br>Summerland, BC |
| <b>Project No.</b> | 2605393 |

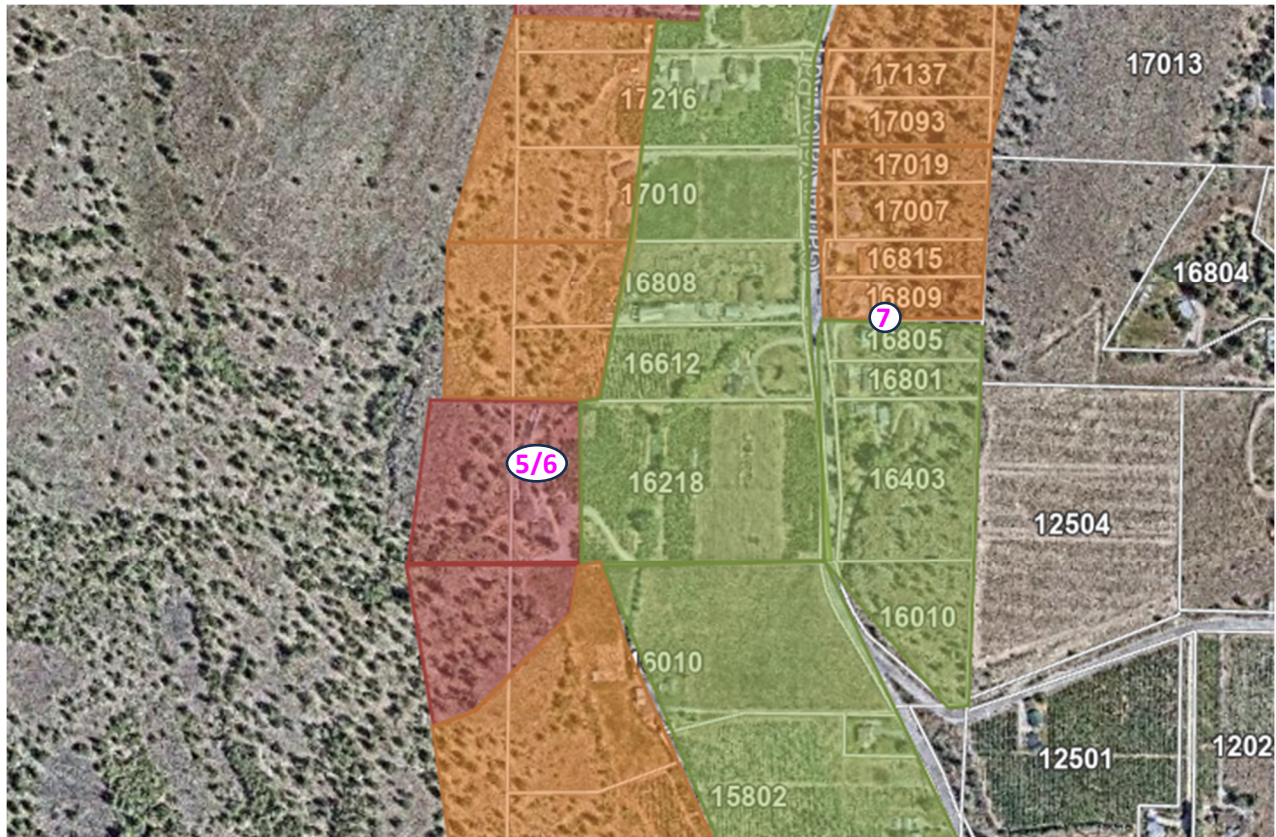
**Figure 2 – Garnet Valley Properties Potentially Impacted by Post-Wildfire Slope Hazards (Red and Orange). Properties not considered at increased risk from slope hazards (Green). Approximate Photo locations in pink. Imagery from DoS Spatial Viewer August 20, 2026.**

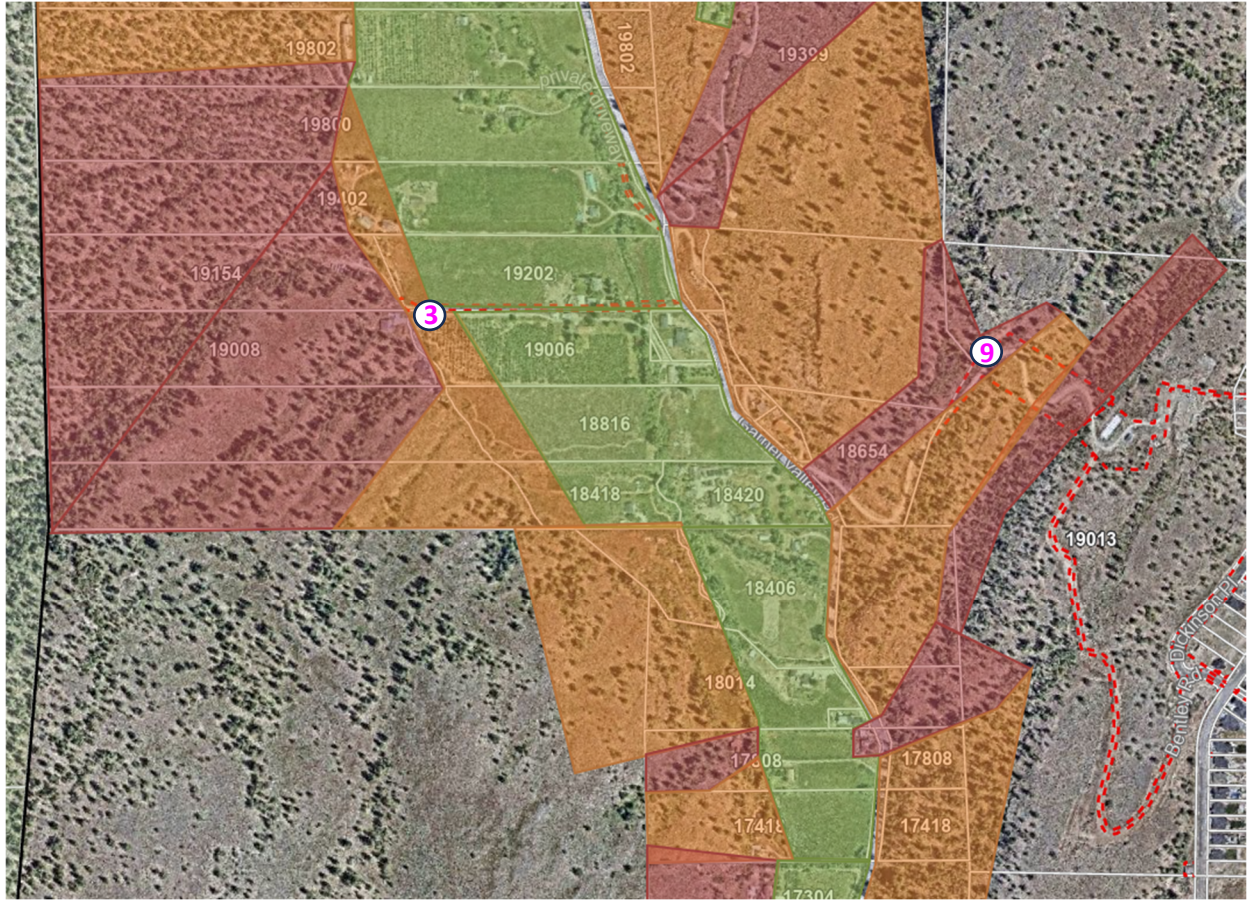
**Figure 3 – Garnet Valley Properties Potentially Impacted by Post-Wildfire Slope Hazards (Red and Orange). Properties not considered at increased risk from slope hazards (green). Approximate Photo locations in pink. Imagery from DoS Spatial Viewer August 20, 2026.**

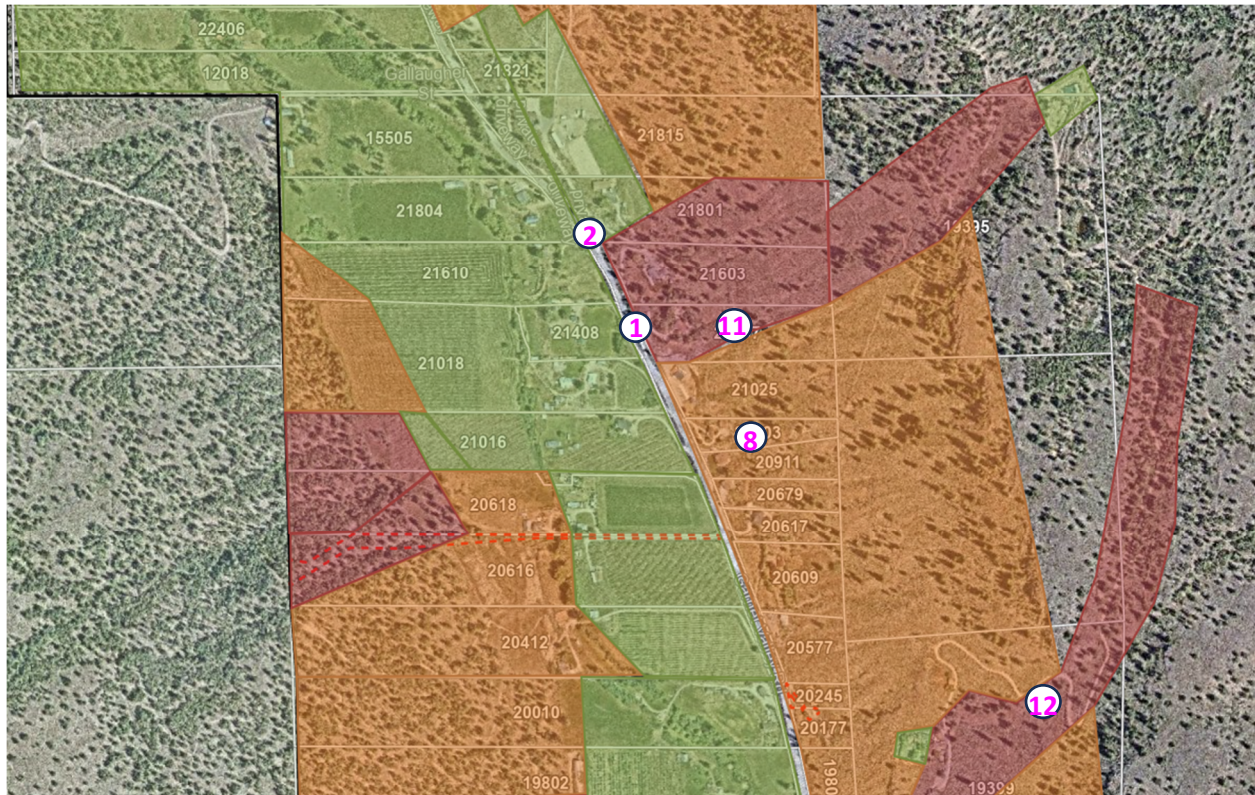
**Figure 4 – Garnet Valley Properties Potentially Impacted by Post-Wildfire Slope Hazards (Red and Orange). Properties not considered at increased risk from slope hazards (Green). Approximate Photo locations in pink. Imagery from DoS Spatial Viewer August 20, 2026.**

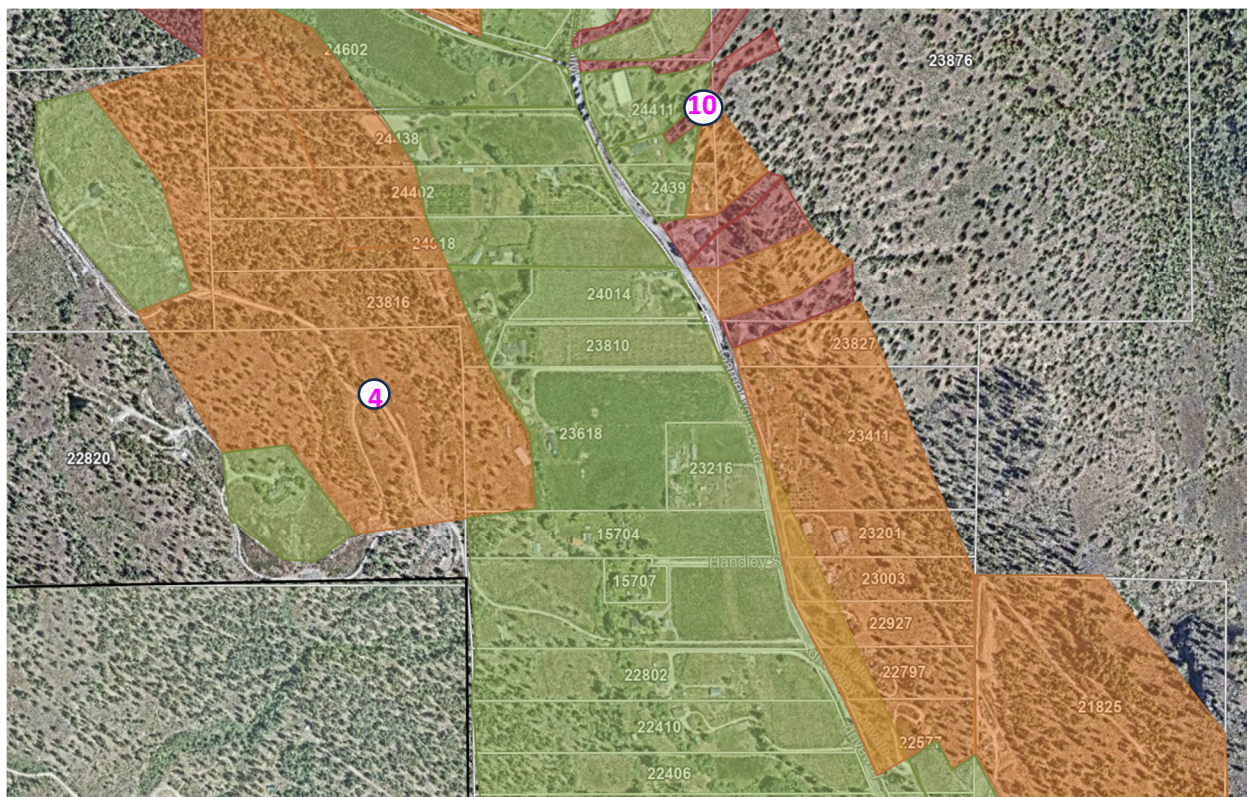
**Figure 5 – Garnet Valley Properties Potentially Impacted by Post-Wildfire Slope Hazards (Red and Orange). Properties not considered at increased risk from slope hazards (Green). Approximate Photo locations in pink. Imagery from DoS Spatial Viewer August 20, 2026.**

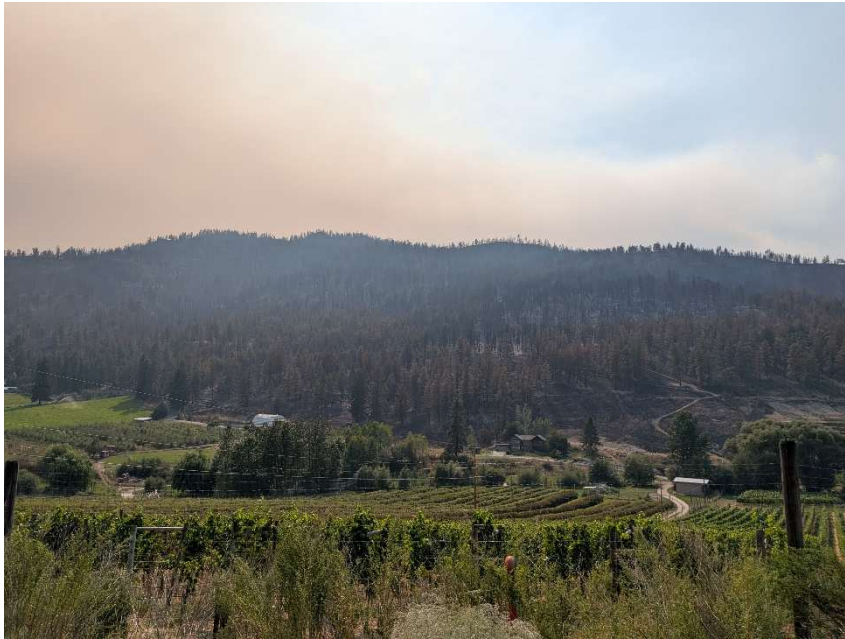
- The base of the valley on the west side of Garnet Valley Rd is generally flat to gently sloping. Where Eneas Creek, homes and buildings are away from the base of the west slope they are generally not expected to be impacted by post-wildfire slope stability and debris flow/debris floods (Figures 2 - 5) (Photos 1-2).

Photo 1. Looking west at the west side of Garnet Valley Rd.

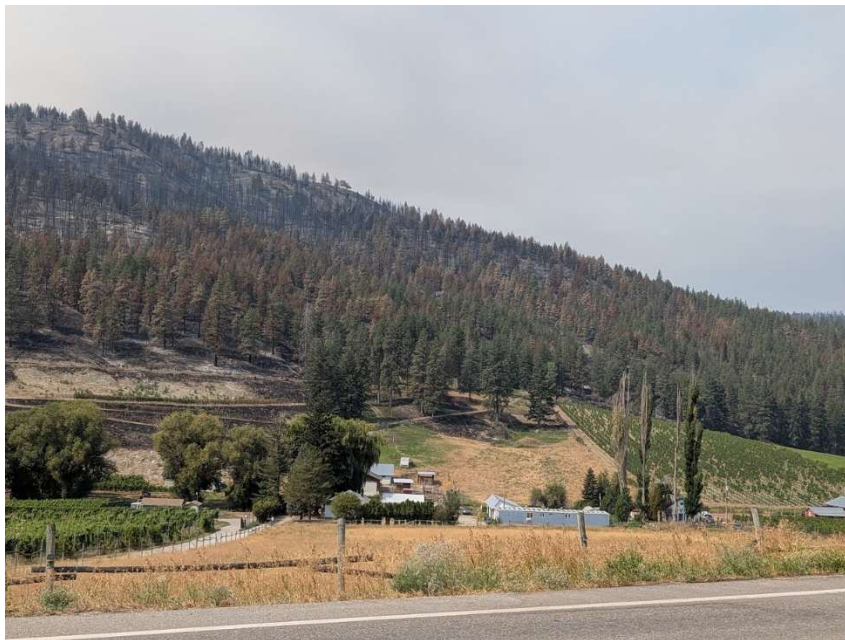
Photo 2. Looking west from Garnet Valley Rd.

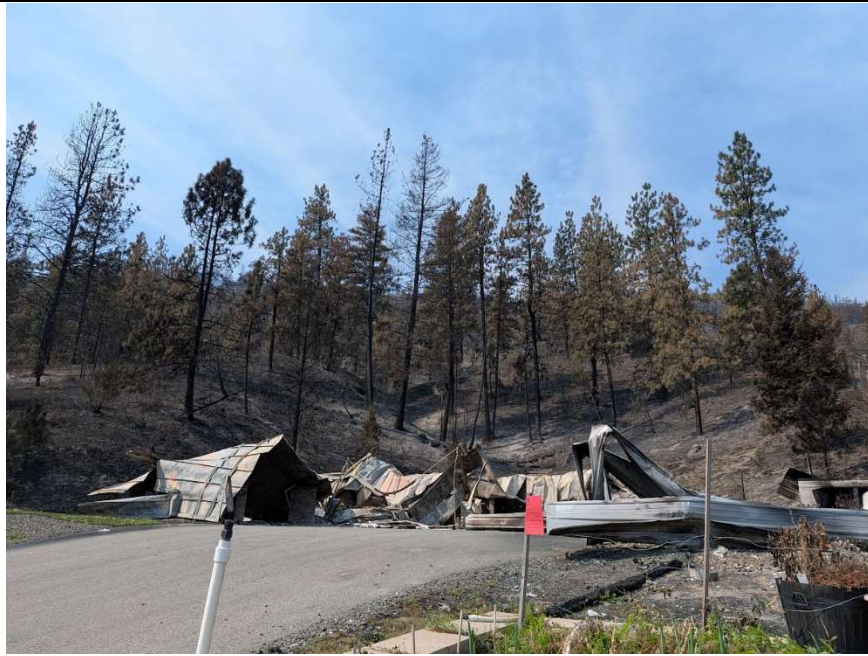
- Homes and buildings on the west side of Garnet Valley Rd which are close to the base of the slope and/or situated within the potential runout zones of burnt gullies are at risk of potential post wildfire impacts (Photo 3-5). Buildings in red potential runout zones (Figures 2-5) include but may not be limited to:

Photo 3. Burned gully with previous building immediately at the base.

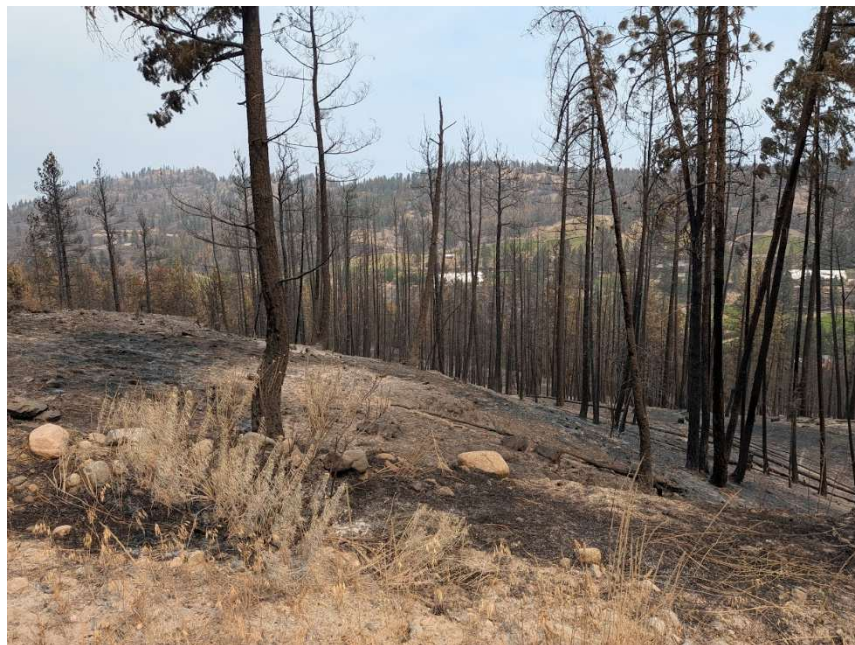
Photo 4. Heavily burned slope downslope of 22820 Garnet Valley Rd looking northeast.

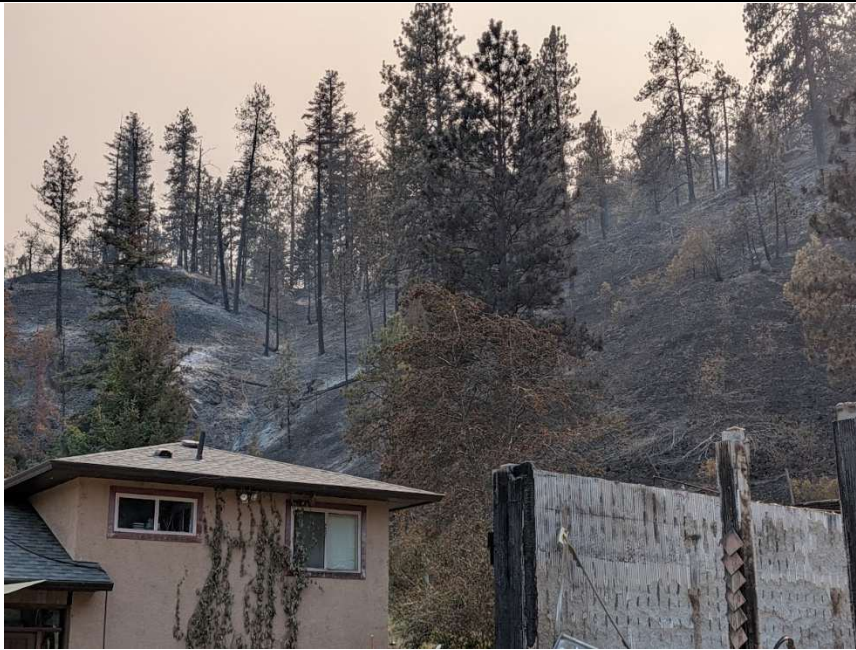
Photo 5. Burned gully immediately upslope of remaining house on 16218 Garnet Valley Rd.

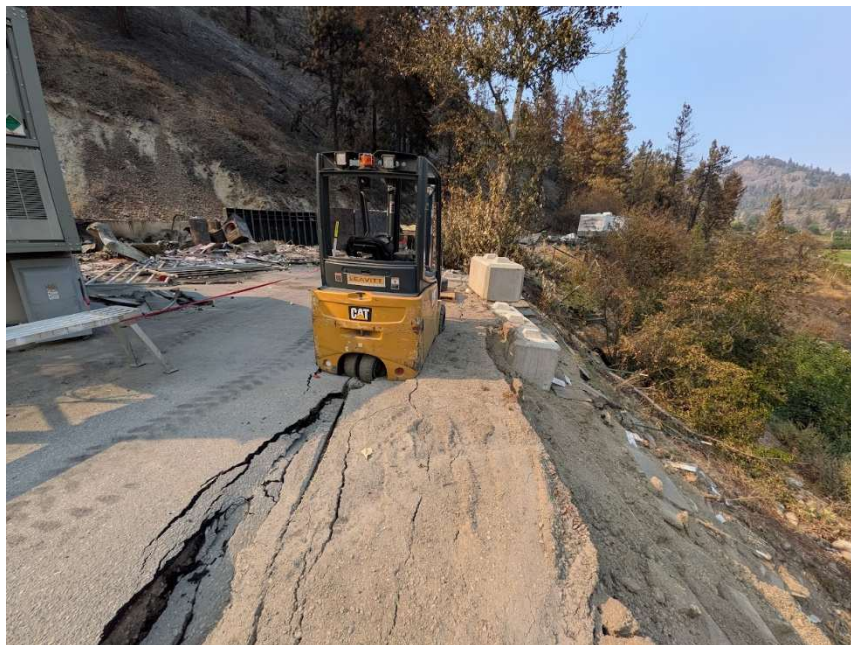
- Additionally, there are failed and failing retaining walls on 16218 Garnet Valley Rd which should be cordoned off until removed and re-sloped or rebuilt (Photo 6)

Photo 6. Failed retaining wall on 16218 Garnet Valley Rd.

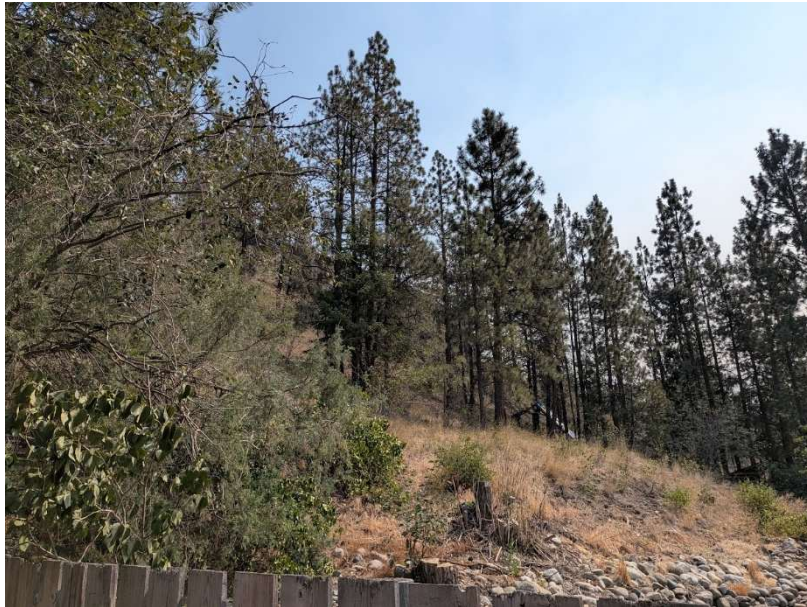
- The southern properties on the east side of Garnet Valley Rd did not experience significant fire activity (Photo 7). This includes 16010, 16403, 16801 and 16805 Garnet Valley Rd.

Photo 7. Slope above homes on the east side of Garnet Valley Rd, south end, looking southeast.

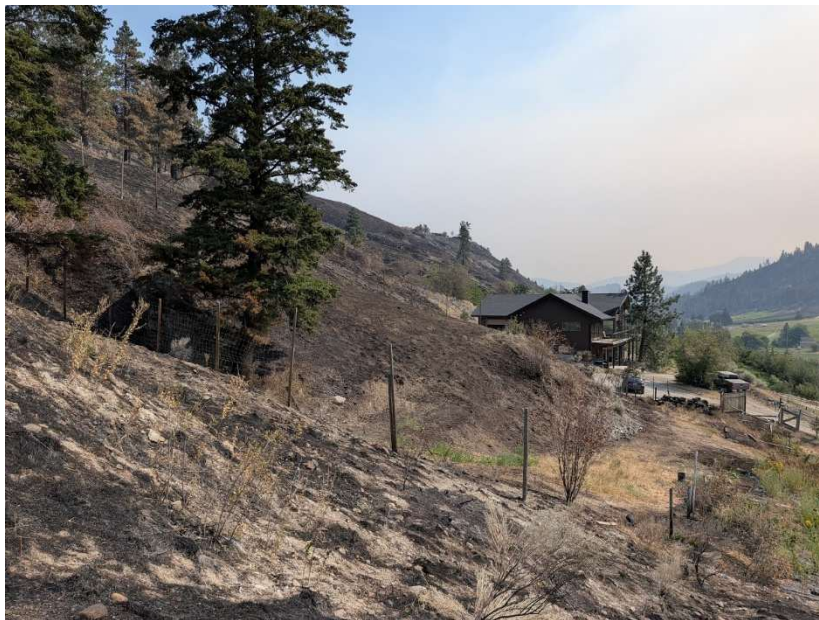
- Most homes on the east side of Garnet Valley Rd are on or close to steeper slopes and fall within the orange slope hazard zone (Photo 8) though some have sufficient flat area upslope of the dwellings to mitigate potential risk (Figures 2-5).

Photo 8. Burnt slopes above homes on the east side of Garnet Valley Rd, looking south.

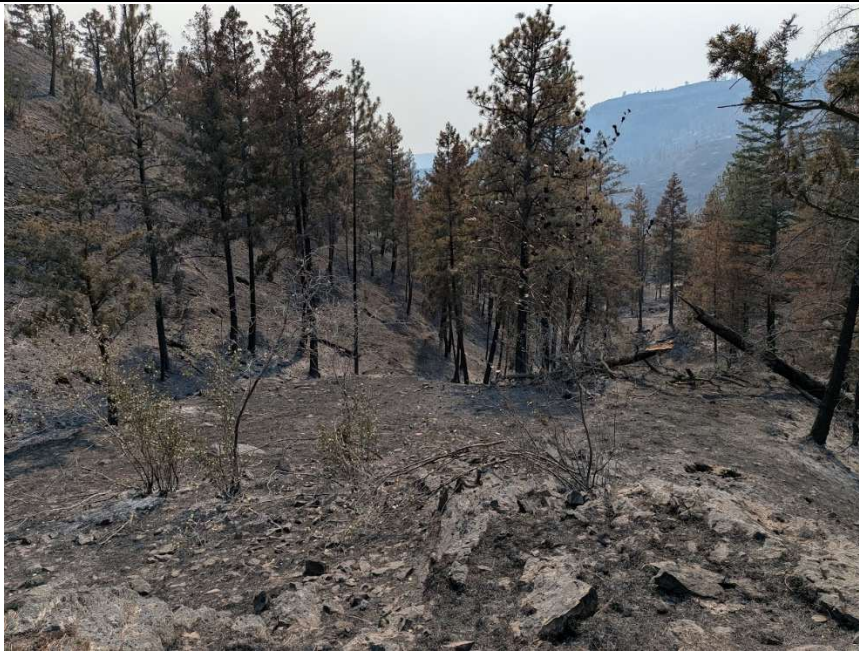
- Some homes and/or driveways on the east side of Garnet Valley Rd are within or potentially impacted by burnt gullies (Photo 9). Properties in red zones (Figures 3-5) include:

Photo 9. Gully upslope (west) of Garnet Valley Rd, looking southwest.

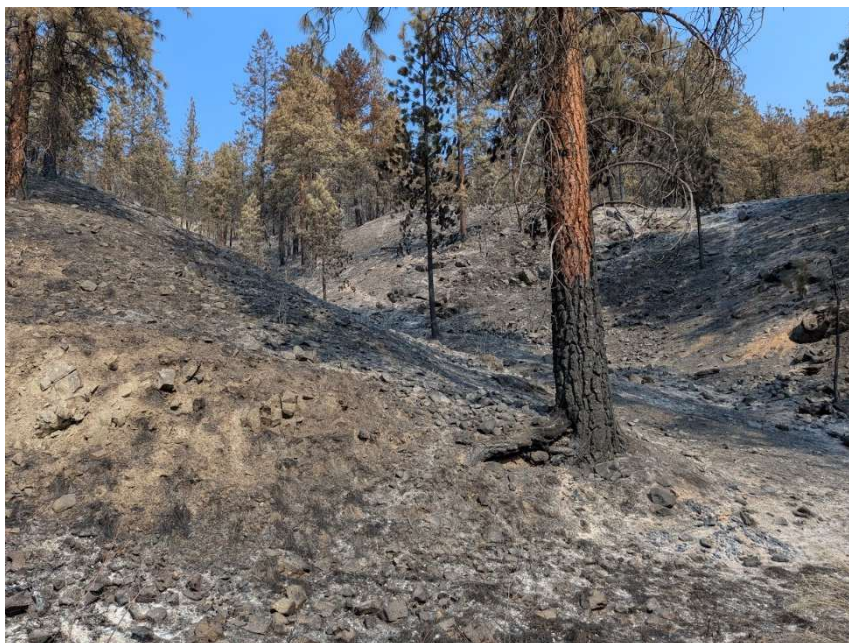
- 24023 Garnet Valley Rd
- In other locations along Garnet Valley Rd burnt gullies may cause impacts to the road and properties in future, however no buildings are in the direct runout path (Photo 10)

Photo 10. Gully upslope (west) of Garnet Valley Rd, looking northeast.

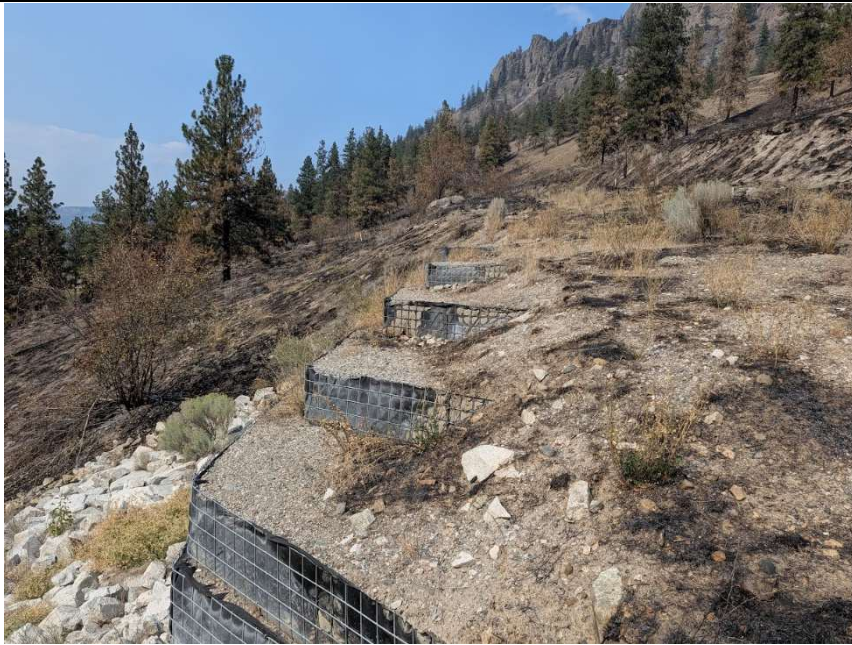
- A gabion basket retaining wall below the Fortis BC gas main on 21207 Garnet Valley Rd was noted to have sustained some damage (Photo 11) and should be fully inspected and assessed for stability.

Photo 11. Damaged gabion wall upslope of 21207 Garnet Valley Rd looking north.

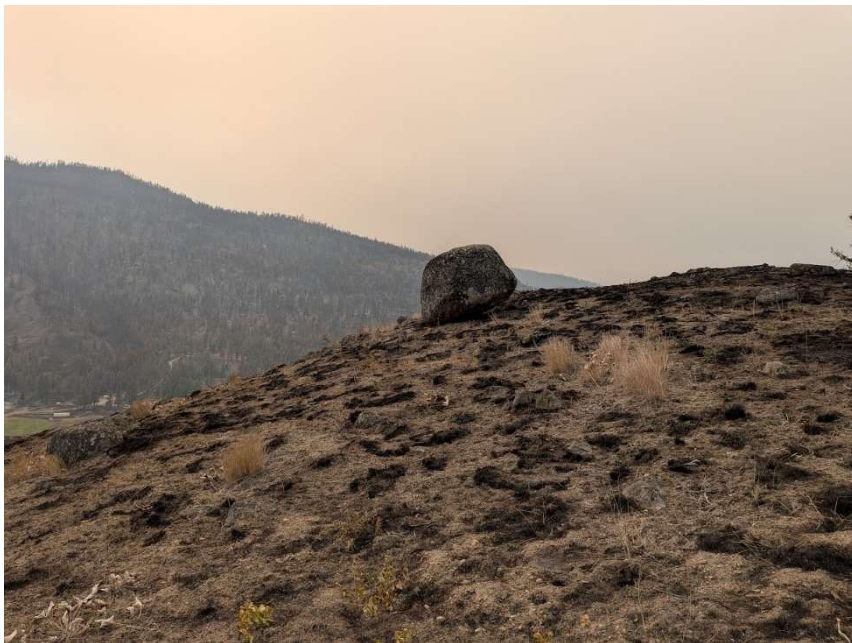
- On 19399 Garnet Valley Rd, two potentially unstable boulders were noted on the upper slopes. Post wildfire rain events may have an increased risk of destabilizing the soil around the boulders. The house is not in the direct runout path due to the overall topography, however, initial observation indicate that the boulders have the potential to reach Garnet Valley Rd and/or properties on the west side. (Photo 12).

Photo 12. Boulder on 19399 Garnet Valley Rd looking northwest.
