# Technical Memorandum

| <b>From:</b> | Brittany Linnett, P.Eng., Senior Geotechnical Engineer |
| <b>Date:</b> | August 17, 2026 |
| <b>Re:</b> | Preliminary Slope Hazard Assessment, Hunters Hill, Rev 1<br>Summerland, BC |

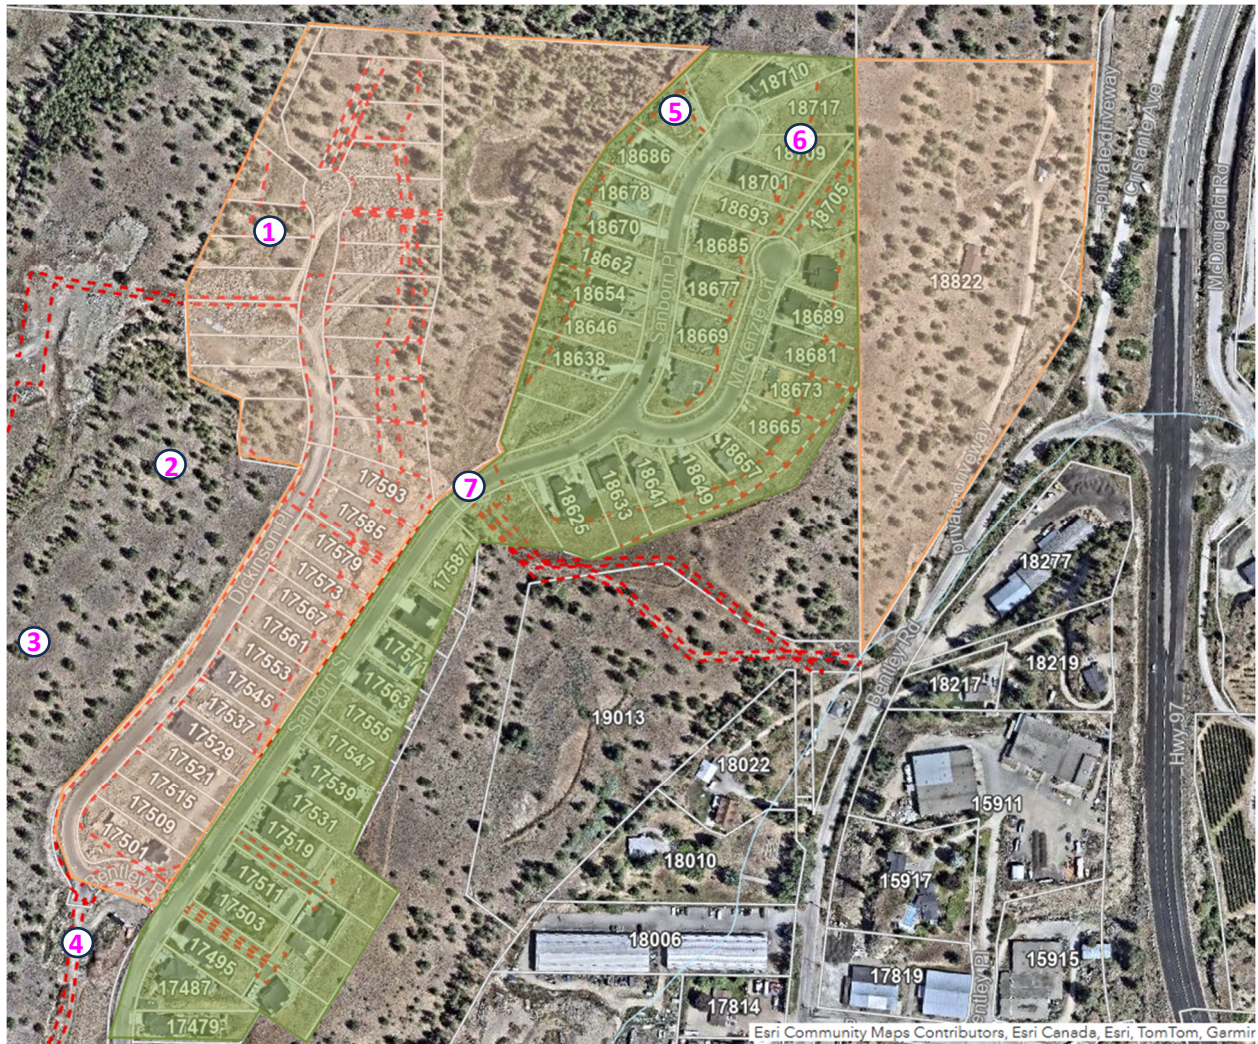
**Figure 2 – Hunters Hill Properties Potentially Impacted by Post-Wildfire Slope Hazards (Orange). Properties not considered at increased risk from slope hazards (green). Approximate Photo locations in pink. Imagery from DoS Spatial Viewer August 16, 2026.**

For the purposes of the initial assessment and re-entry criteria development it is Terrane's recommendation that homes immediately downhill of fire impacted slopes, or downslope of fire impacted drainages, are evacuated if the Zone 5 precipitation criteria are met (Table 1). Impacted properties in the Hunters Hill neighbourhood are shown in Figures 2 and 3, below.

- Impacted properties should remain evacuated until 24 hours after the end of the rain event for 1 hour, 12 hour, and 24 hour criteria, or 48 hours after the end of the rainfall event if the 48 hour criteria is exceeded (see Table 1), or after an assessment by a qualified professional engineer.
- A rainfall gauge with remote monitoring and alarm capabilities should be placed within 2.5 km and 150 m of elevation of the impacted areas. If remote monitoring is not available, then the gauge should be checked hourly during significant rainfall. Snowmelt is not included in the criteria detailed in this memo.

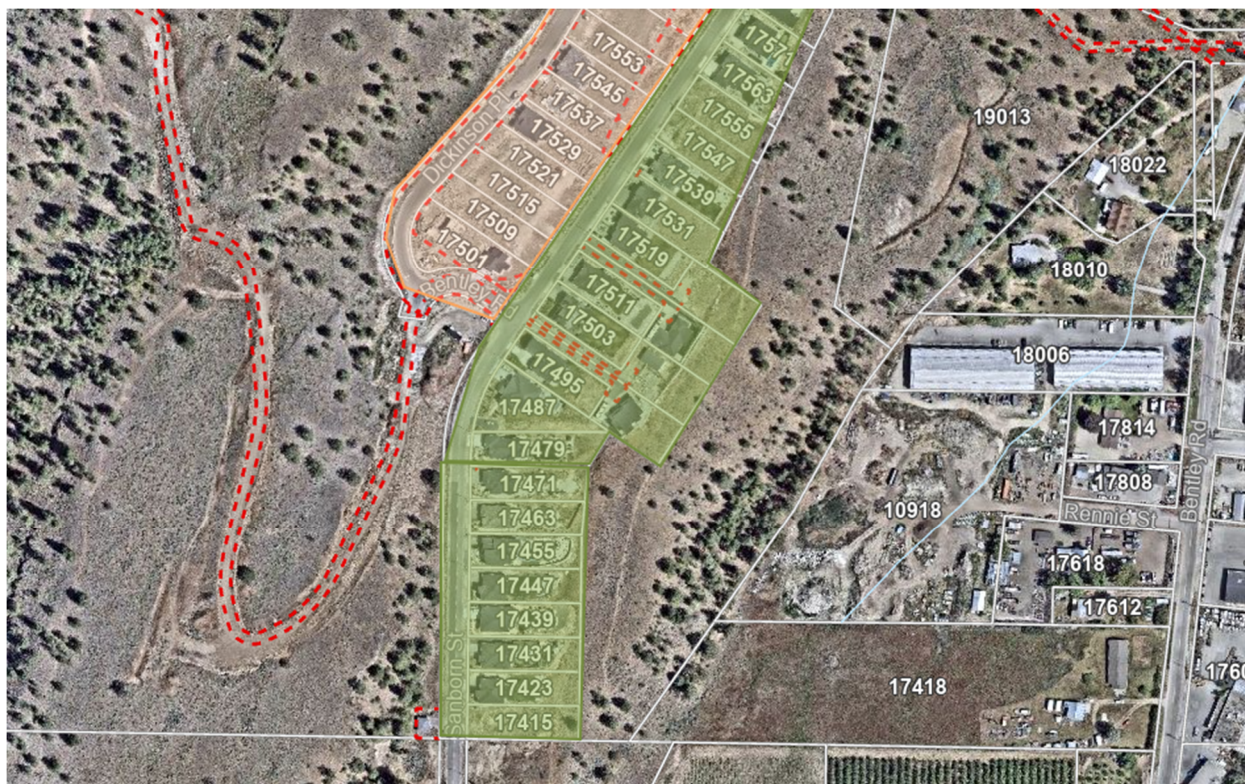
**Figure 3 - Hunters Hill Properties Potentially Impacted by Post-Wildfire Slope Hazards (Orange). Properties not considered at increased risk from slope hazards (green). Imagery from DoS Spatial Viewer August 16, 2026.**

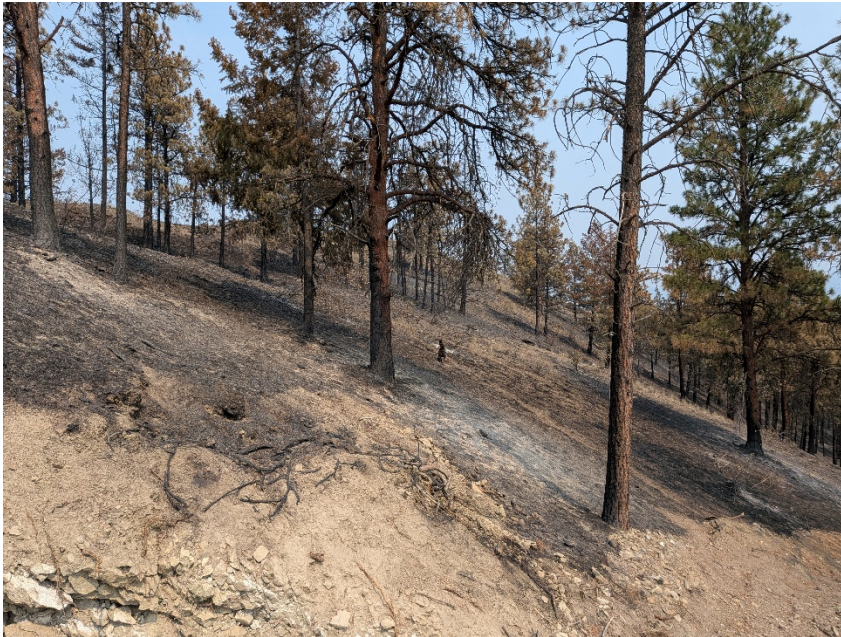
- The majority of the undeveloped area was impacted by the fire, and the burn appeared to be of varying intensity (Photos 1-2).
- In the area upslope of Dickinson Place some voids were noted where the fire has burned into tree roots (Photo 3).

Photo 1. Upslope of Phase 4 looking north.

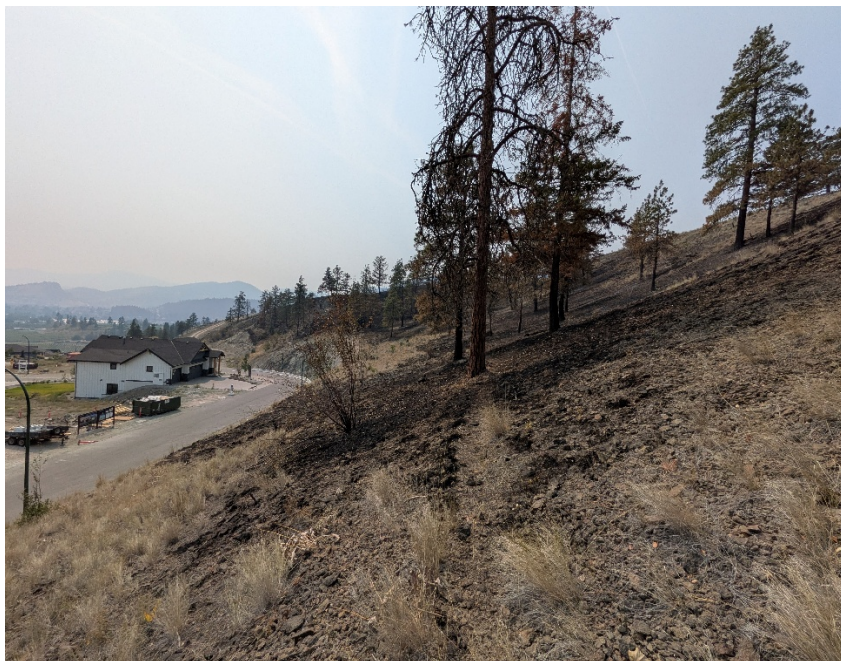
- In Phase 4 undeveloped lots back directly on to the burned slope to the northwest, however, no home construction has been completed in this area at the time of this memorandum (Photo 2).

Photo 2. Slope above Phase 3 (Dickinson Place) looking south.

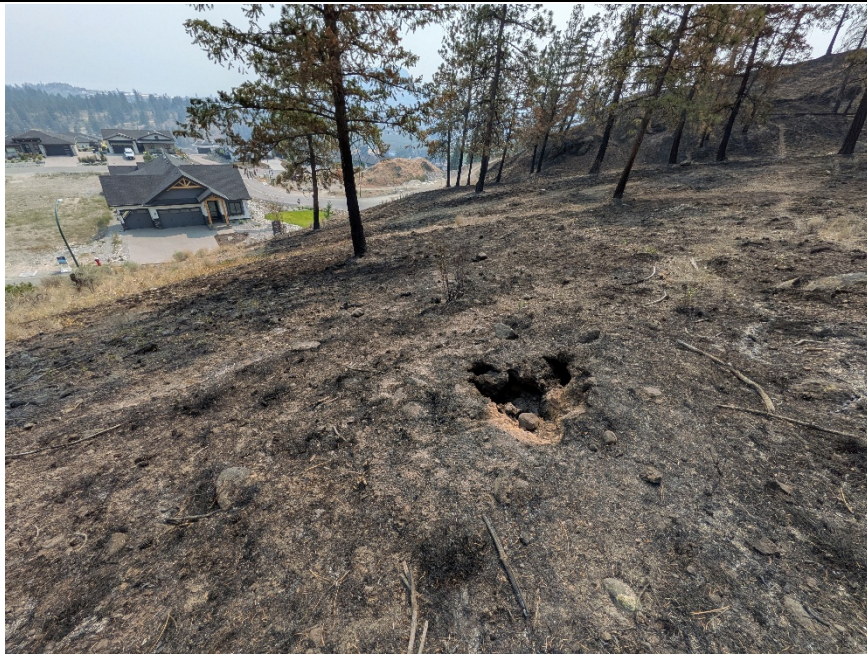
Photo 3. Voids from burnt roots above Dickinson Place, looking east.

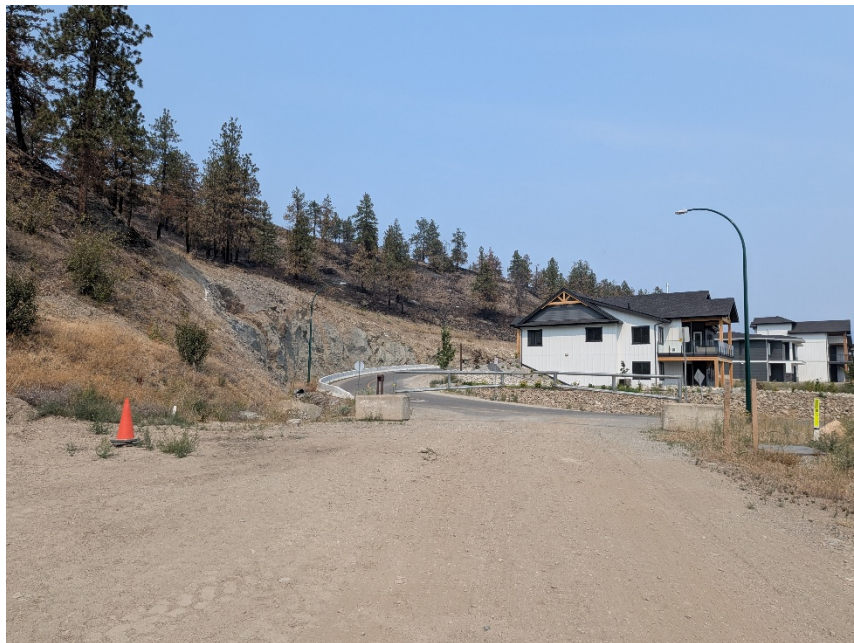
Photo 4. Slope above Dickinson Place, looking north.

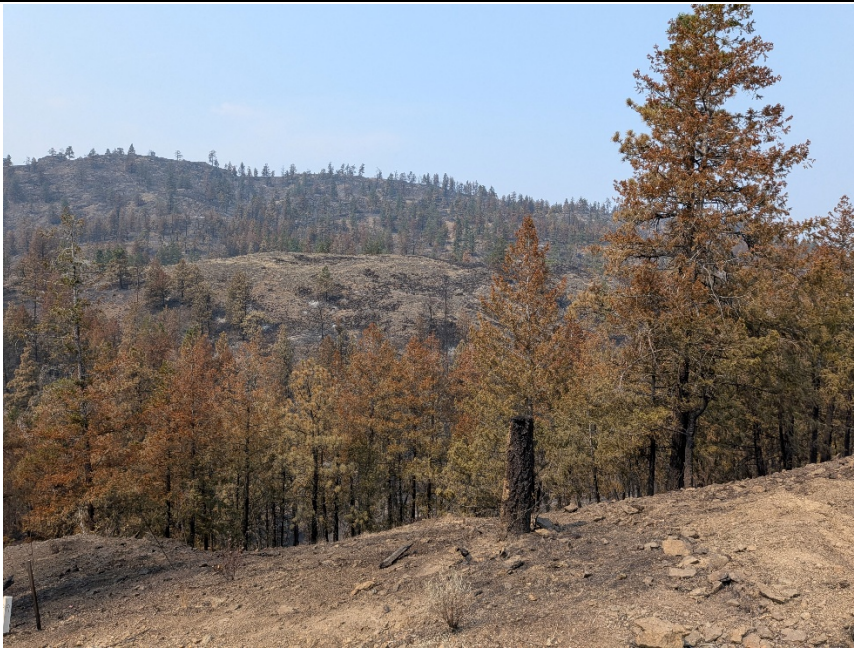
- Phase 1 and Phase 2 of Hunter Hill (Sanborn St, McKenzie Crt, and Sanborn Pl) do not have significant slopes uphill of homes, though some slopes north and east of McKenzie Court have been burned (Photo 5).

Photo 5. Slope west of Sanborn Place looking northwest.

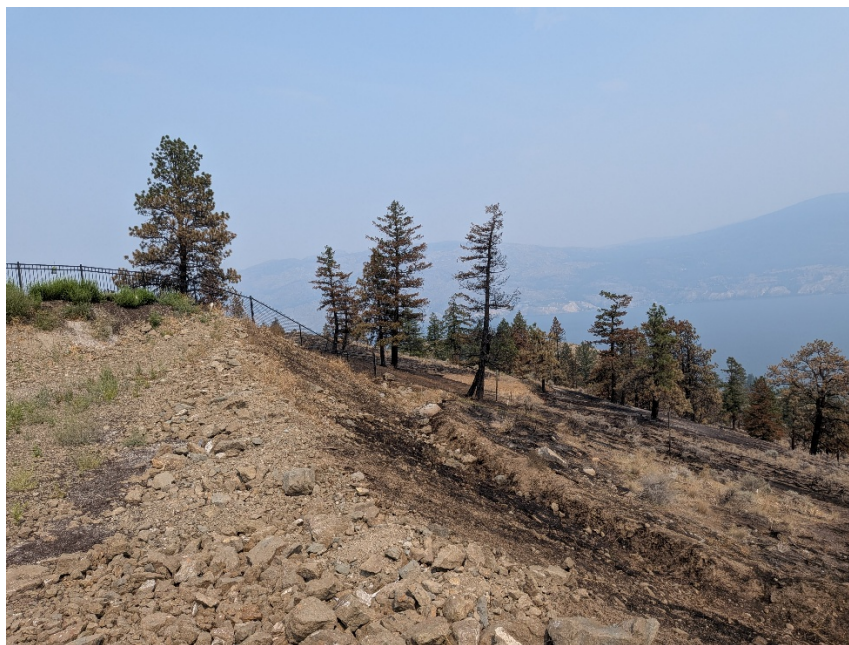
- The slope below McKenzie Court, upslope of 1822 Bentley Rd, has been impacted by the fire (Photo 6).
- The environmentally protected area downslope of Phase 4 which crosses Sanborn St has been significantly impacted by fire activity, however no homes are immediately downslope of the affected area (Photo 7).

Photo 6. Slope east of Sanborn Place, above 1822 Bentley Drive, looking northeast.

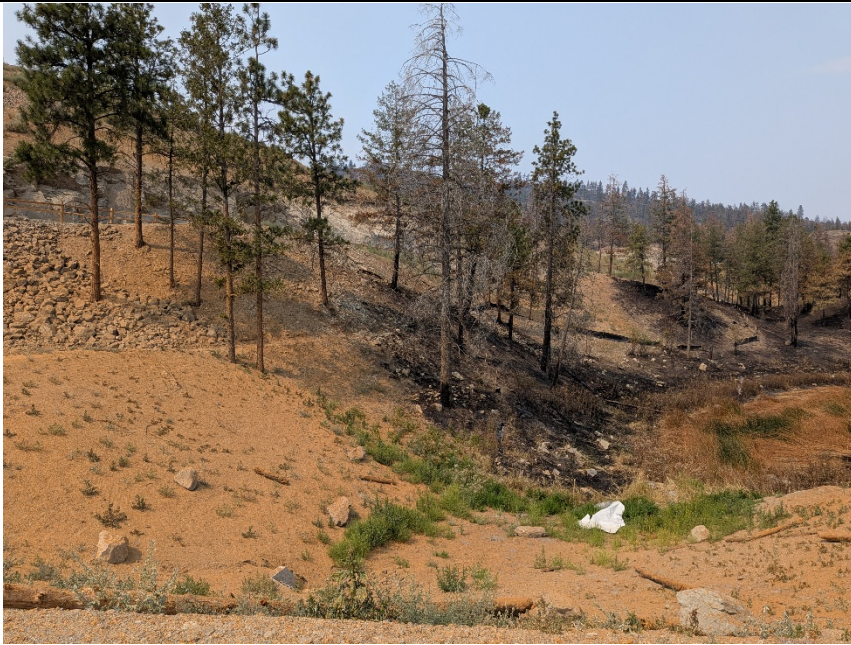
Photo 7. Environmentally protected area above Sanborn St, looking northeast.
