PRE-RENOVATION HAZARDOUS MATERIALS ASSESSMENT REPORT

**9525 WHARTON STREET
SUMMERLAND, BC V0H 1Z2**

Prepared by: Compass Environmental Solutions

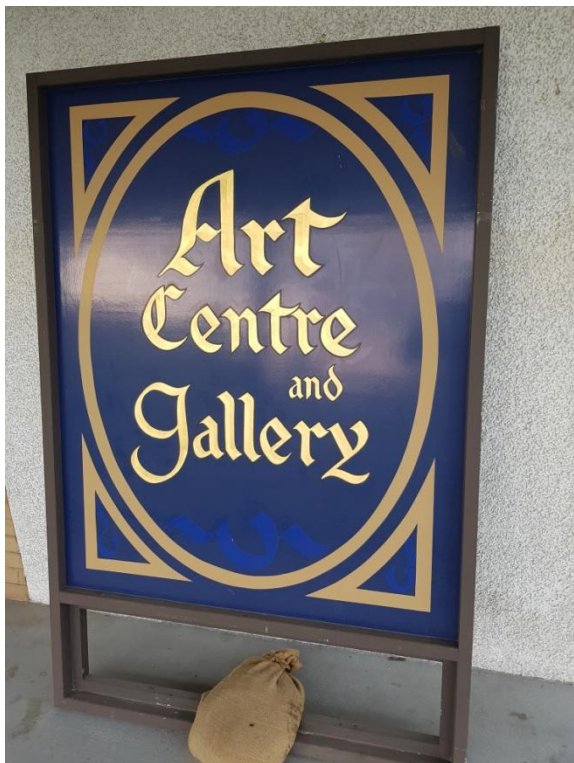
Front sign. Exterior stucco of building

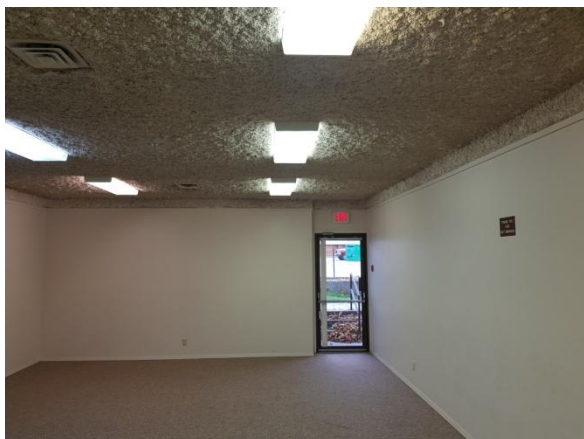
NW Room in basement – sound insulation on the ceiling

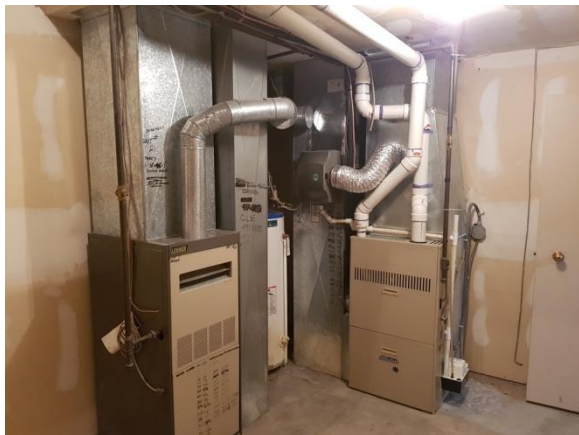
Utility Room in basement – no white duct tape wrap on the heating ducts

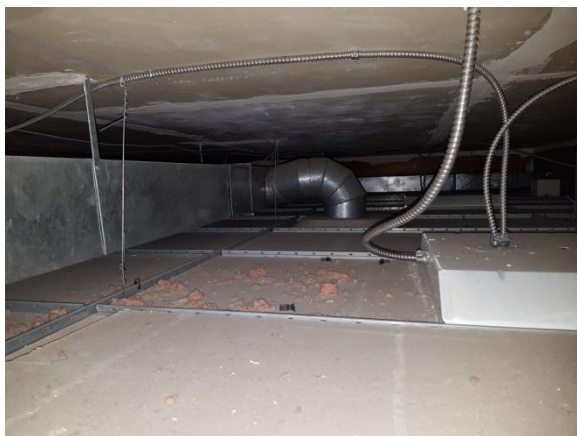
Above ceiling tiles – ducts do not have any mastic or tape on them

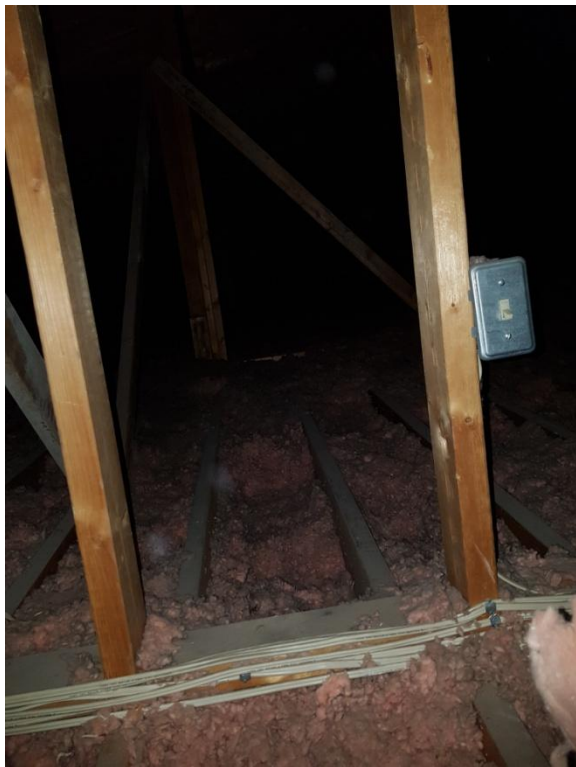
Attic has fiberglass insulation. Could definitely use another 6" for better long term energy efficiency.

Did not find any Vermiculite in this building.
