ROTARY BEACH TEE PIER
CONDITION ASSESSMENT REPORT
UPDATE DECEMBER 2022

LAKESHORE DRIVE SOUTH, SUMMERLAND, BC

22-00359

December 19, 2022

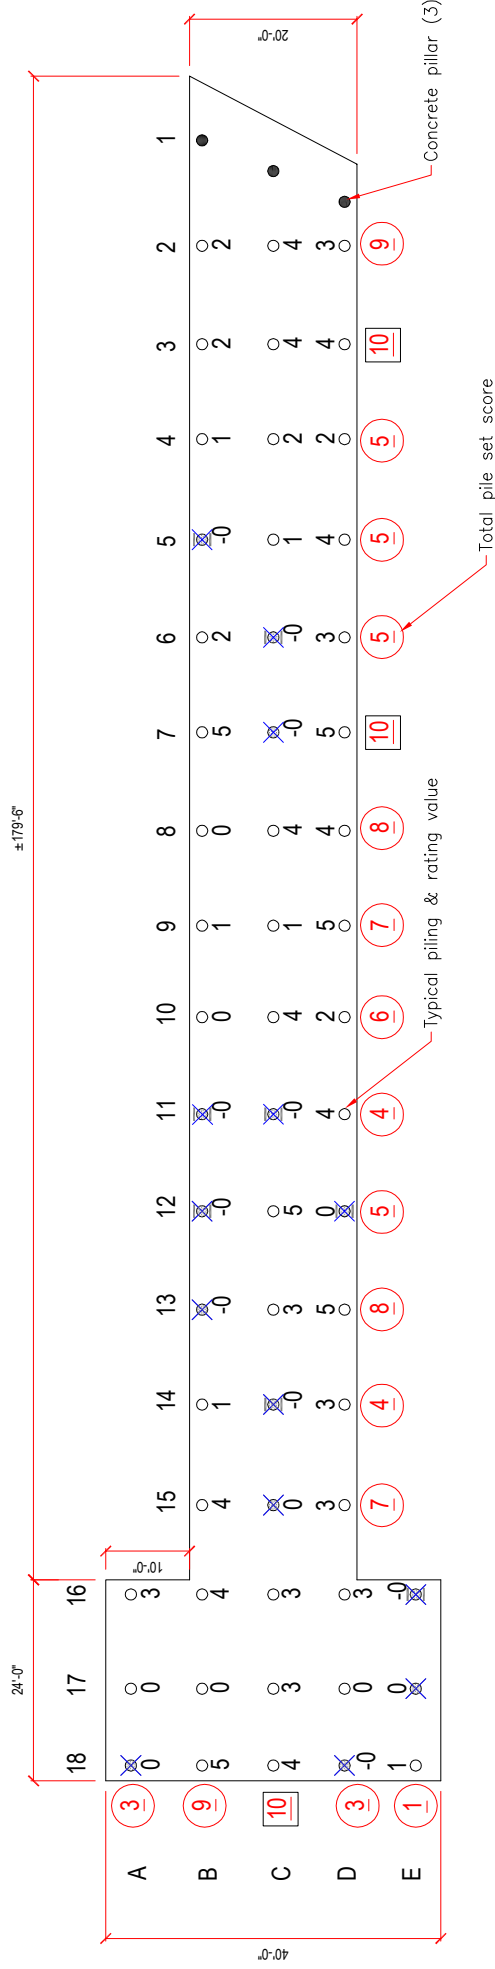
TEE PIER PLAN - CURRENT CONDITION

Based on our evaluation 15 pilings have dropped to a lower score from good and moderate to poor, failed and broken with a rating of 2 to 3, 0 to 1 and -0 respectively since the last evaluation. Replacement of these pilings is required.

There are 25 pilings that have failed and need immediate replacement. There are another 15 pilings that are in critical condition and need immediate replacement. A total of 40 pilings are now in need of immediate replacement of the total of 57. As noted in the Shoreline Pile Driving report, replacing a single pile would require the removal of the deck planks within that location along with the deck joists and the cross beam on top of the pilings. Since the deck joists span over a couple of cross members, the existing joists may need to be cut above the location of the cross member with the piling to be replaced. As this would need to be done for each pile it would be advantageous to change a complete set of 3, all at one time. This will save time and labor costs. There are no 3 piling sets that have completely failed; however, there are a number of sets that are very close. There are 5 sets with a total score between 1 and 4. There are 11 sets with a total score between 5 and 9, and another 3 sets with a total score of 10.

The individual pilings for the pier have deteriorated considerably over the past 41 months since our last review. Most of the visible deterioration is occurring toward the Tee end which has the most exposure. **Based on this accelerated deterioration of the majority of pilings we recommend the pier is closed to the public. Before the pier can be open to the public, we recommend the immediate replacement of all piling sets. The accelerated deterioration of the individual pilings has rendered this decision as the overall safety of the pier is critical.**
