# FINAL REPORT

## Facility Condition Assessment Summerland Arena & Curling Club Complex

8820 Jubilee Road East,  
Summerland BC, V0H 1Z5

Date: July 13, 2022  
Project No.: 20211925

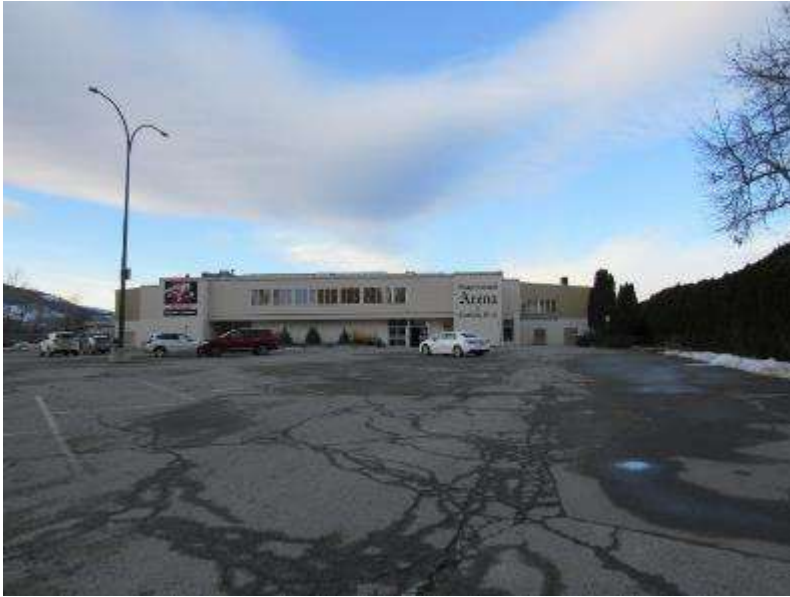
**Photo #A1:** Longitudinal and alligator cracks caused by freeze thaw and age of surface in the parking lot area.

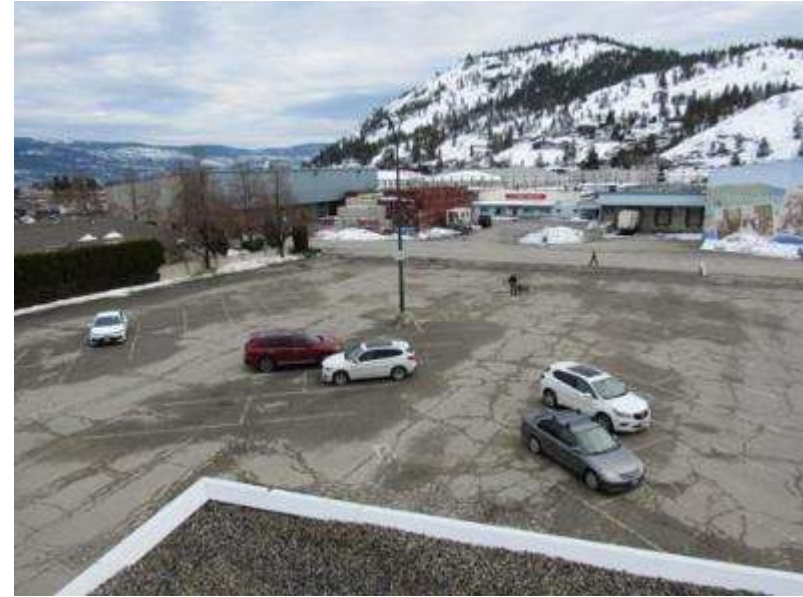
**Photo #A2:** Current condition of the parking stall marking.

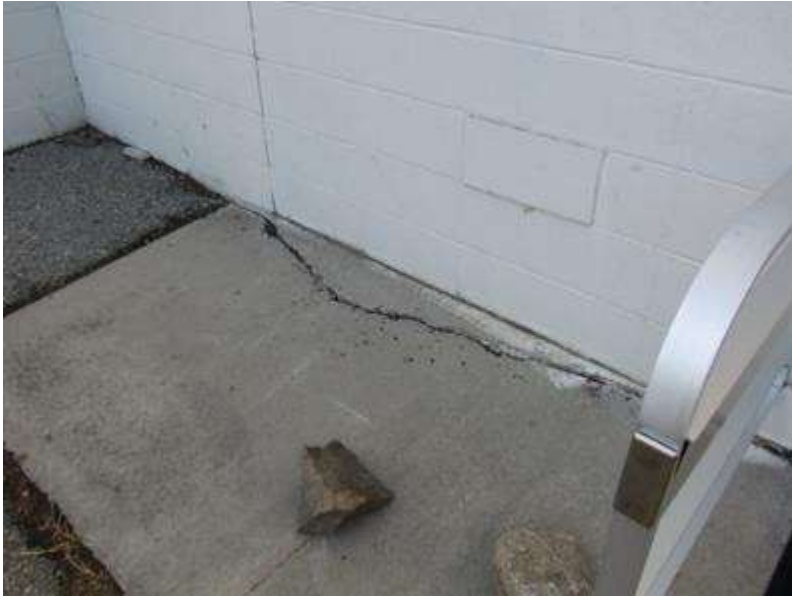
**Photo #A3:** Crack on Concrete apron.

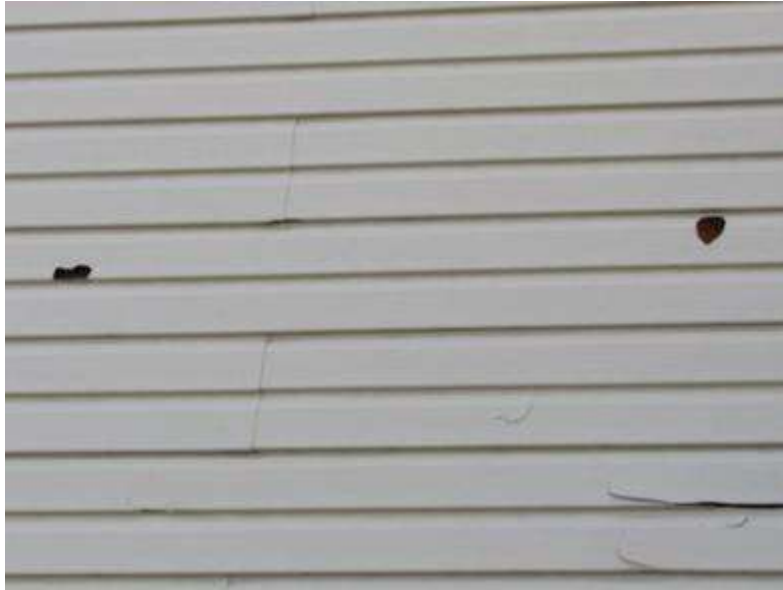
Photo #A5: Damages of vinyl siding.

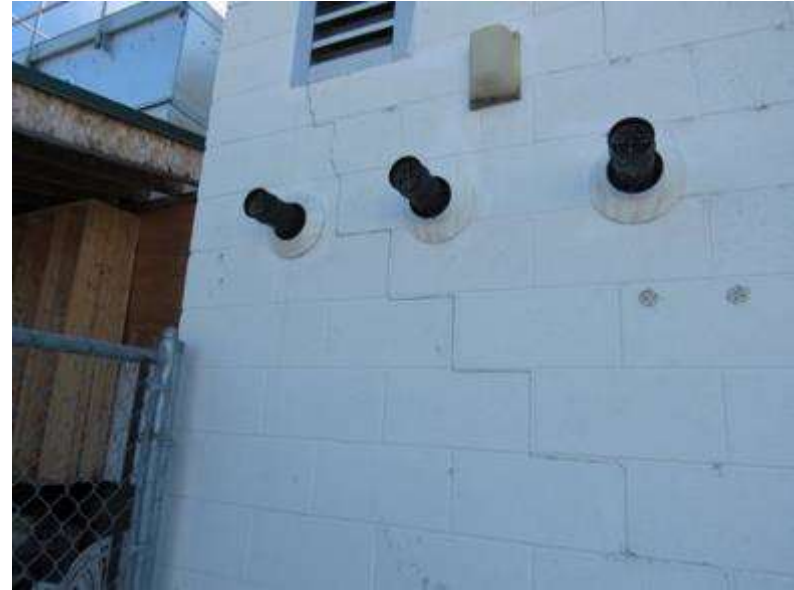
Photo #A6: Step crack on the concrete block wall.

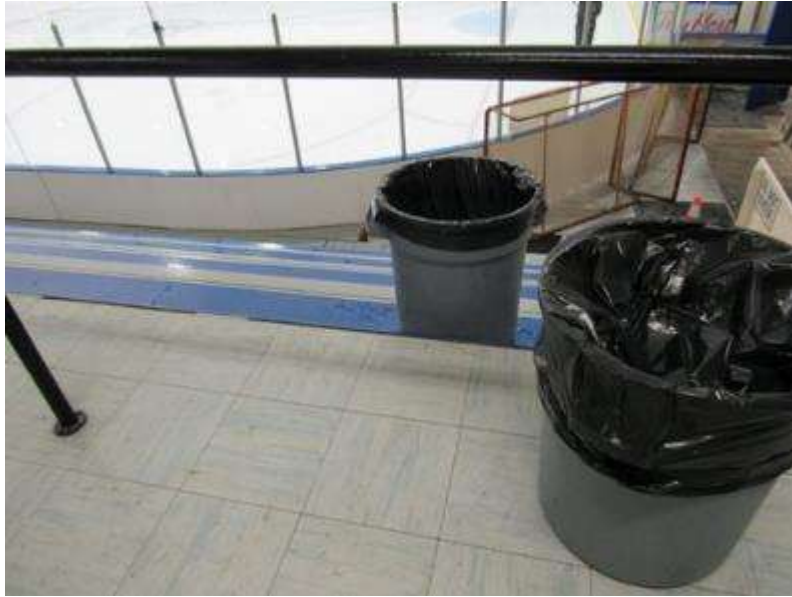
Photo #A13: 2<sup>nd</sup> floor of Ice arena. Buckets were observed in the water leak area.

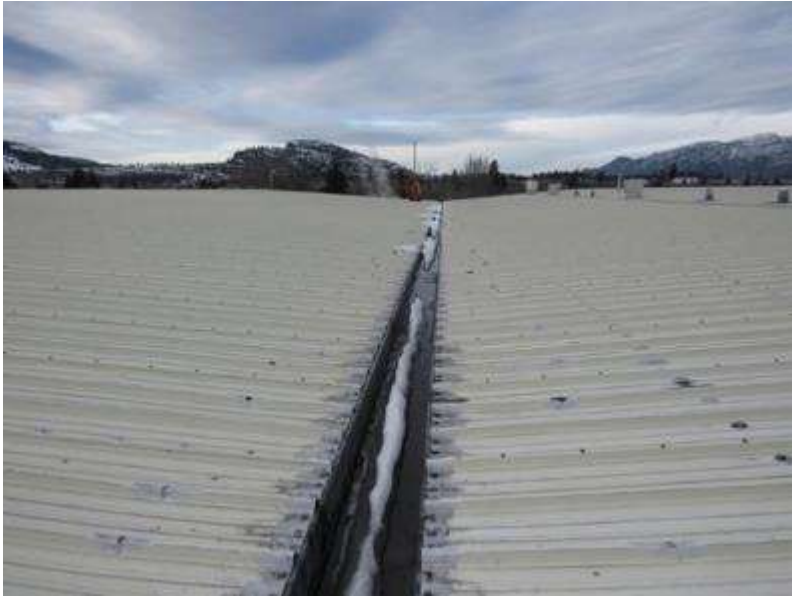
**Photo #A23:** Sloped metal roof. An active water leak was observed around the metal trench gutter. Localized repair areas also observed.

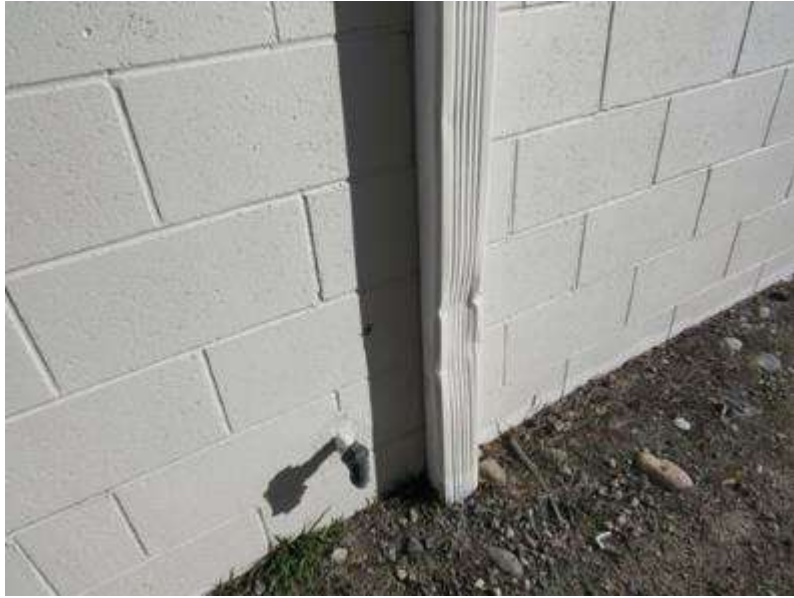
**Photo #A25:** Dented metal downspout.

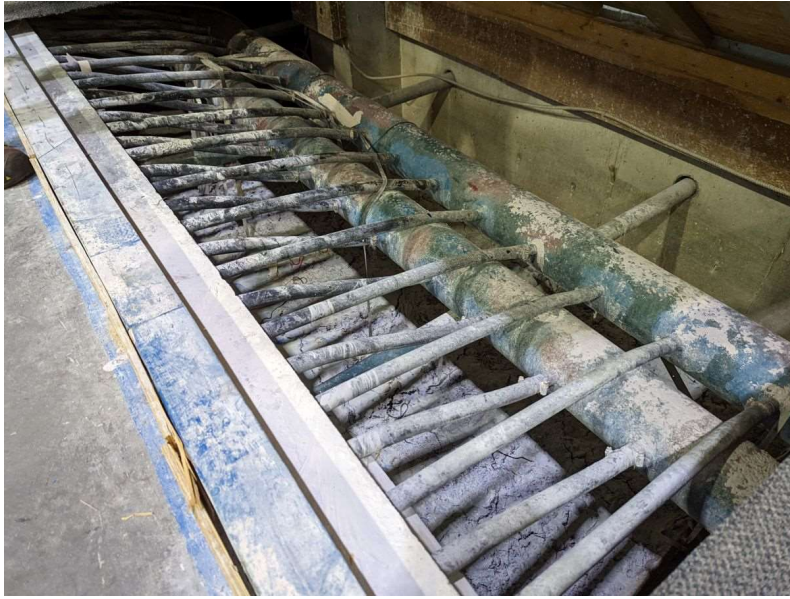
**Photo #S5:** Steel header pipes (Corrosion observed).

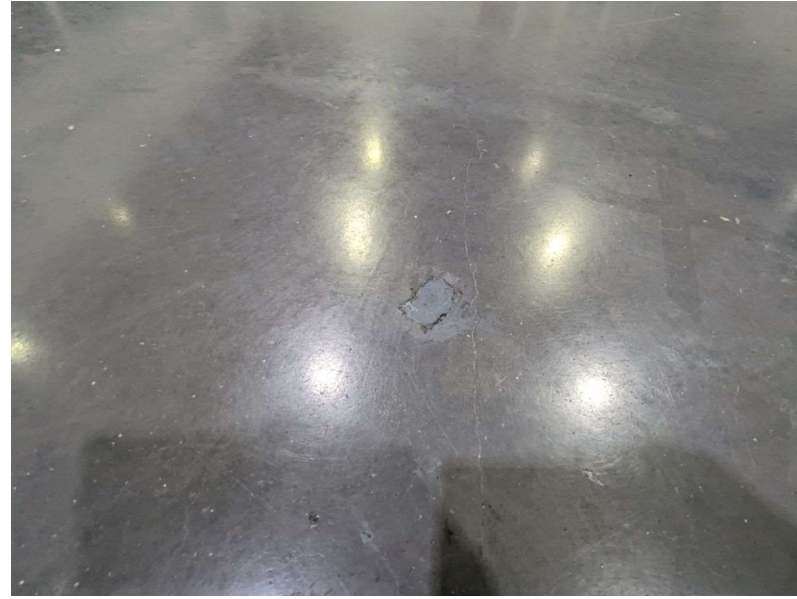
**Photo #S6:** Evidence of localized repair on SOG.

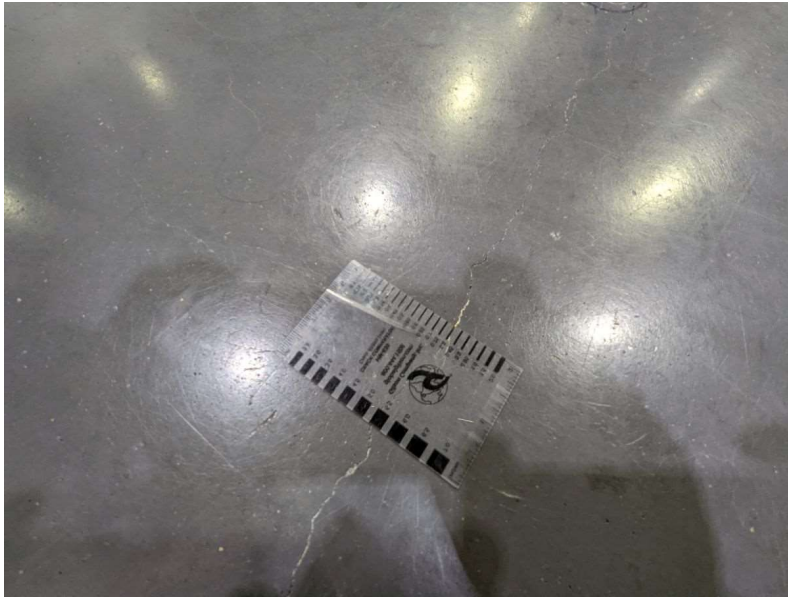
**Photo #S7:** Hairline crack in hocky arena.

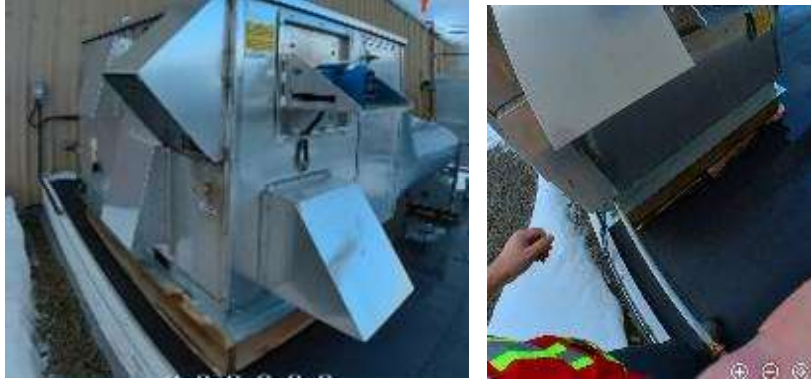
**Photo #M23:** Dehumidifier. Supply Gas line is not identified.

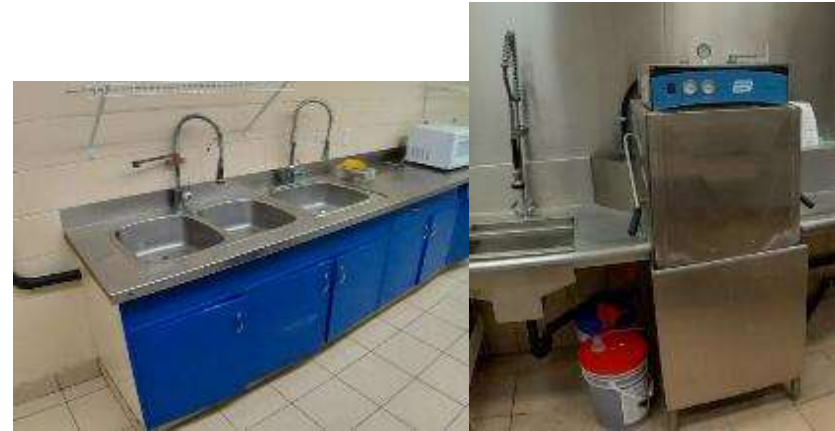
**Photo #M26:** Hand Sinks missing in Commercial kitchen and Concession.

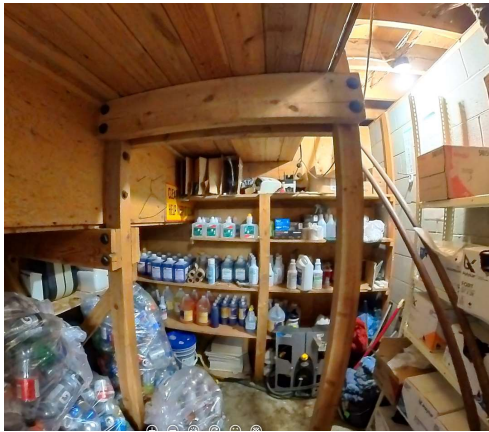
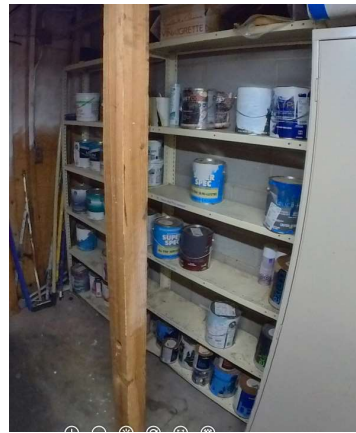
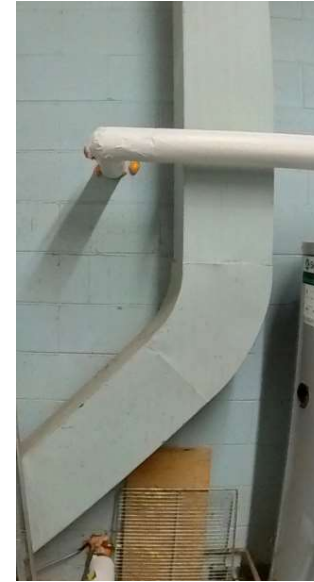
**Photo #M27:** Under Bleachers Non-Ventilated Chemical Storages.

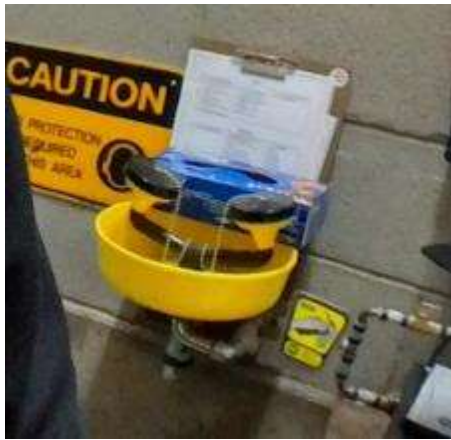
**Photo #M31:** Eye Wash Station. No temperature water supply mixing valve/sensor observed.

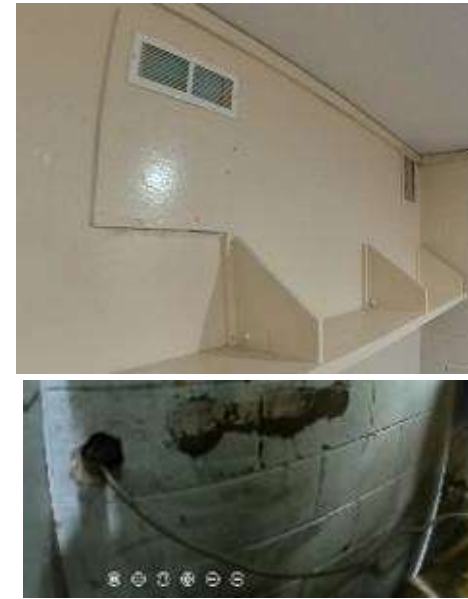
**Photo #M32:** All Grilles are blocked off at Room #6. Numerous locations where fire sealant missing.

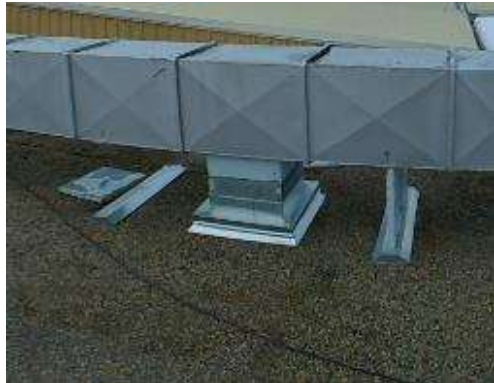
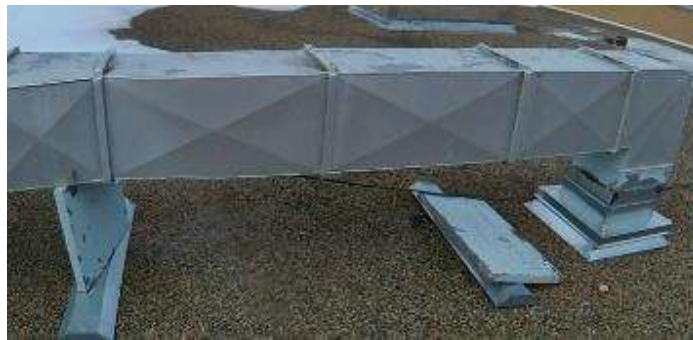
**Photo #M33:** Supports for Ductwork on the Roof to be fixed.

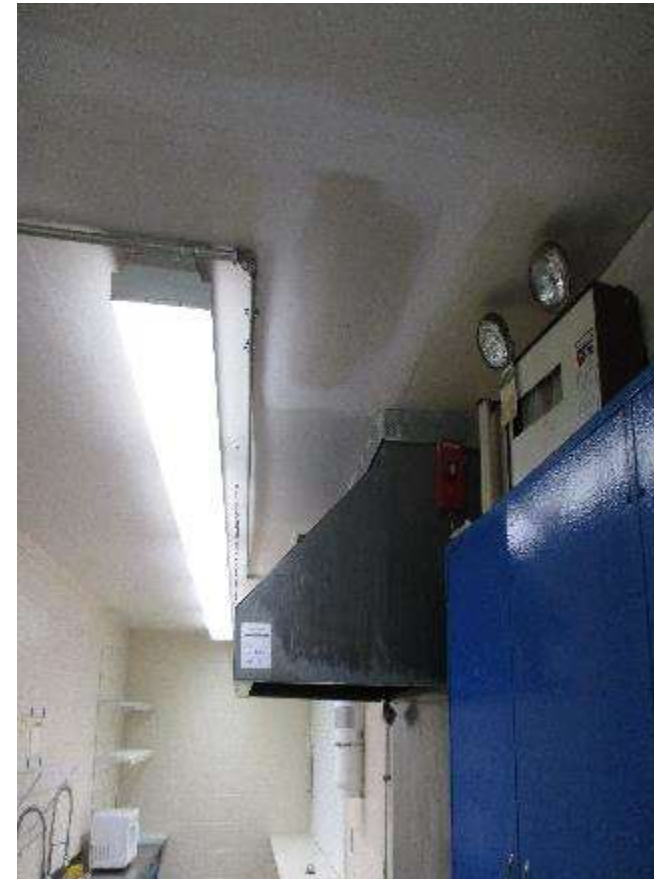
**Photo #E6:** Concession Area Surface mounted Fluorescent recessed lighting and Legacy emergency battery pack with heads
