PROPERTY CONDITION ASSESSMENT

Summerland Aquatic and Fitness Centre

13205 Kelly Avenue
Summerland, BC, V0H 1Z0

Project No.: 155618238

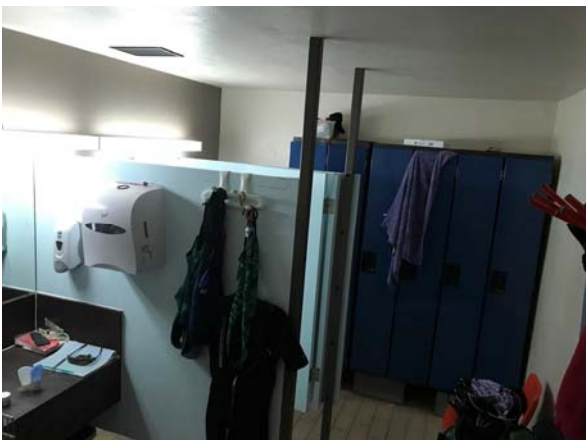
Photo A5
View of staff women's washroom. One water closet has been removed for storage.

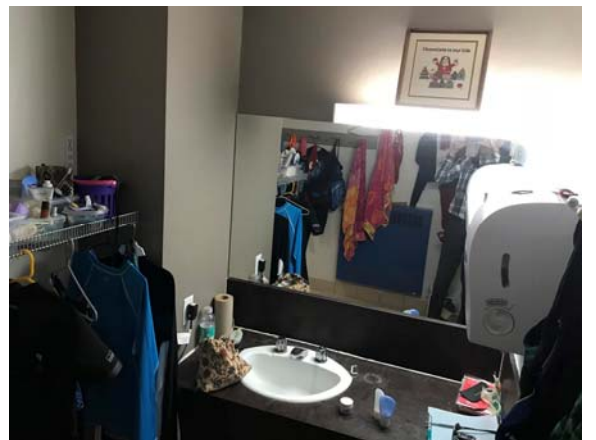
Photo A6
View of vanity in staff women's washroom.

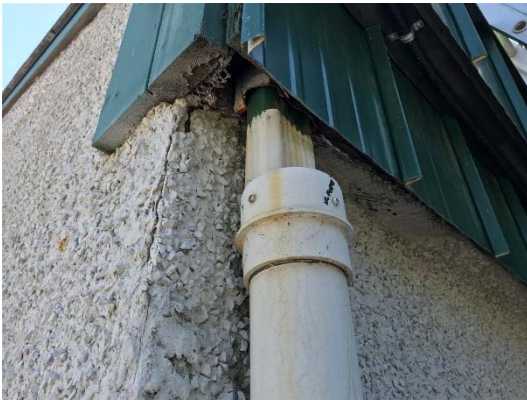
Photo A9
View of typical soffit to downspout condition.

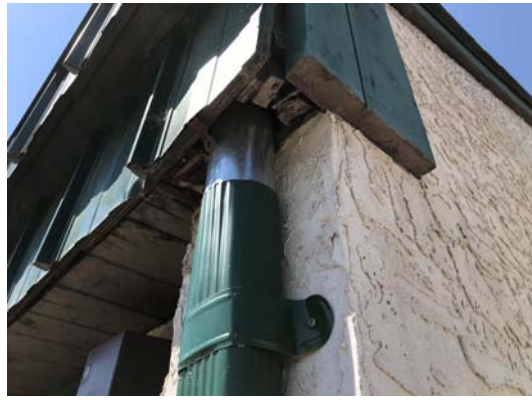
Photo A10
View of typical soffit to downspout condition.

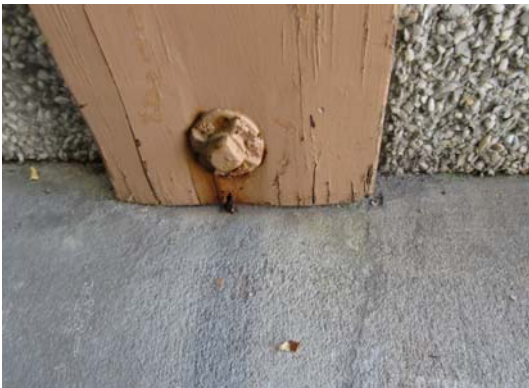
Termite damage was observed at exposed column south of the front entrance. The termite-affected portion of the column requires remediation as soon as possible to prevent further damage and to limit the extent and cost of future repair.

Photo S3
Column base at entrance with termite damage below bolted connection. Repair is recommended.

Remediate the building envelope to mitigate moisture issues and prevent possible damage of structural elements. Remediate column at front entrance with termite damage. Conduct load studies on existing capacities of storage shed and mechanical service mezzanine. Remediate deteriorated exterior paving to reduce tripping hazards. Replace staff deck.

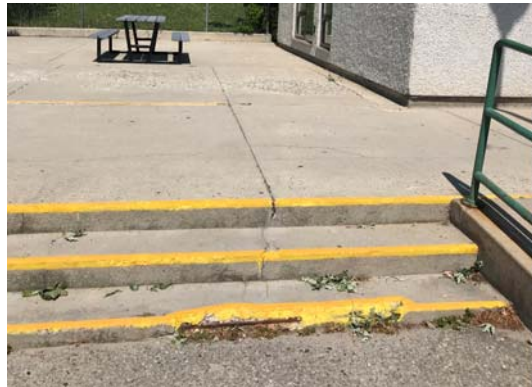
Exterior concrete paving elements on the frontage of the facility appears to be in poor condition. There is spalling of concrete at stair nosing and at locations where significant rain water spillage from roof is suspected. Cracks and differential settlements of pavement creating potential tripping hazard were also observed. The steps were painted yellow as visual warnings. (refer to **Photo S6**, **Photo S7** and **Photo S8**)

Photo S6
Deteriorated stair nosing

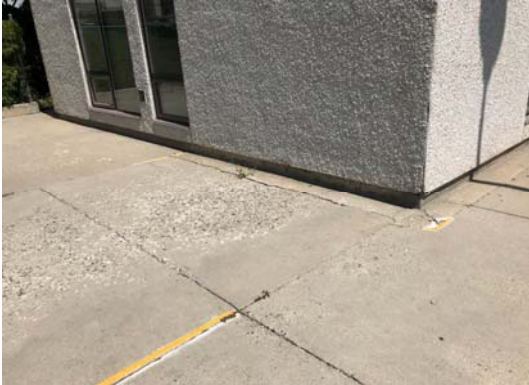
Photo S7
Spalling and differential settling of pavement at main entrance creating a tripping hazard.

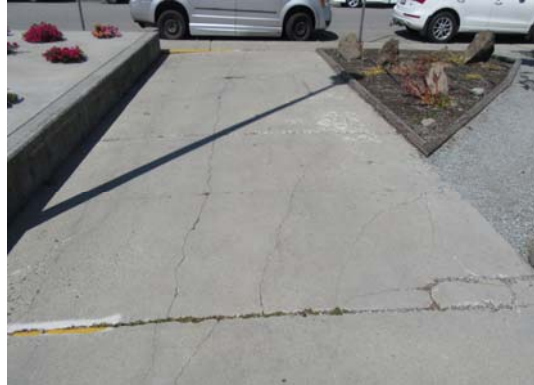
Photo S8
Cracks on concrete paving at front entrance.

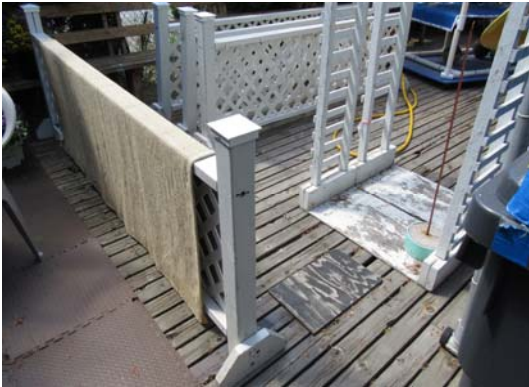
Photo S9
Exterior Deck

There is an exterior wood framed staff deck. This is currently being closed off from use due to deterioration and termite infestation. Due to its poor condition, it is recommended that this deck be removed and re-built as required. (refer to **Photo S9**)

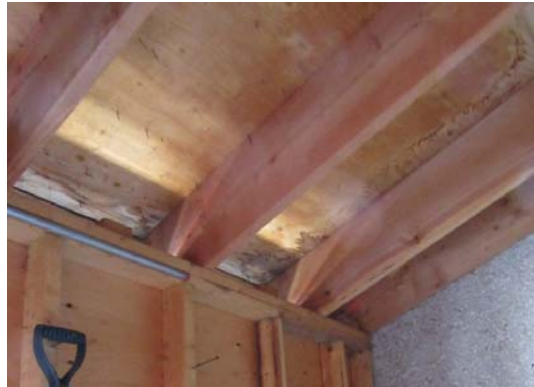
Photo S10
Plywood roof sheathing is in bad condition.

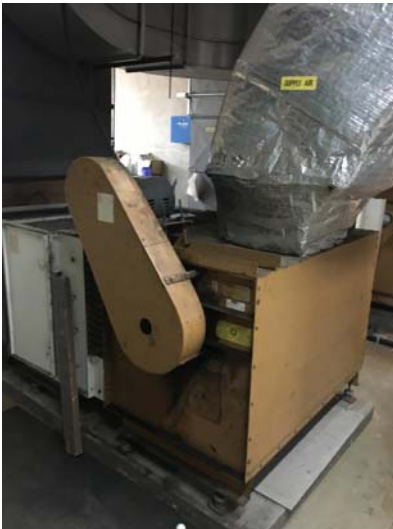
Photo M1A
Pool Lobby (AHU)

This air handler and all the associated components are original and have reached their estimated service life and should be replaced. (refer to Photo M1A)

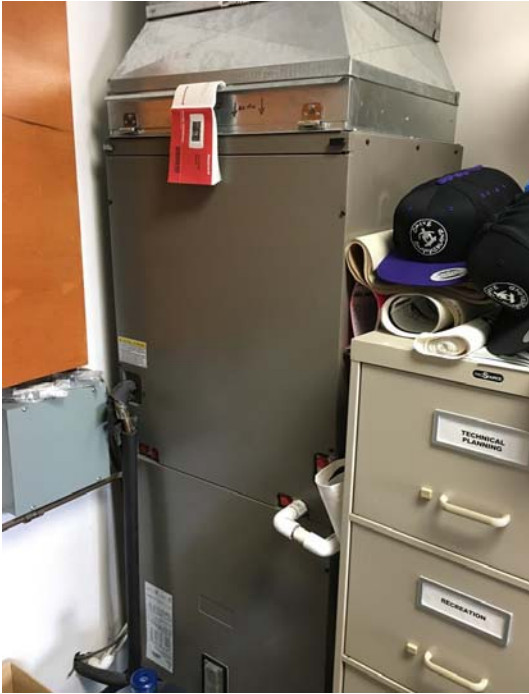
Photo M2A
Office Space Heat Pump Unit

Heat pump unit is estimated to be approx. 10-12 years old and does have some life left before it is scheduled to be replaced. (refer to Photo M2A and Photo M2A)

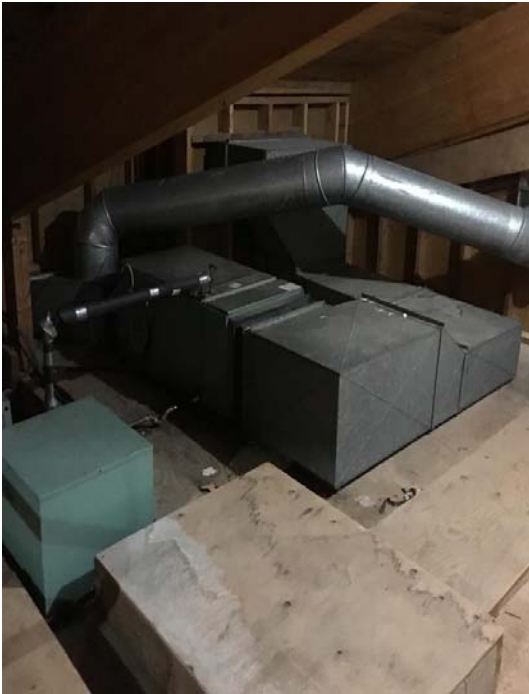
Photo M5
Meeting Room (AHU)

This air handler and all the associated components are original and have reached their estimated service life and should be replaced. (refer to Photo M5)

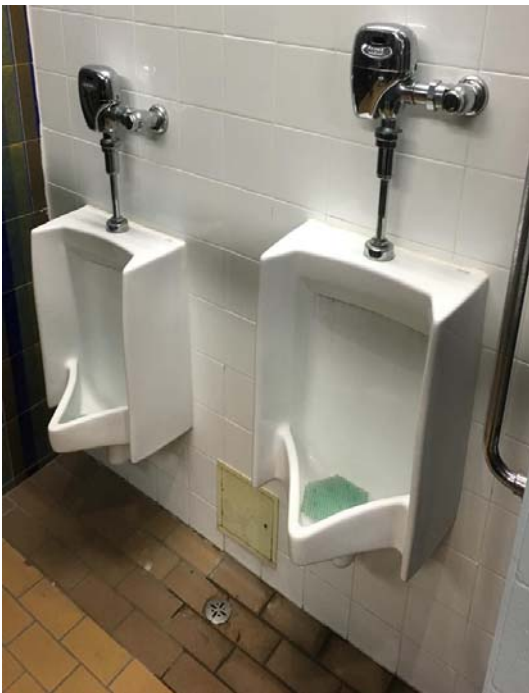
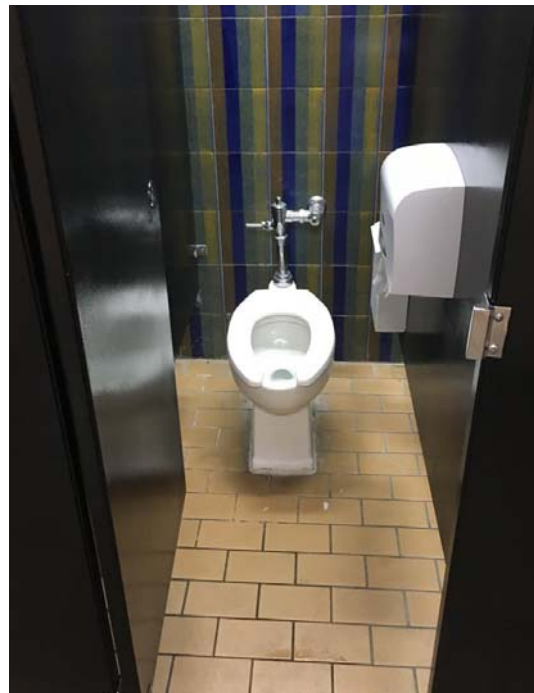
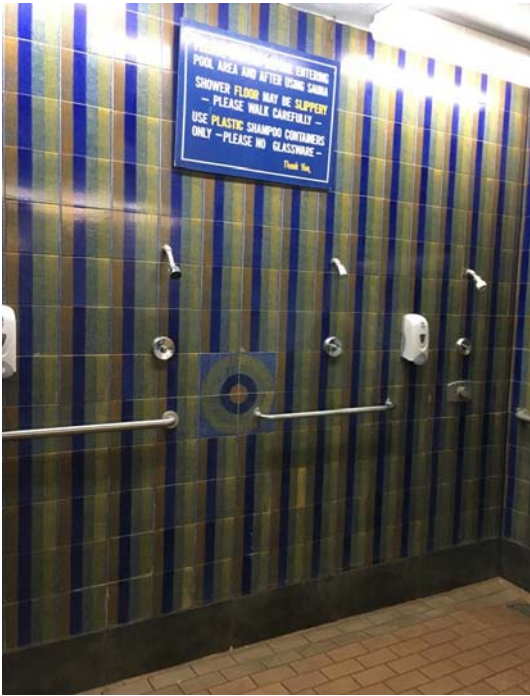
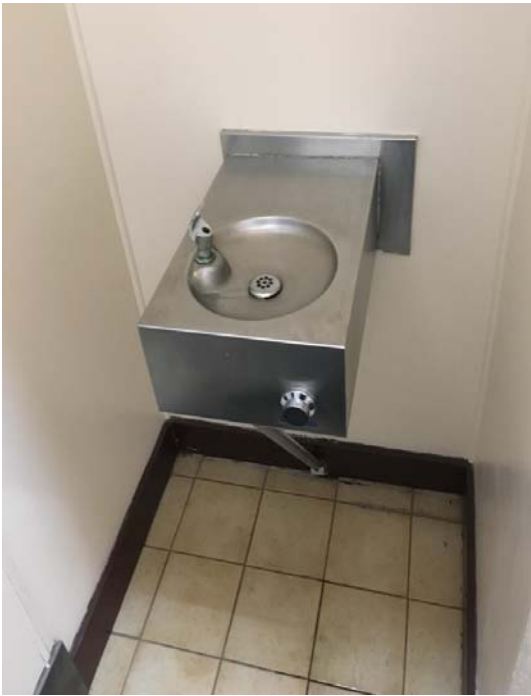
Plumbing systems are original to the building. The piping is copper and is getting close to reaching its life expectancy. There are pin hole leaks starting to show up in some of the piping in the last while and will only get worse over time.

The piping where pin leaking was experienced has been replaced. It is recommended that the copper piping systems be replaced within a 5-year period. (refer to Photo M7, Photo M8, Photo M9 and Photo M10)

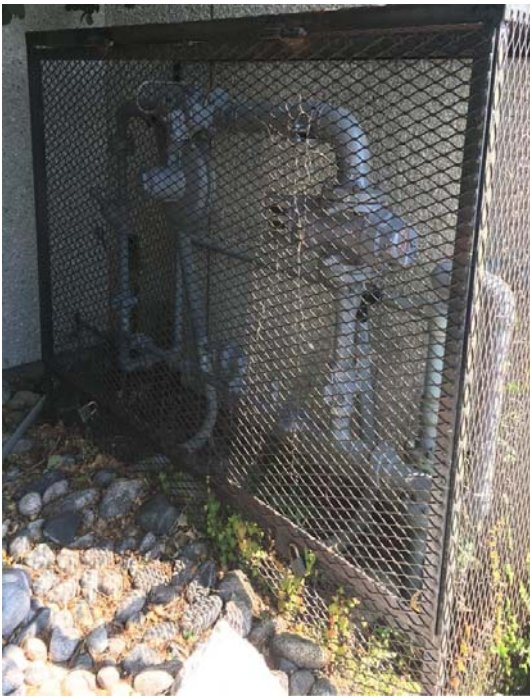
Photo M11
Gas Meter Enclosure

The building site services underground were not visible, but the incoming water entrance for Domestic water was visible in the mechanical room. It looked to be in reasonable condition. The exit of the sanitary drainage was not visible during the site visit. The storm system consists of exterior roof gutters that drain to down spouts along the exterior of the building. The downspouts then get piped underground and out to drywells around the perimeter of the building. It is not clear where the drywells are located around the site. The gas service to the site comes in on the Southwest corner to the existing gas meter and then serves the building. (refer to **Photo M11**)

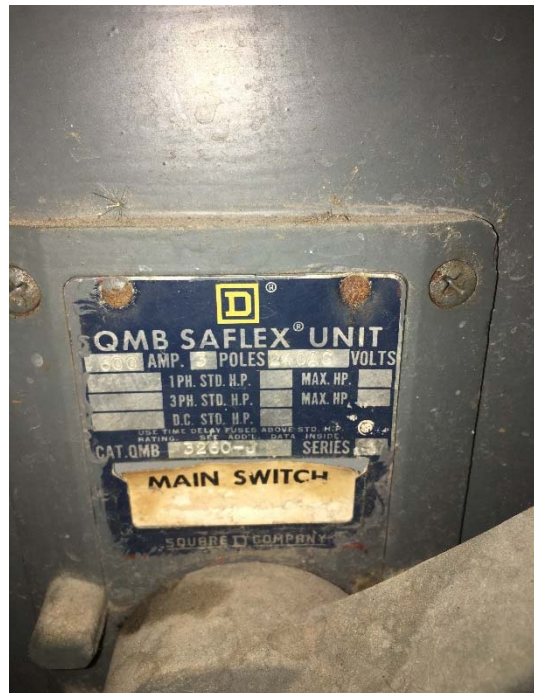
Photo E5
Corroded main breaker

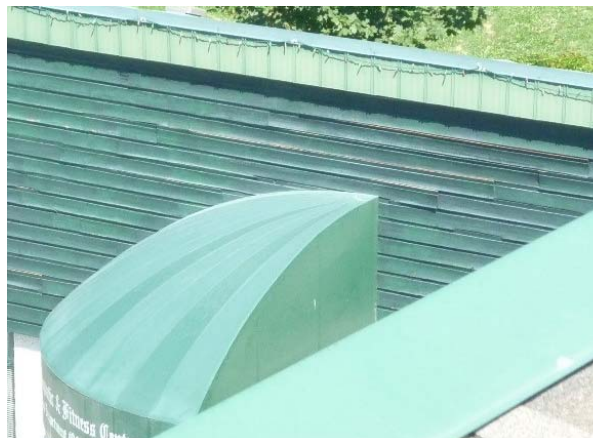
Photo Env5
Wood Cladding and entrance canopy creating snow trap.

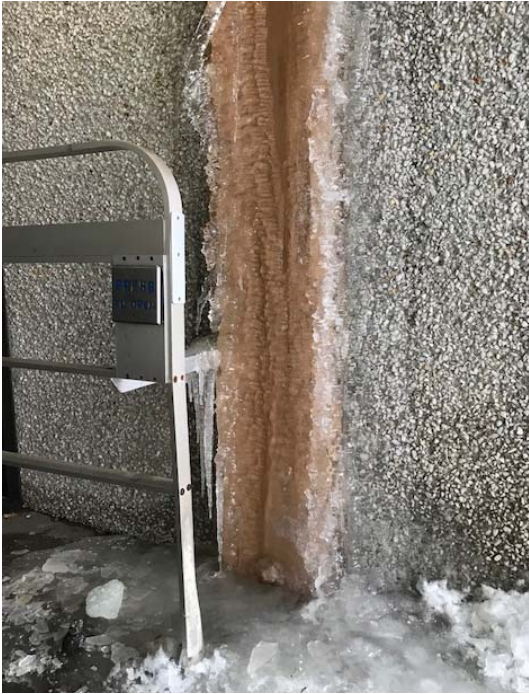
Photo Client1
View of ice buildup at structural column on South side the main entrance

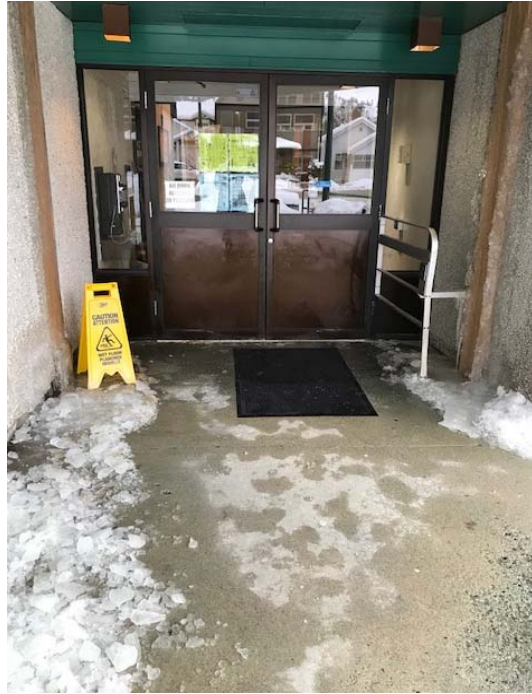
Photo Client2
View of main entrance during winter with ice.

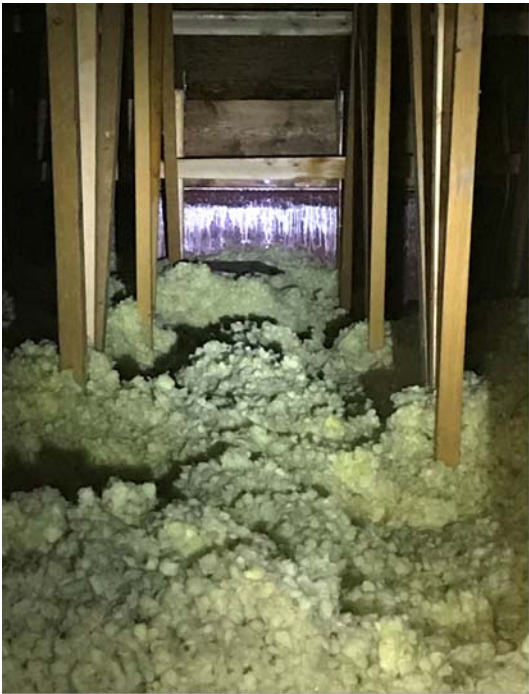
Photo Client3
View of attic space with daylight and significant ice buildup visible.

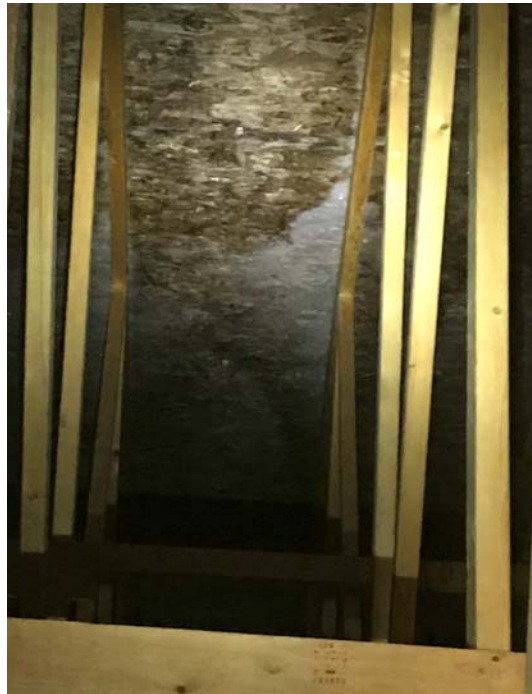
Photo Client4
Underside of roof sheathing with significant signs of moisture and frost.

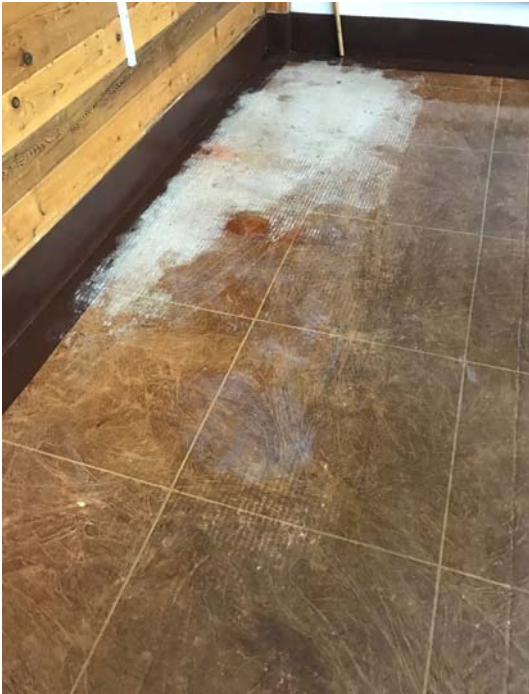
Photo Client5
View of frost buildup on floor in the original fitness room.

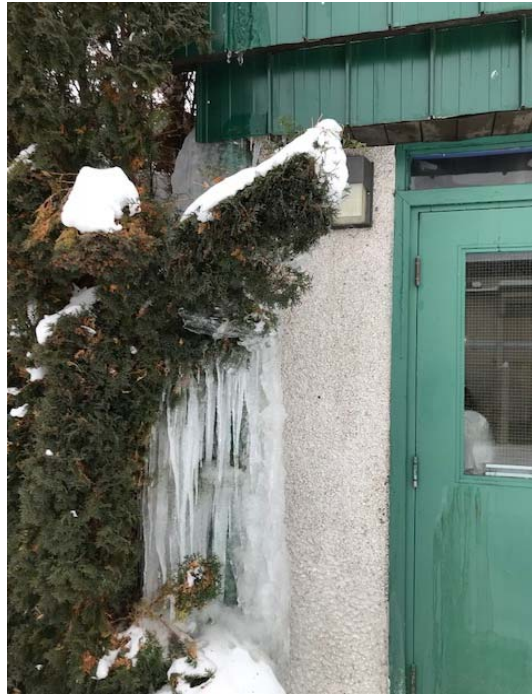
Photo Client6
View of ice buildup typical at downspouts.
