## THE CORPORATION OF THE DISTRICT OF SUMMERLAND COUNCIL REPORT

DATE: January 4, 2018 File: 2016-1787  
TO: Linda Tynan, Chief Administrative Officer  
FROM: Dean Strachan, MCIP, RPP, Director of Development Services  
SUBJECT: OCP Amendment and Rezoning – 13610 Banks Crescent - Update

## Summerland – iCasa Resort Living Erosion and Sediment Control Work Plan

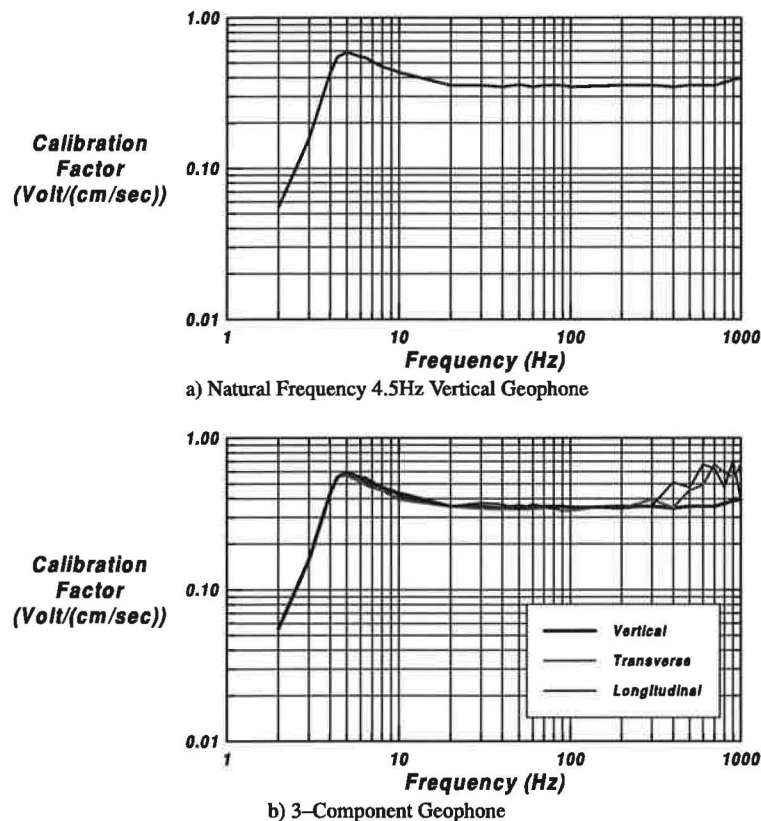
Fig. 1. Calibration curve for 4.5 Hz geophone and 3-component geophone: (a) Natural frequency 4.5 Hz vertical geophone; and (b) 3-component geophone.

velocity transducer, which usually is called geophone, is widely used for ground vibration measurement. The response of velocity transducer becomes nonlinear at low frequencies and has a natural frequency since it is a single-degree-of-freedom system. It is, therefore, necessary to calibrate exact voltage output of the geophone with frequency [7]. Typical calibration curve for the geophone (with open shunt damping) which has a natural frequency of 4.5 Hz is presented in Fig. 1a. Calibration factor is constant in frequencies approximately ranging from 10 to 500 Hz, representing the reliable range of vibration measurement using this transducer. For the vibration measurements at low frequencies below 10 Hz, the 2 Hz geophone (Mark Product L-4) was used with a factory calibration chart.

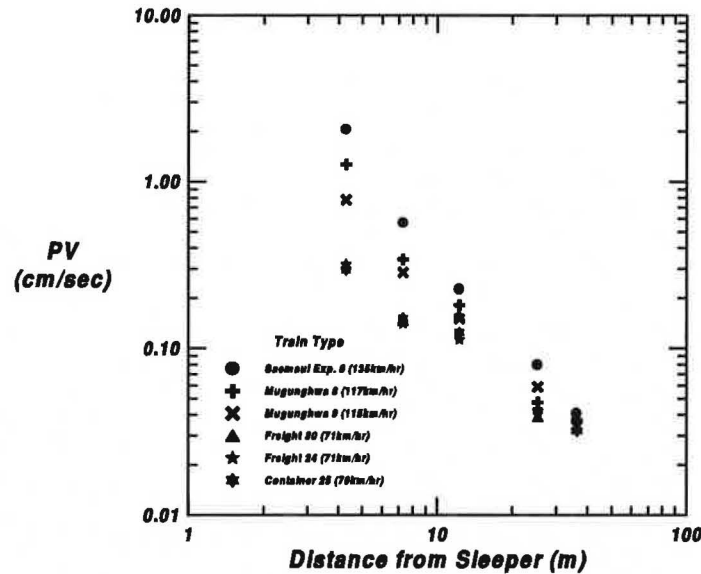
Fig. 6. Attenuation characteristics with distance of various train loading.

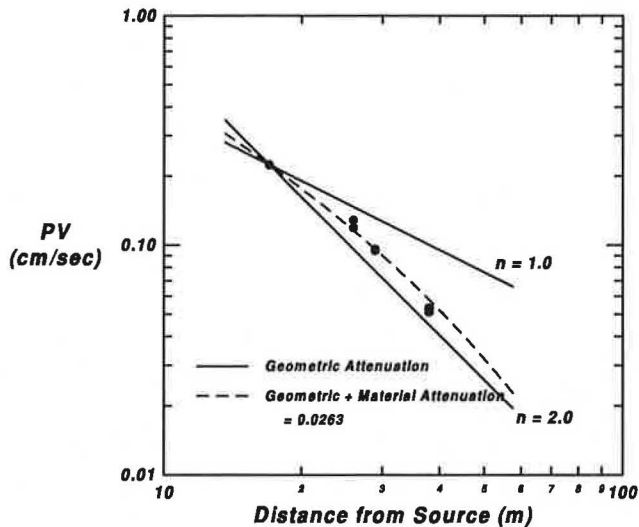
friction pile driving are shown in Fig. 13. Using the geometric damping coefficient of 1.0 representing the in-depth point source, the measured characteristics matched well with the  $\alpha$  value of 0.026 and the corresponding damping ratio of the site is 5–6% which is a little high at a maximum strain amplitude of about 0.001%. With the

Fig. 13. Attenuation with distance of friction pile driving induced vibration.

geometric damping coefficient of 2.0 representing the surface point source, geometric damping exceed actual attenuation data.

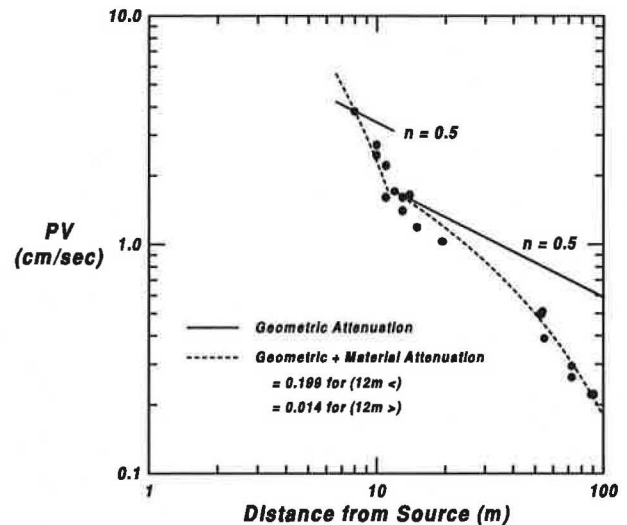
The typical attenuation of particle motion with distance is shown in Fig. 15. The attenuation characteristics were predicted by using the geometric damping coefficient of 0.5, which is for the case of a surface point source

Fig. 15. Attenuation with distance of hydraulic compaction induced vibration.

generating the surface wave. The corresponding  $\alpha$  values can be estimated separately as 0.199 in the near field within 12 m and 0.014 in the far field beyond 12 m. The wavelength of the propagation wave is about 12 m. The corresponding damping ratio in the near field was about 40% at the strain amplitude of 0.05% and the damping ratio in the far field was about 3% at strain amplitude of about 0.004%. Taking the soil type of the site and the experiencing strain level into consideration, the estimated damping ratios in the far field is reasonable, but the damping ratio in the near field is quite high. In the near field within the distance of one wavelength, body wave energy is significant and cannot be ignored in the estimation of geometric attenuation coefficient [15]. Therefore, the reason of high damping ratio can be explained by the body wave propagation in the near field which did not counted in the estimation of geometric attenuation coefficient.

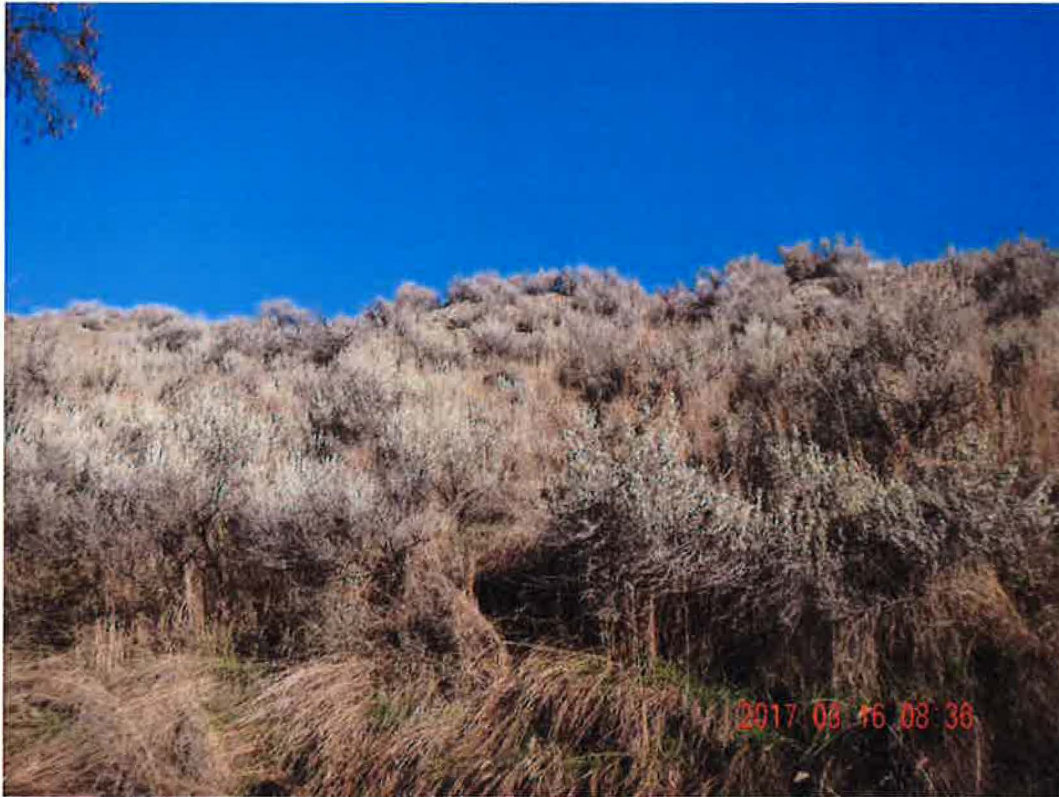
**Photo 1.** View of the shrub steppe ecosystem, photo taken in the northeast corner of the subject property (all photographs taken March 16, 2017).

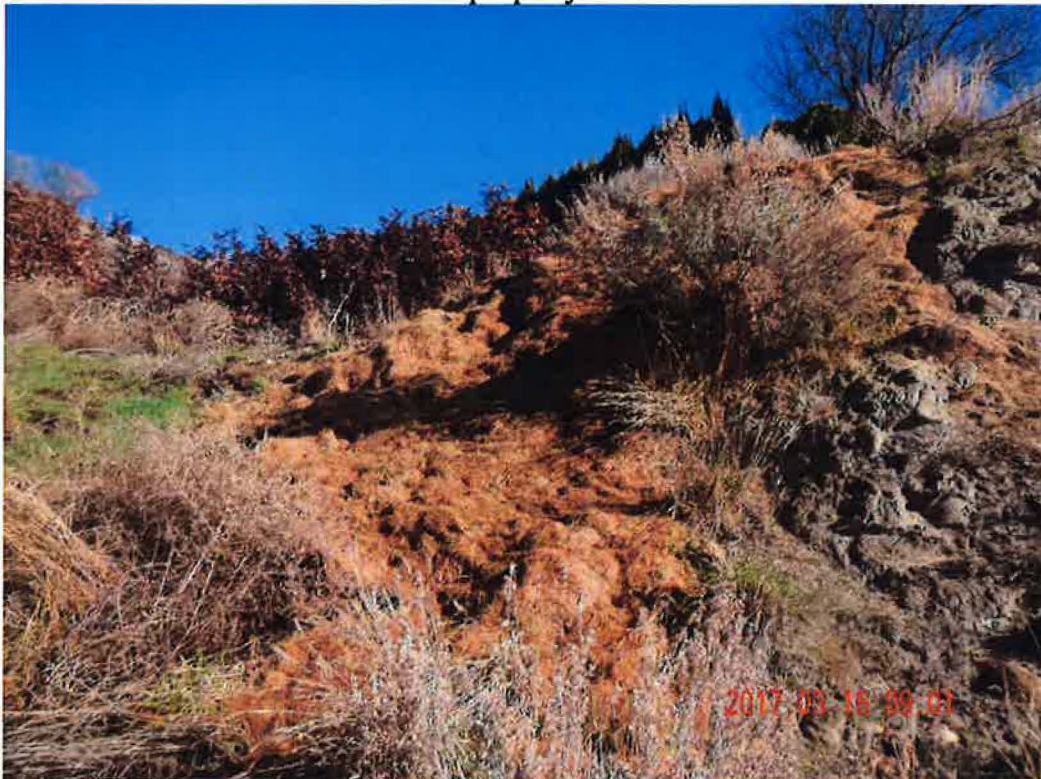
**Photo 4.** Yard waste and associated invasive species located just north of the subject property adjacent to the property boundary.

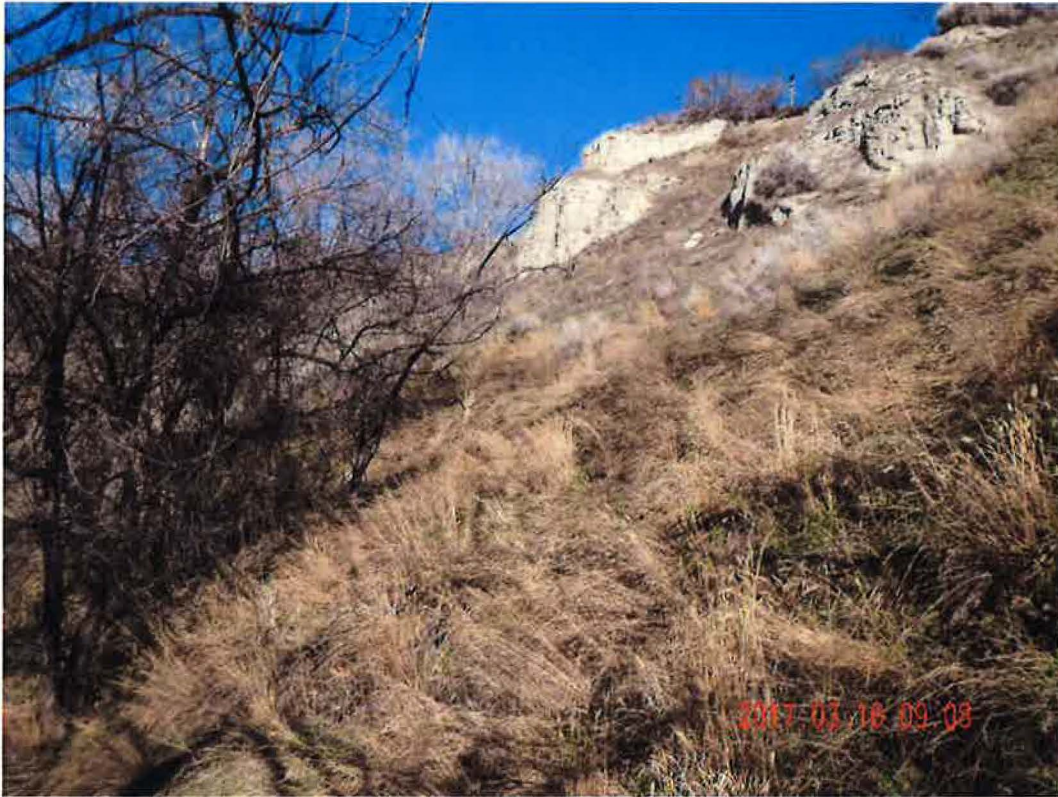
**Photo 5.** View of the silt bluffs located along the northern boundary of the subject property.

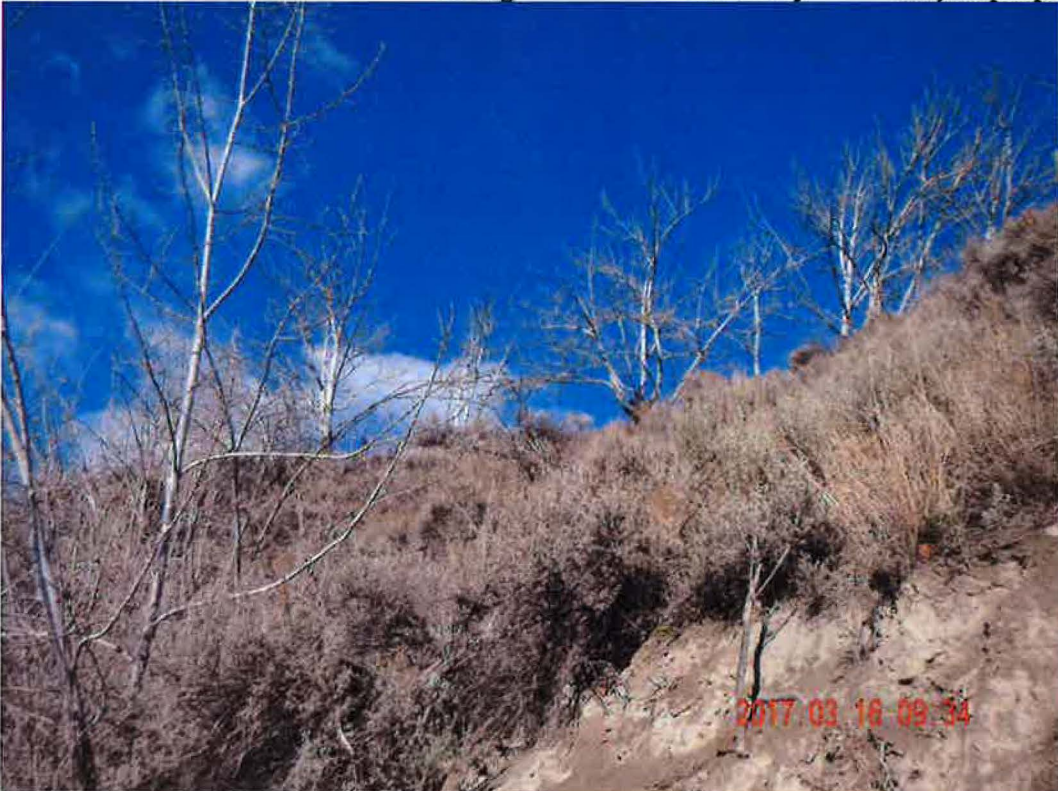
**Photo 6.** Silver poplars disrupting the natural shrub steppe ecosystem along the northern boundary of the subject property.

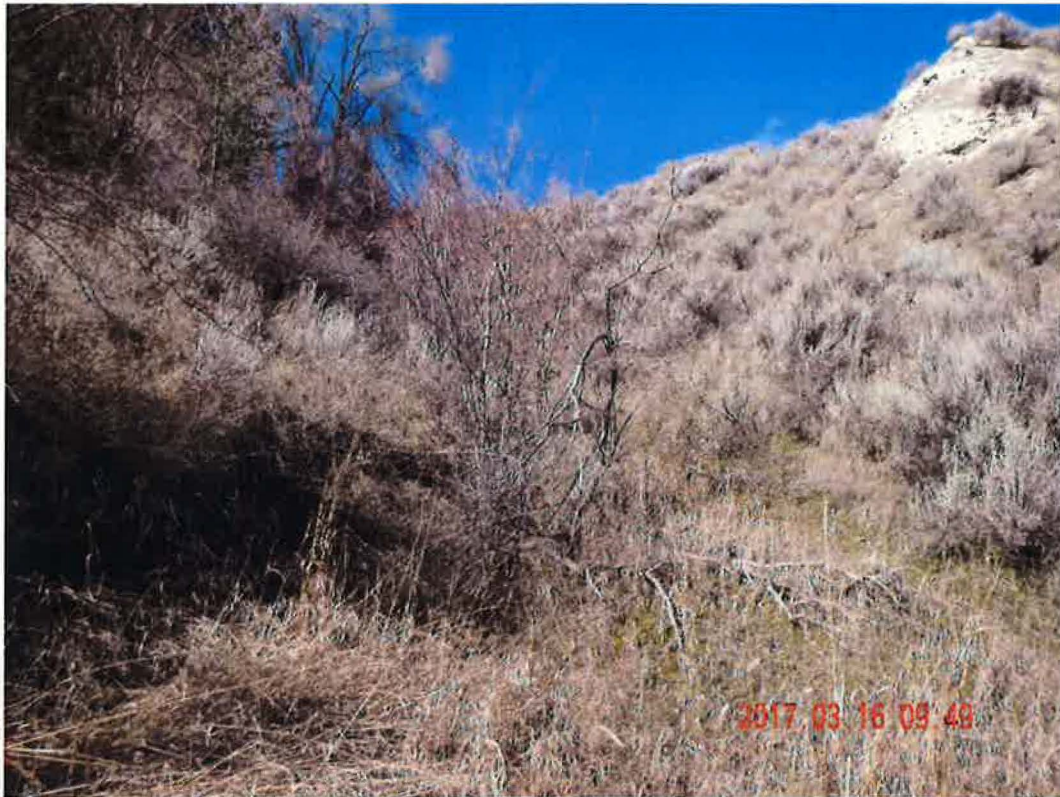
**Photo 7.** Transition zone with the shrub steppe ecosystem to the viewer's right and the woodland, cool aspect ecosystem to the left. Douglas maple and Saskatoon are located in this drainage gully.

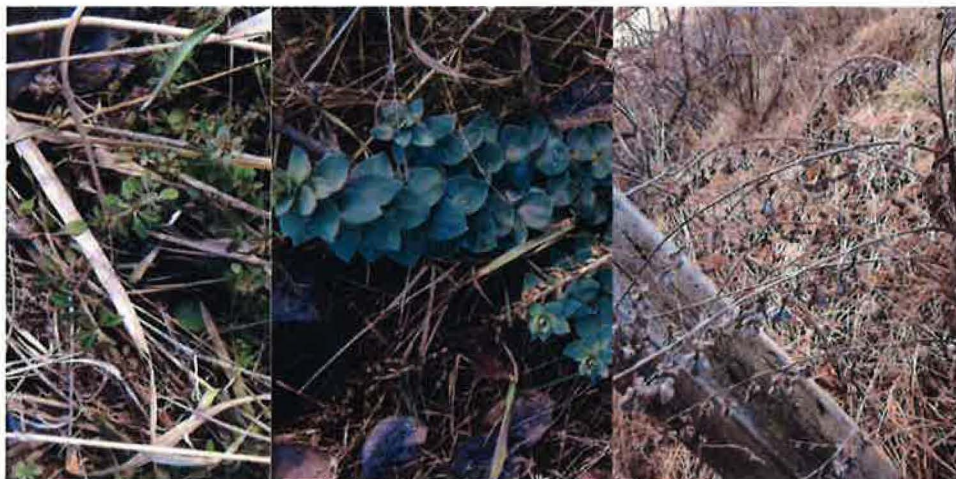
**Photo 8.** Some of the invasive species located within the subject property. Left to right: cleavers, Dalmatian toadflax, hounds tongue.

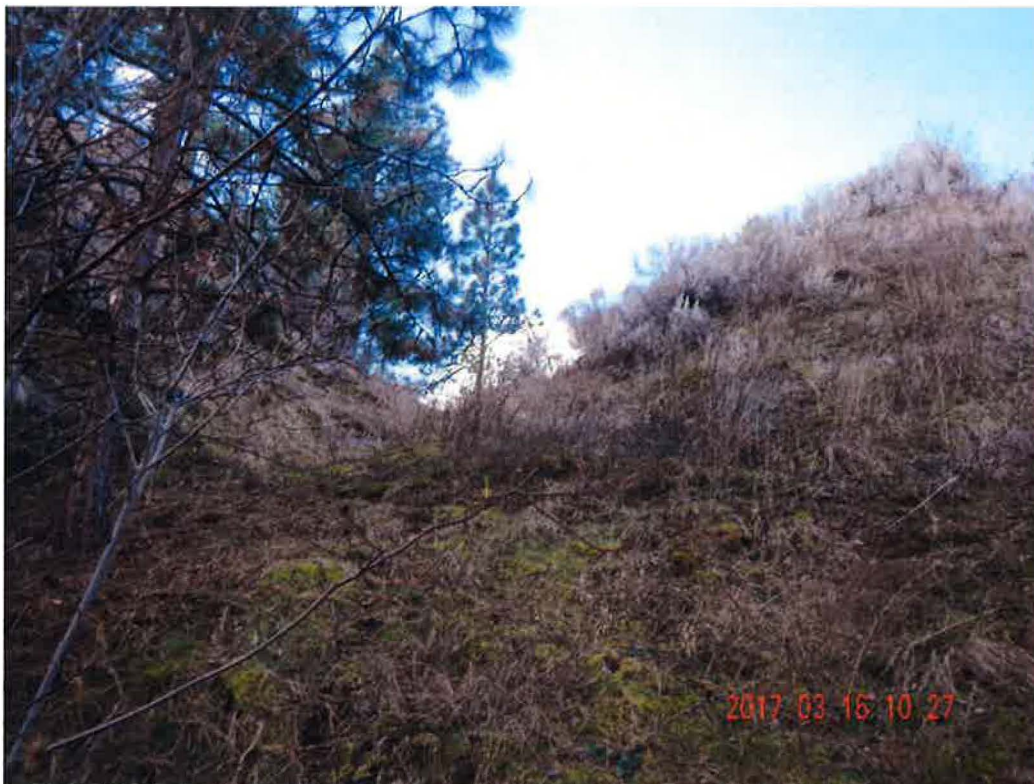
**Photo 9.** View of the cool aspect of the subject property characterized by ponderosa pine, moss and shrubs.

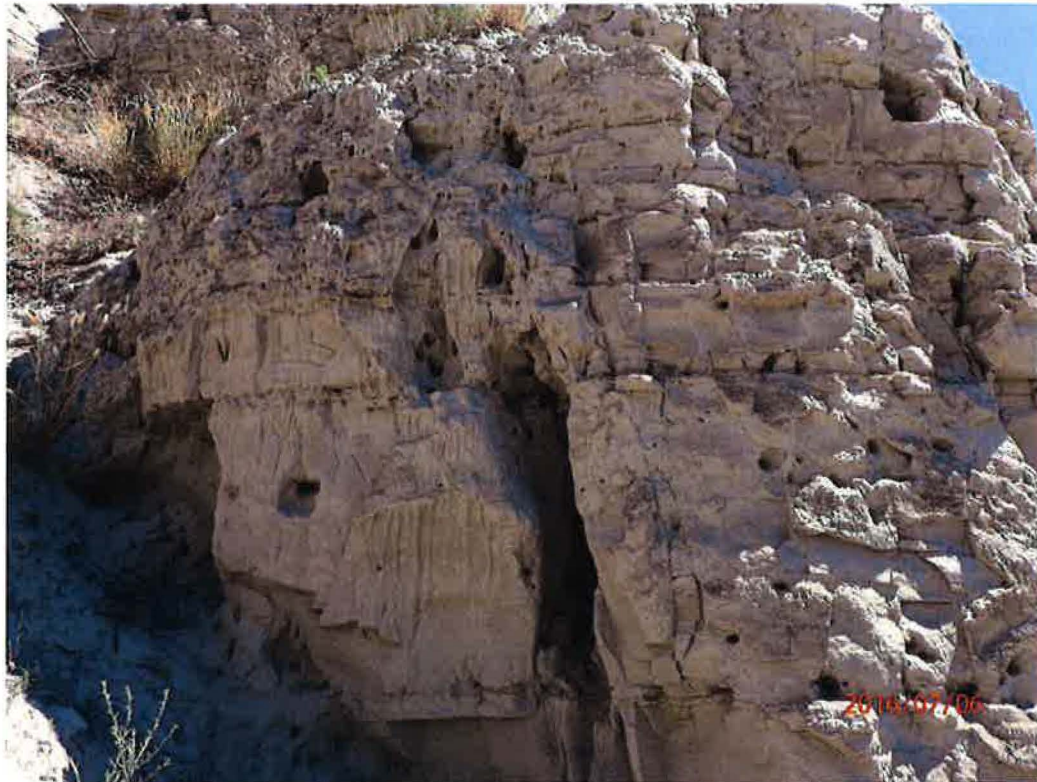
**Photo 11.** Bird foraging activity within silt bluffs (photo taken July, 2016).

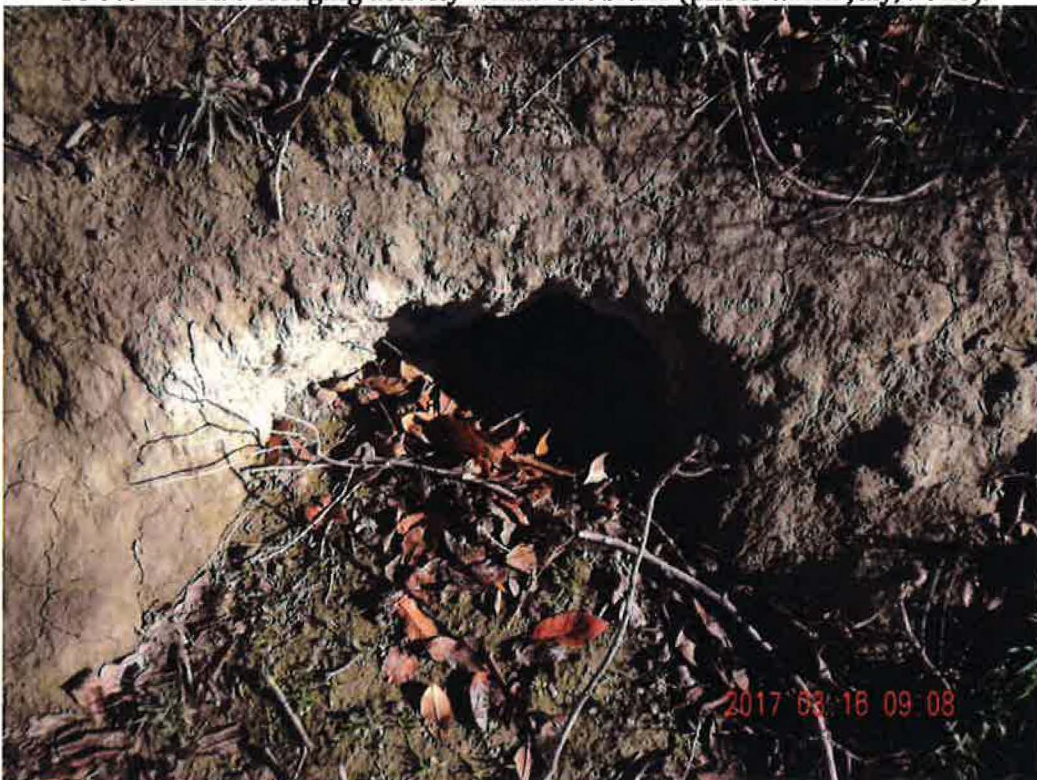
**Photo 12.** One of many unused burrows located within the subject property. Based on the level of landscape fragmentation and shape of burrows, previous species use is assumed to have been marmot. This is corroborated by observations of adults in the early spring 2017 site visit.
