GIANT'S HEAD MOUNTAIN

TRAILS RE-DEVELOPMENT PLAN

SEPTEMBER 2017

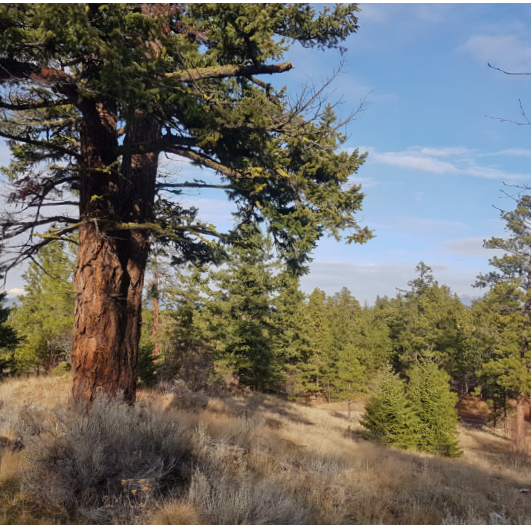
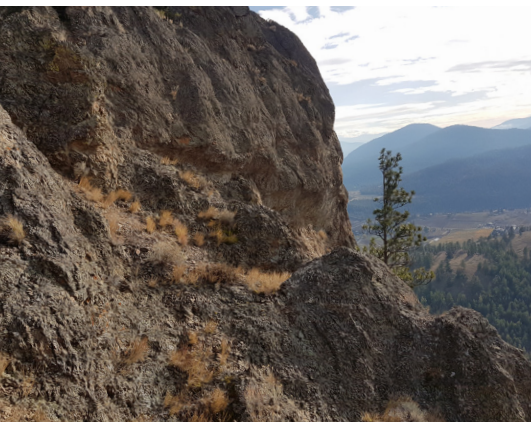
Top: Blue-listed Ponderosa pine / Douglas fir woodland (Credit: Mountain Pacific Environmental Consultants)

Bottom: Typical sparsely-vegetated rock bluff (Credit: Mountain Pacific Environmental Consultants)

The woodland area in the northern portion of the park consists of a mixed Ponderosa pine and Douglas fir stand that is also red-listed by the CDC. However, a number of existing trails have caused significant disturbance. The woodland areas in the southern portion of the park are likewise affected by human use; while consisting of blue-listed areas, the highest amount of disturbance occurs near the summit where numerous trails, road access, and invasive plant species occur. Nevertheless, the oldest trees in the park grow in this area and stand health is good.

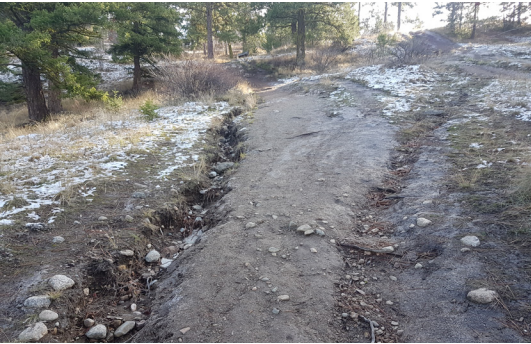
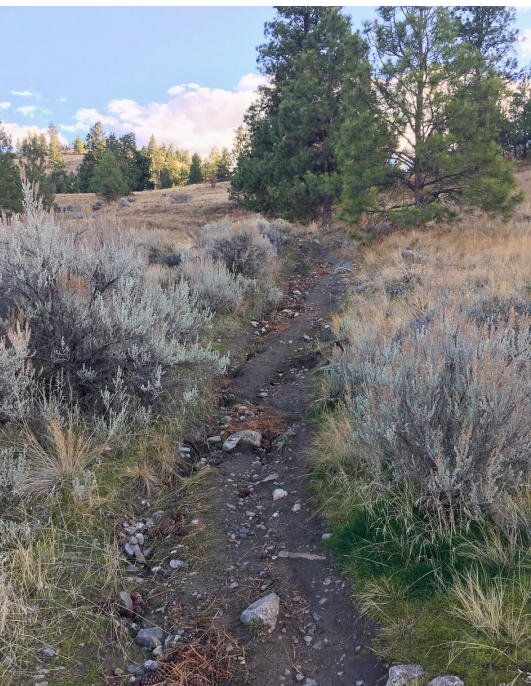
Top: Trail erosion and cross-cutting near summit
(Credit: Mountain Pacific Environmental Consultants)

Bottom: Eroding hiking trail

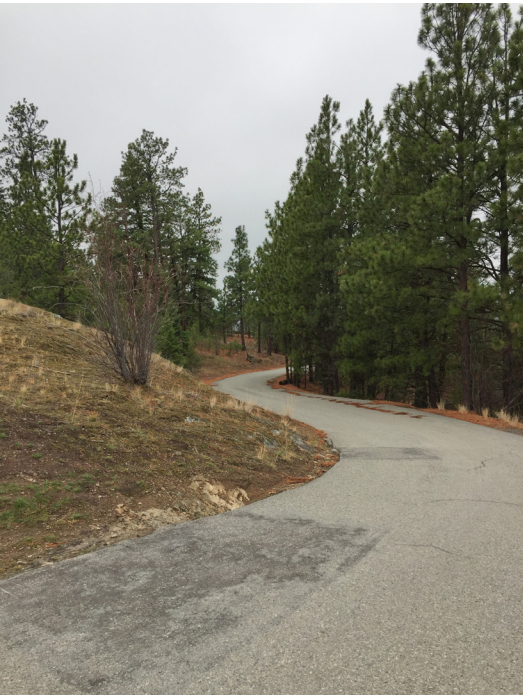
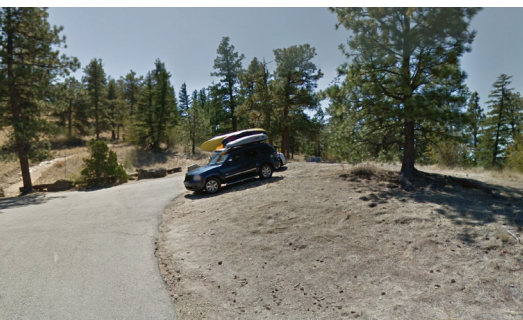
Top: Giant's Head Mountain Park road
Bottom: Summit parking area with unsanctioned expansion onto adjacent grassland area (Credit: Google Maps)

Vehicle parking, both adjacent to the park entrance and within the park itself, is a significant issue. Parking at the base of the mountain is limited to parallel parking on the gravel road shoulder along Milne Road, which is both limited in quantity and a potential nuisance or hazard to the adjacent residential development. Unscheduled parking occurs all along the park road (particularly at switchbacks and viewpoints), some of which is causing further erosion, de-vegetation, and encroachment into former picnic or viewpoint areas. A small parking area near the summit has approximately 6 official parking spaces, but the absence of parking lot delineation has seen additional parking encroachment onto the adjacent grassland.

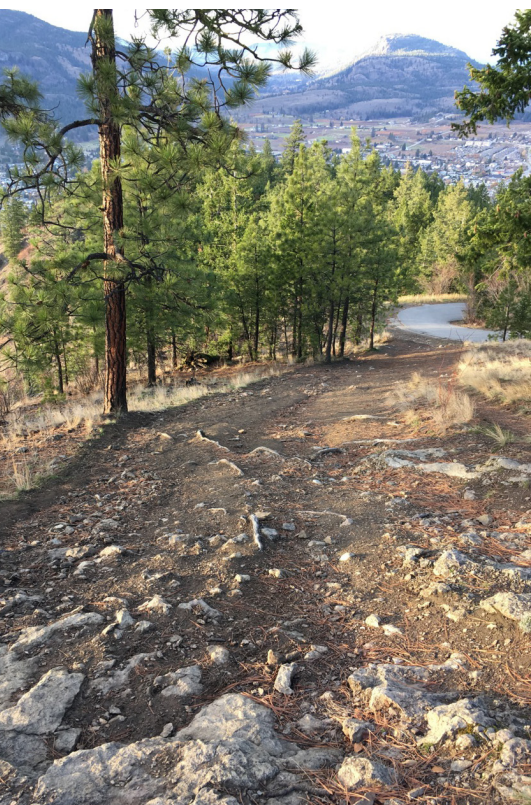
Trail with erosion, widened by use over time

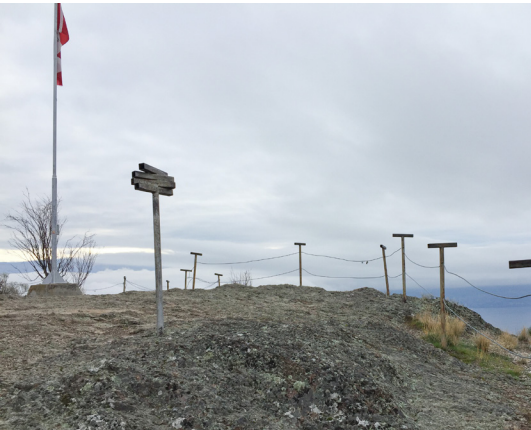
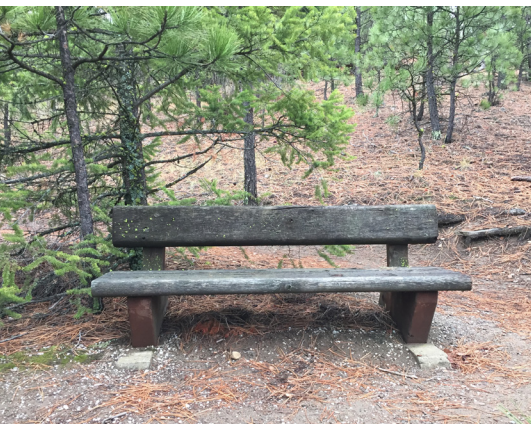
Top: Existing cable guardrail at summit
Bottom: Example of existing weathered furniture

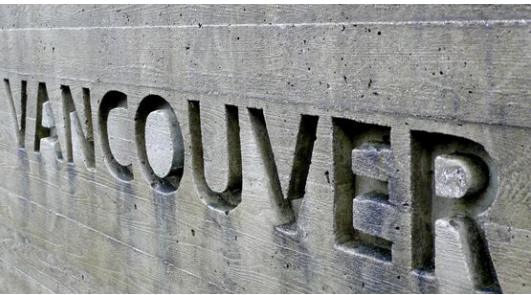
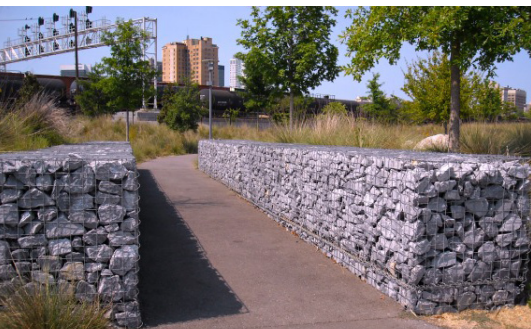
Top: Park entry sign & 'The Grind' wall precedent
Bottom: Gabion basket retaining wall

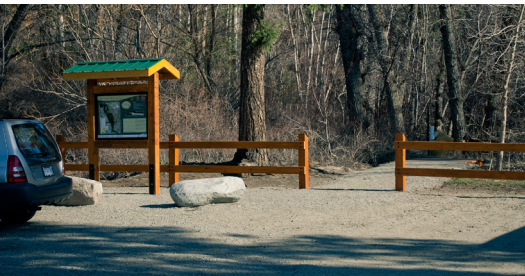
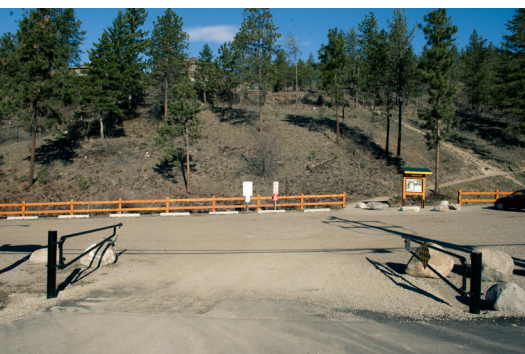
The expanded upper parking lot will include 12 stalls in a re-surfaced granular area with wheel stops and strategically-placed boulders to prevent parking outside of the lot. With improvements to the existing maintenance road creating a one-way vehicle access route, circulation will be well-marked and further delineated with guardrails to protect grassland areas and, where necessary, separate pedestrian trails and roadway. There will also be approximately 16 overflow parking stalls added on this one-way vehicle route.

As the main access point to the upper view-point, the intersection of The Grind trail and the parking lot will be marked with a small kiosk providing regulatory and wayfinding information. Minor improvements, such as concrete and gabion retaining walls, will also be included.

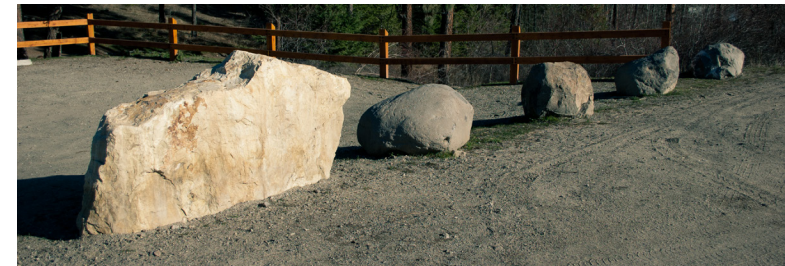
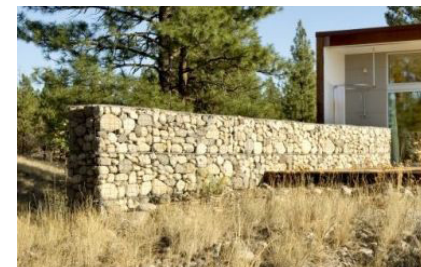
Top: Upper Parking Area location plan

Middle: Use of guardrails to mark trailheads

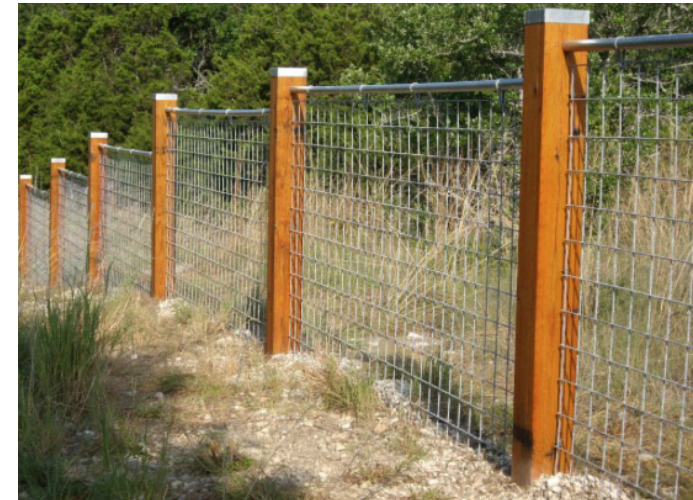
Top: Upper Viewpoint location plan
Bottom: Proposed viewtube refurbishment
Right: Guardrail types for safety and habitat protection

Improvements for subsequent phases include replacing benches and refurbishing the view tubes at the upper viewpoint, a historic and well-loved feature that frames named viewpoints of Summerland and the surrounding valley.
