THE CORPORATION OF THE DISTRICT OF SUMMERLAND COUNCIL REPORT

DATE: June 22, 2017 File: 2016-1787
TO: Linda Tynan, Chief Administrative Officer
FROM: Dean Strachan, MCIP, RPP, Director of Development Services
Kris Johnson, P.Eng., Director of Works and Utilities
SUBJECT: OCP Amendment and Rezoning – 13610 Banks Crescent - Update

Ecoscape File No: 16-1837

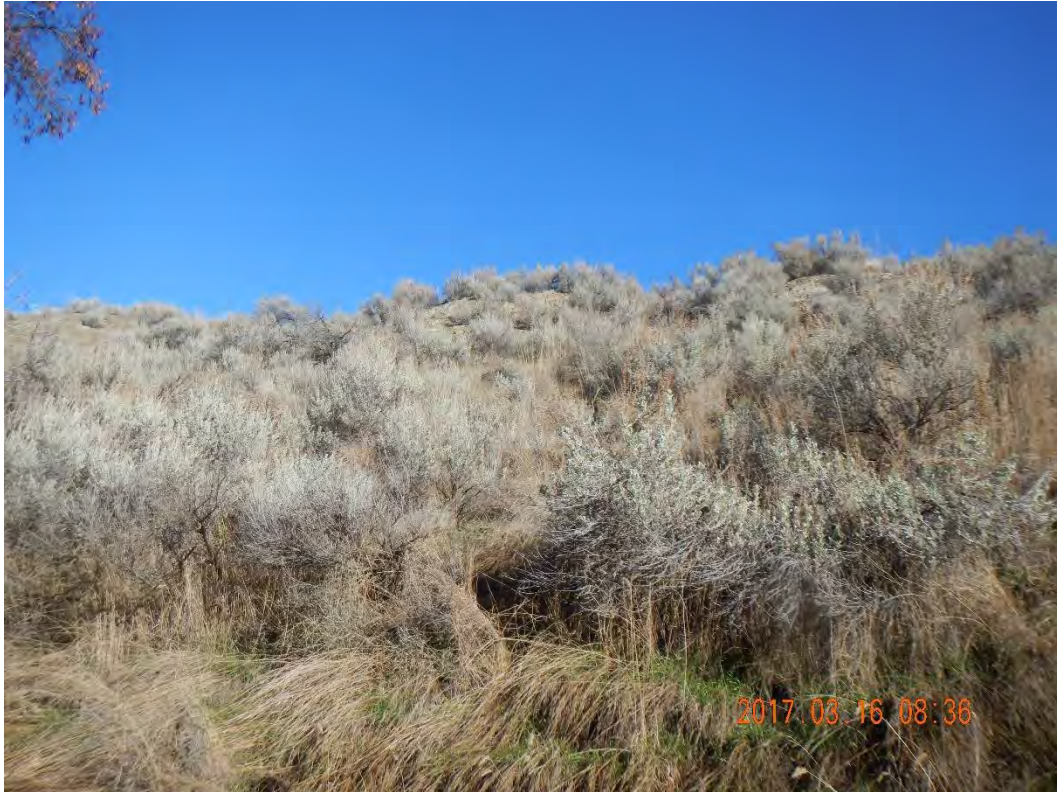
Photo 1. View of the shrub steppe ecosystem, photo taken in the northeast corner of the subject property (all photographs taken March 16, 2017).

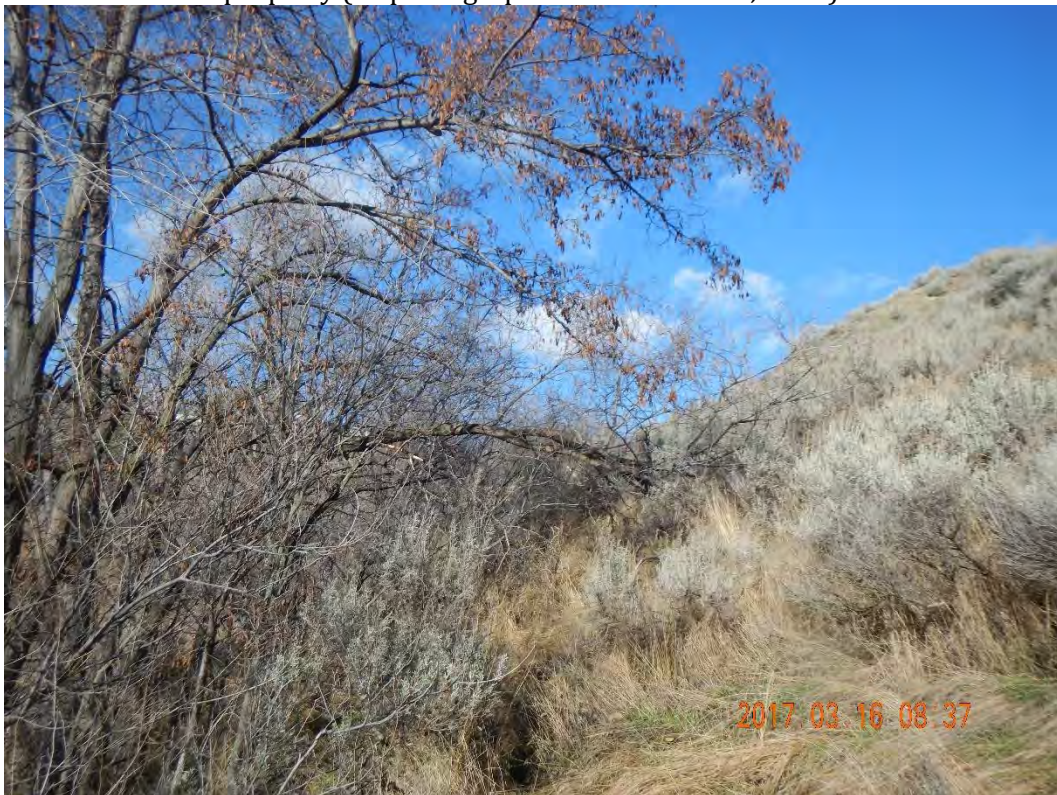
Photo 2. View of the non-native locust and elm trees disrupting the natural shrub steppe ecosystem.

The vineyard and rural residential area generally have a low suitability for wildlife. Similarly, the Siberian elm and black locust treeline that is established along the northern fringe of the vineyard over the lower shrub steppe slopes is degrading the value of this fragmented ecosystem for wildlife.

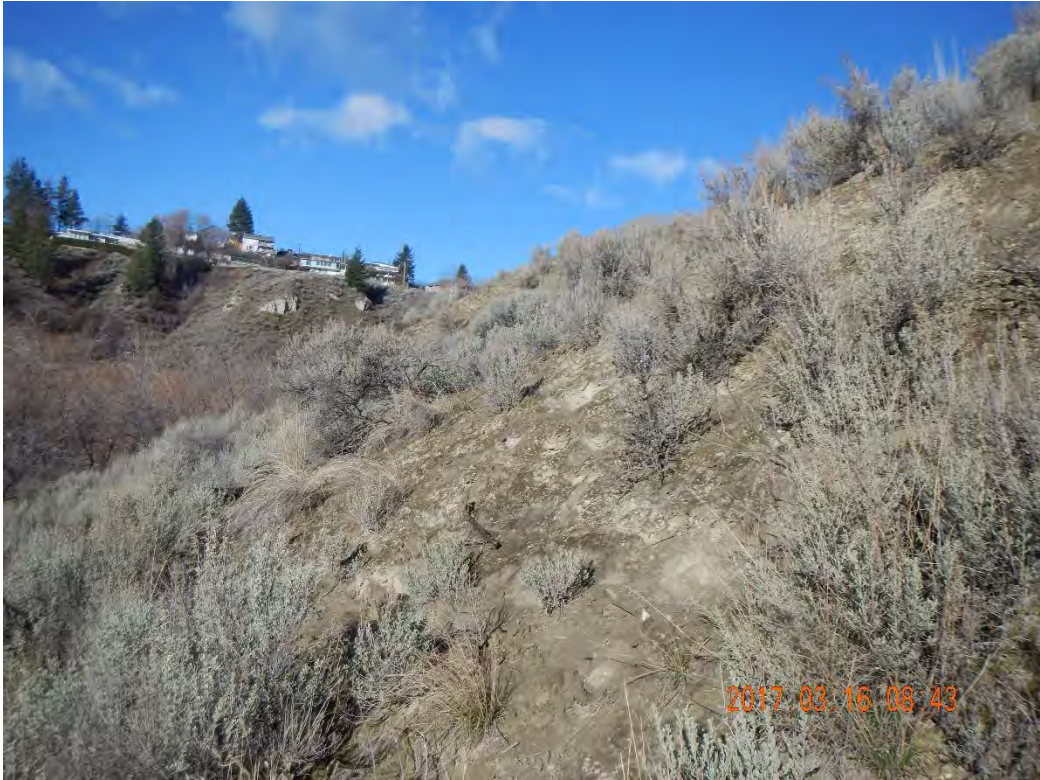
Photo 3. View of the cryptographic crust and bare soil sections within the upper slopes of the subject property.

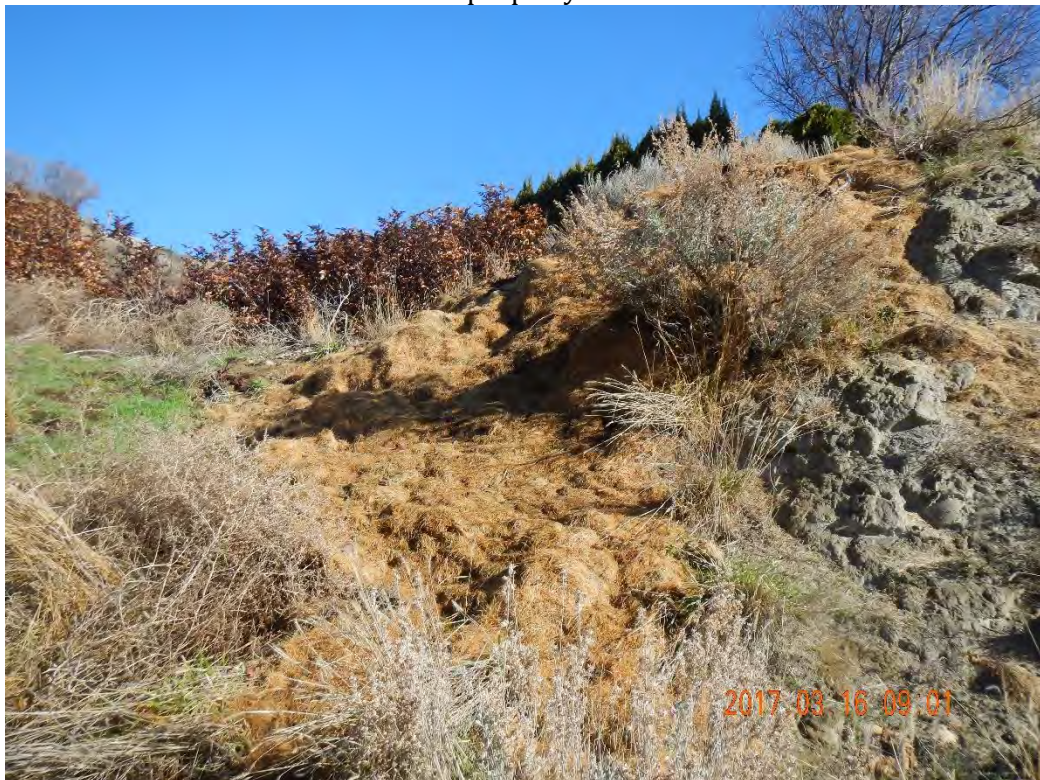
Photo 4. Yard waste and associated invasive species located just north of the subject property adjacent to the property boundary.

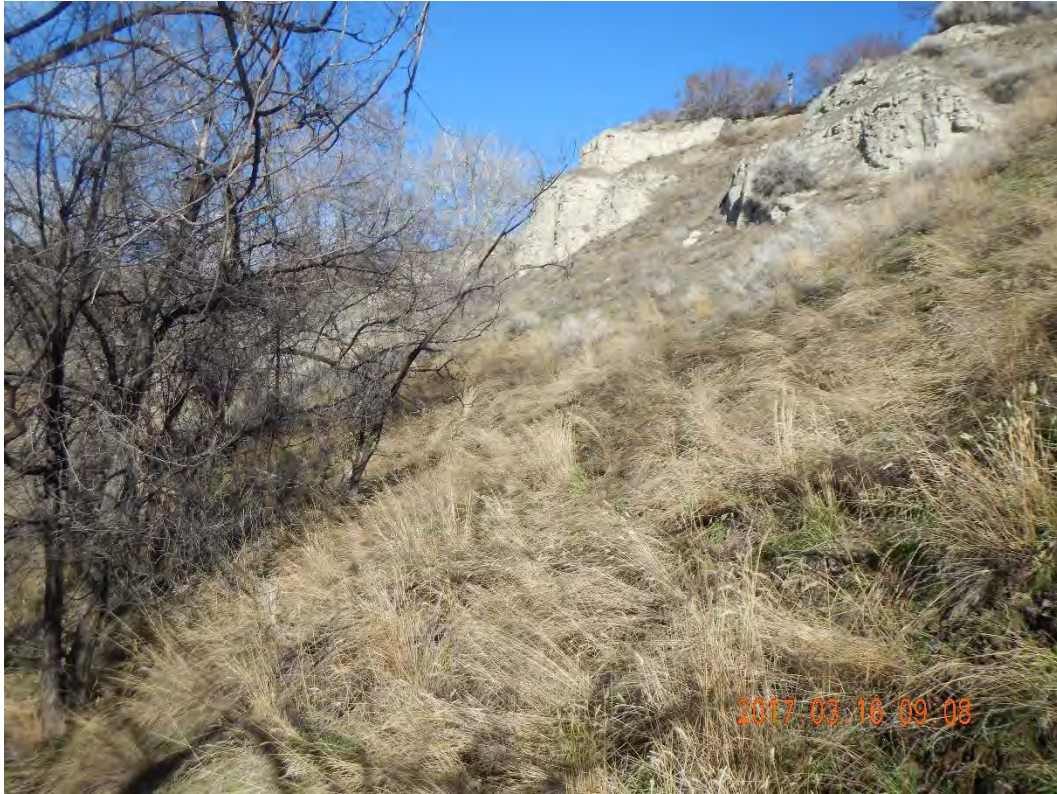
Photo 5. View of the silt bluffs located along the northern boundary of the subject property.

Several mature ponderosa pine trees we documented on the western boundary of the subject property, upslope of the vineyard. These trees and associated grassland and shrub-steppe ecosystems may provide moderate value nesting habitat for woodpeckers and other avian species in the area. No raptor nests, cavities, or woodpecker activity was observed during the site visit; however, the silt bluffs present along the northern boundaries of the subject property showed evidence of bird foraging for insects and possible nesting (Photo 11. Bird foraging activity within silt bluffs (photo taken July, 2016).). Development will not impact the silt bluffs as they are beyond the development footprint.

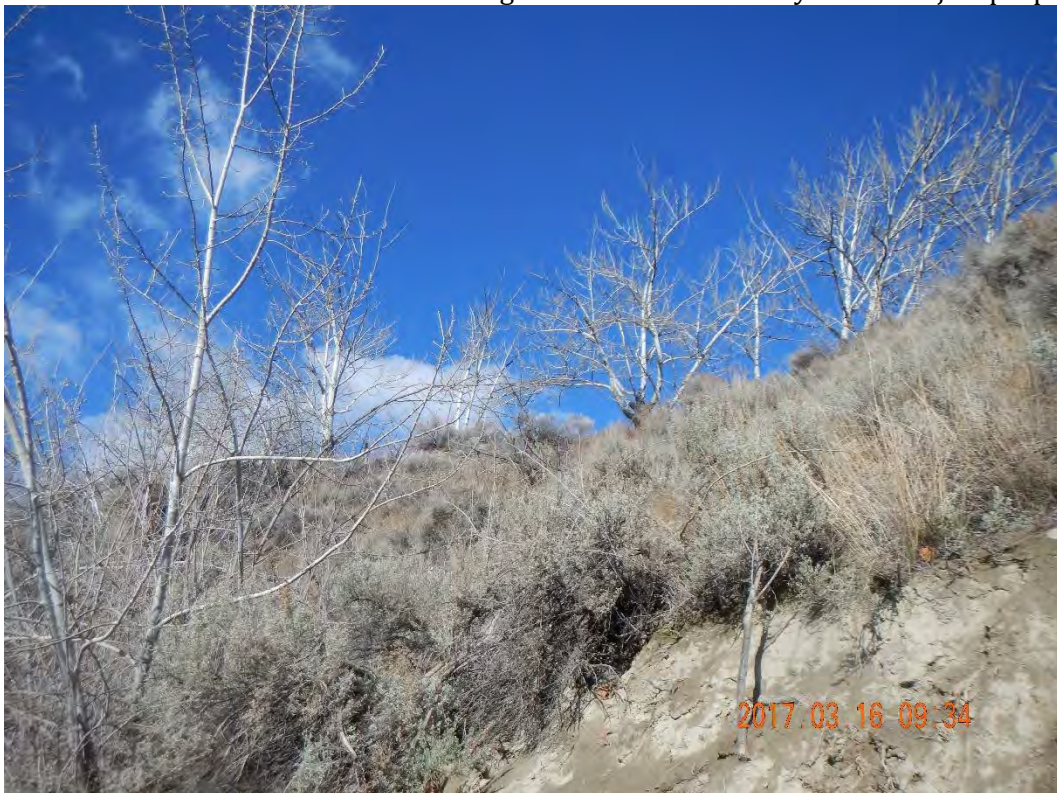
Photo 6. Silver poplars disrupting the natural shrub steppe ecosystem along the northern boundary of the subject property.

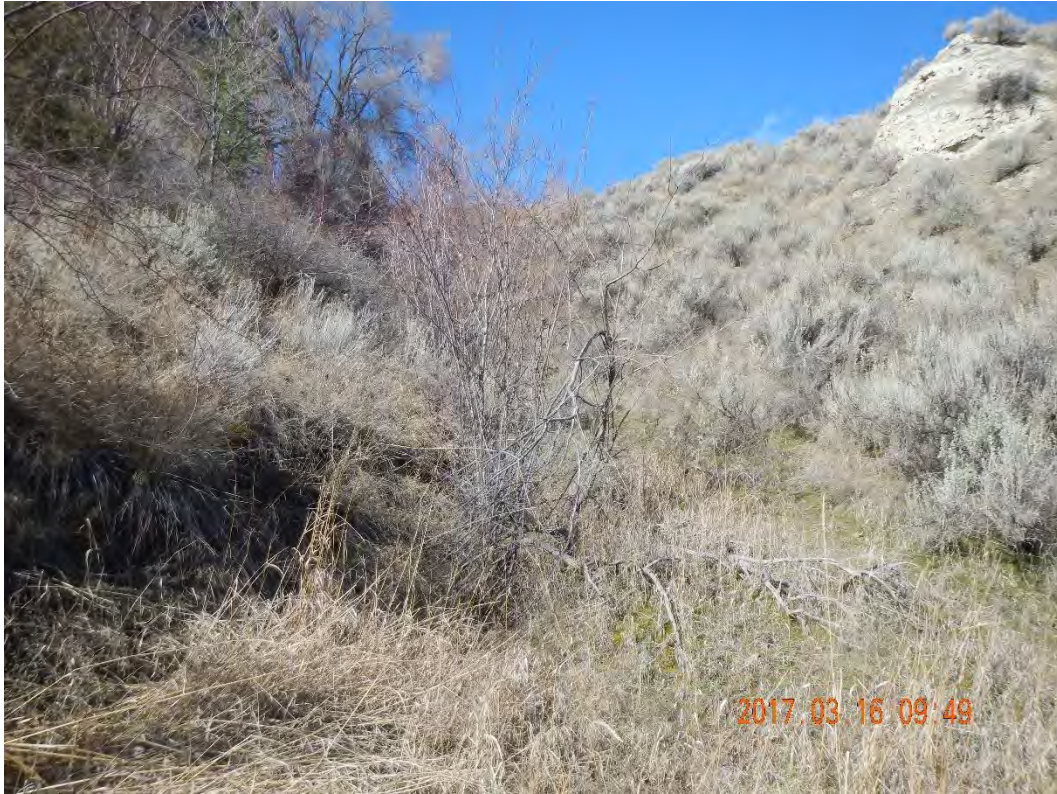
Photo 7. Transition zone with the shrub steppe ecosystem to the viewer's right and the woodland, cool aspect ecosystem to the left. Douglas maple and Saskatoon are located in this drainage gully.

Polygon 5 begins at northwest gully on the subject property and continues to the south adjacent to the vineyard. This polygon represents the cooler north and northeast aspects of the subject property and is characterized by an open canopy of ponderosa pine (PS) with a moderately well-developed shrub stratum with tall Oregon grape (*Mahonia aquifolium*) / Saskatoon (*Amelanchier alnifolia*) and common snowberry (OS) present in on lower slopes and moisture-receiving gullies (Photo 7). OS is not listed but PS is a Red-listed community.

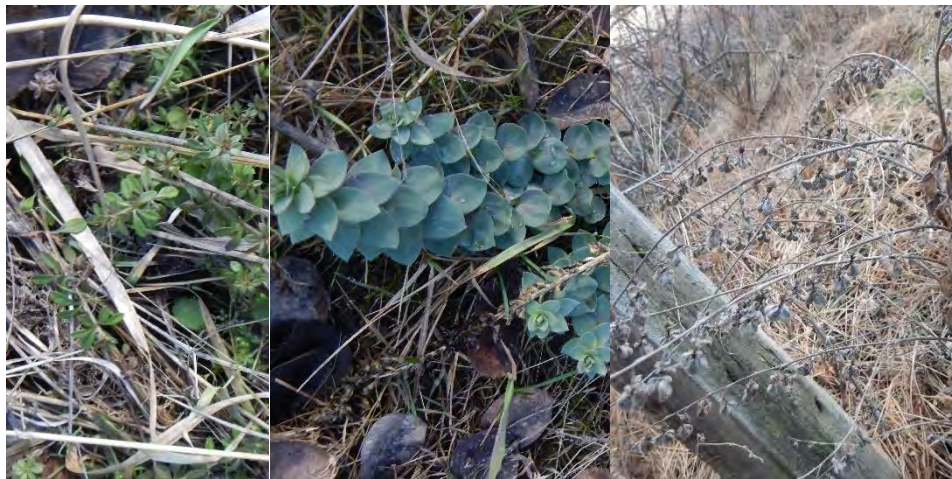
Photo 8. Some of the invasive species located within the subject property. Left to right: cleavers, Dalmatian toadflax, hounds tongue.

As a part of the recommended restoration for offsetting the development footprint, invasive plant species within the remaining subject property must be removed. The dominant invasive plant species found within these areas, as well as effective control measures, are provided in Table 5.

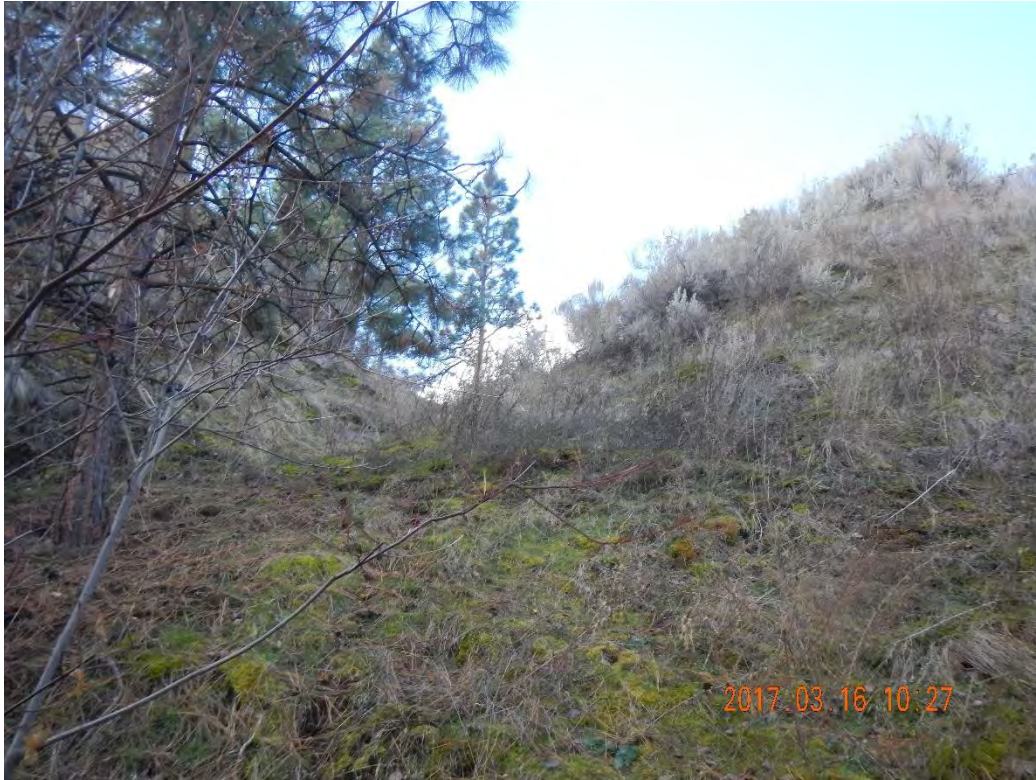
Photo 9. View of the cool aspect of the subject property characterized by ponderosa pine, moss and shrubs.

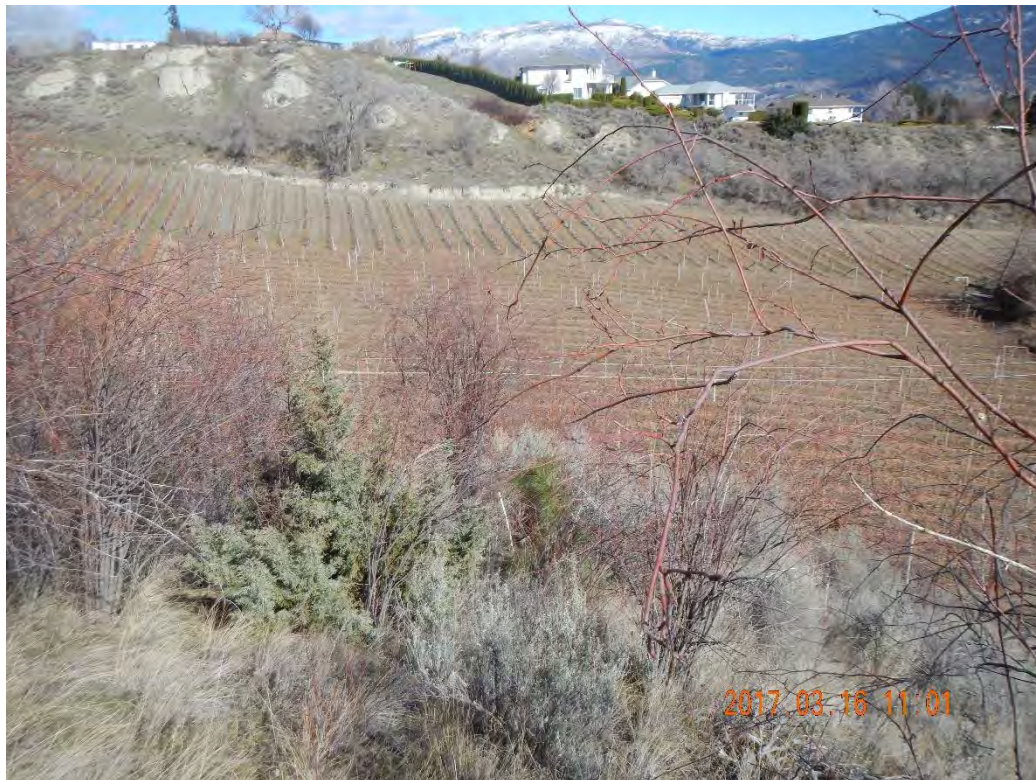
Photo 10. View looking north toward the shrub steppe ecosystem on the subject property and the vineyard below.

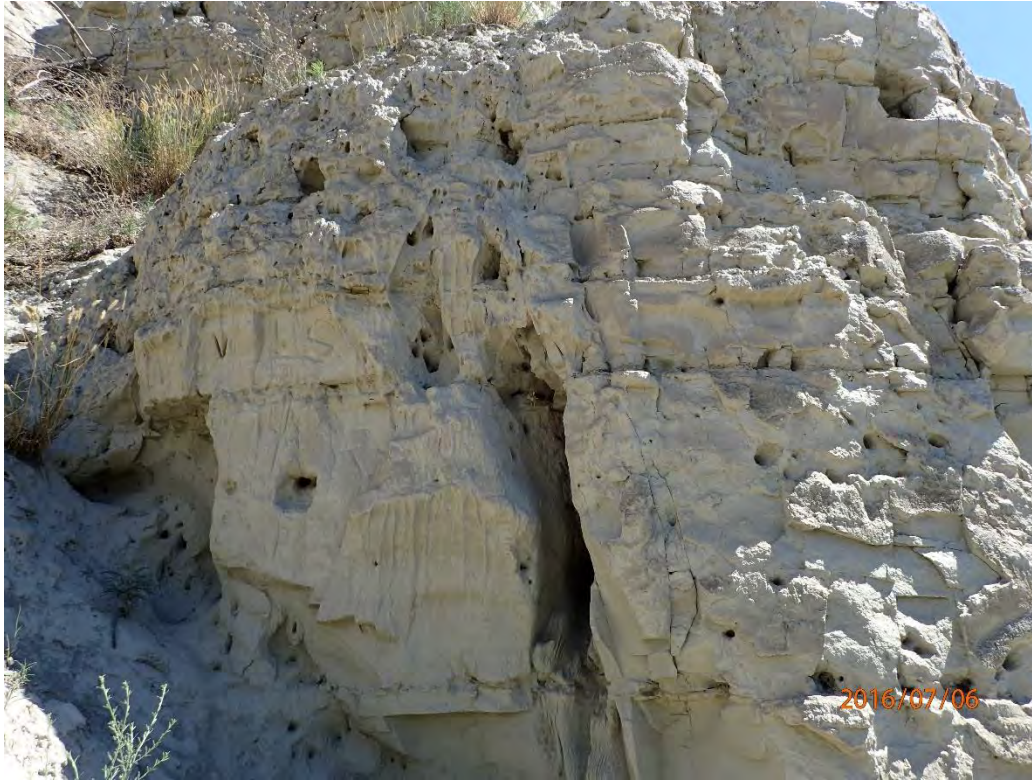
Photo 11. Bird foraging activity within silt bluffs (photo taken July, 2016).

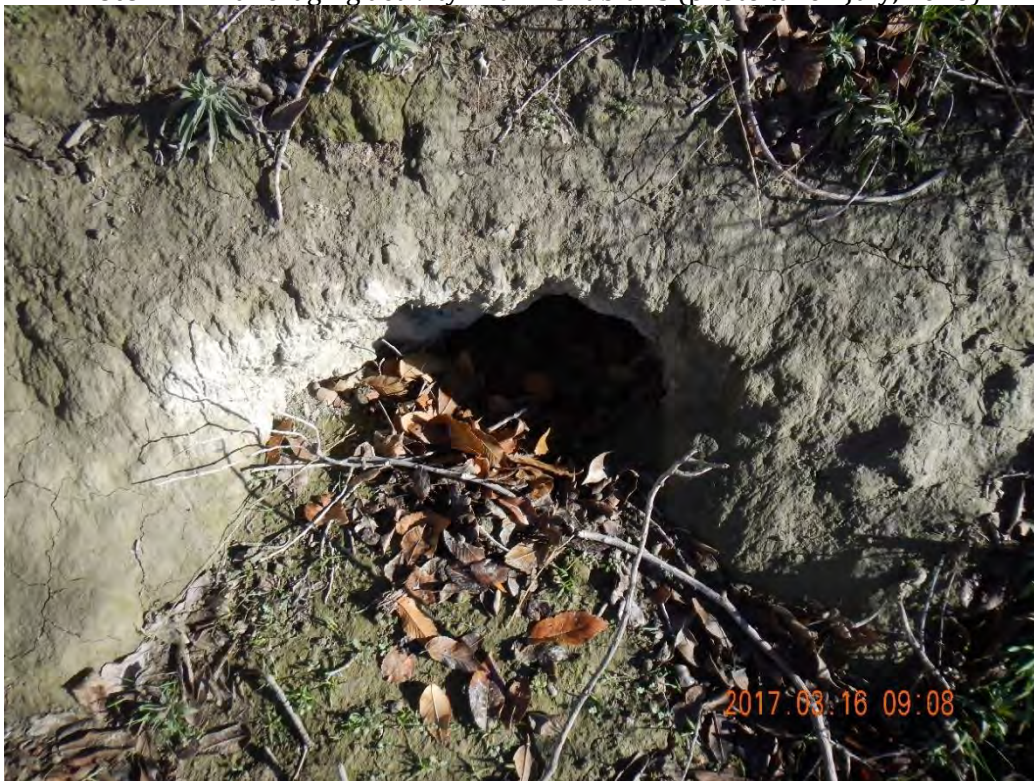
Photo 12. One of many unused burrows located within the subject property. Based on the level of landscape fragmentation and shape of burrows, previous species use is assumed to have been marmot. This is corroborated by observations of adults in the early spring 2017 site visit.
