ARTS & CULTURAL CENTRE Renovation Plan Report

DISTRICT OF SUMMERLAND, BRITISH COLUMBIA

SAHURI + ASSOCIATES ARCHITECTURE INC.

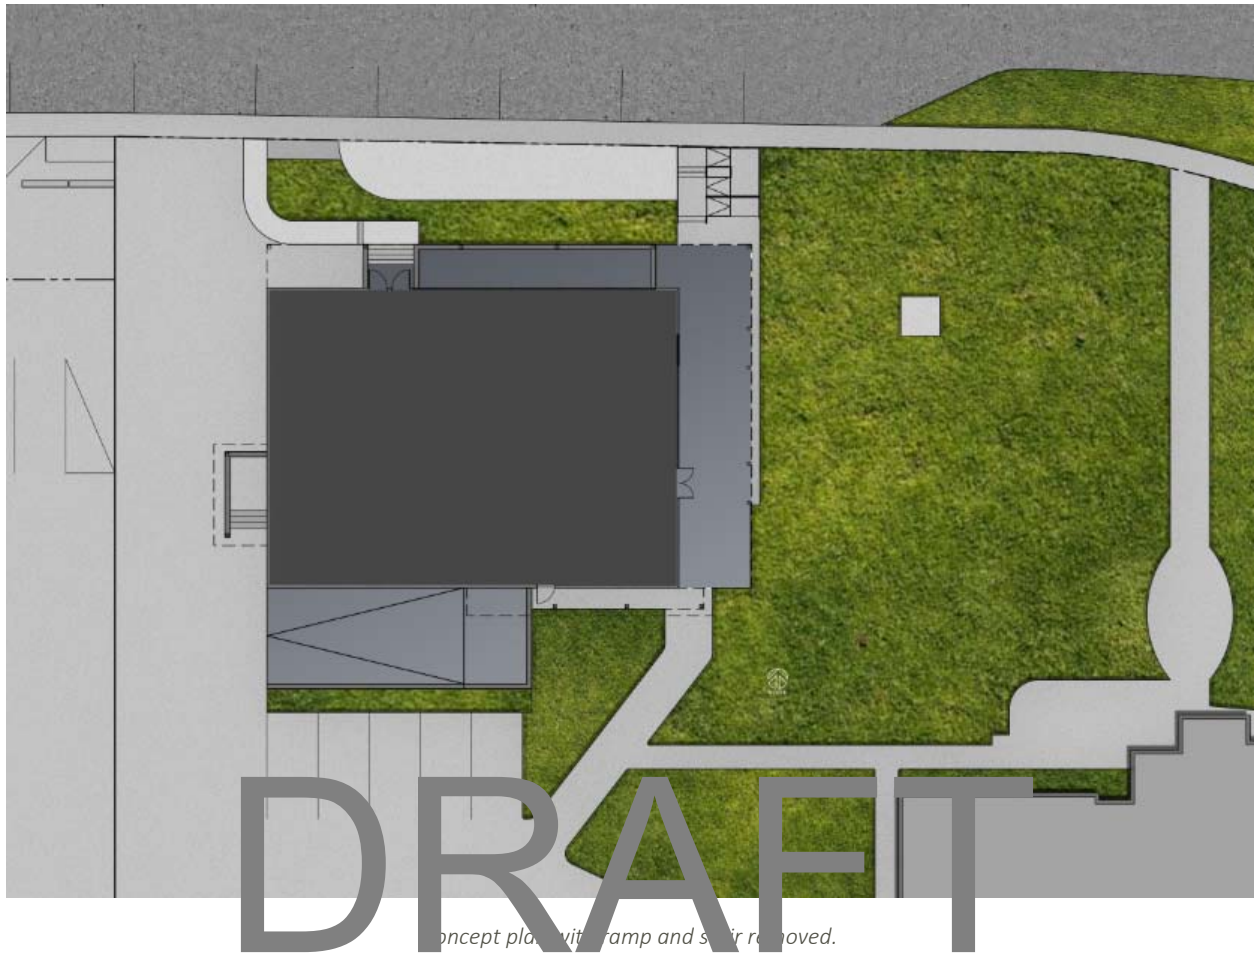
Given that this building is located on an existing, established site the extent of work associated with the site is limited. Our focus included the elimination of the exterior stair and ramp that provided access to the second floor.

Through the course of this project, it was agreed that the lower floor of the building would be established as the 'main' floor of the building. By creating accessible routes from both the parking lot (existing condition) and the street (new ramp and stair) we have an opportunity to consolidate building entry which will aid in security and control of the property. From this point, access to the upper floor is provided internally through the use of a lift.
