DISTRICT OF SUMMERLAND

SUMMERLAND SOLAR ARRAY STAGE 1 PRELIMINARY SITE INVESTIGATION

**Subject: Stage 1 Preliminary Site Investigation
13500 Prairie Valley Road, 12591 Morrow Avenue, and Ottley Avenue Future Road Right-of-Way**

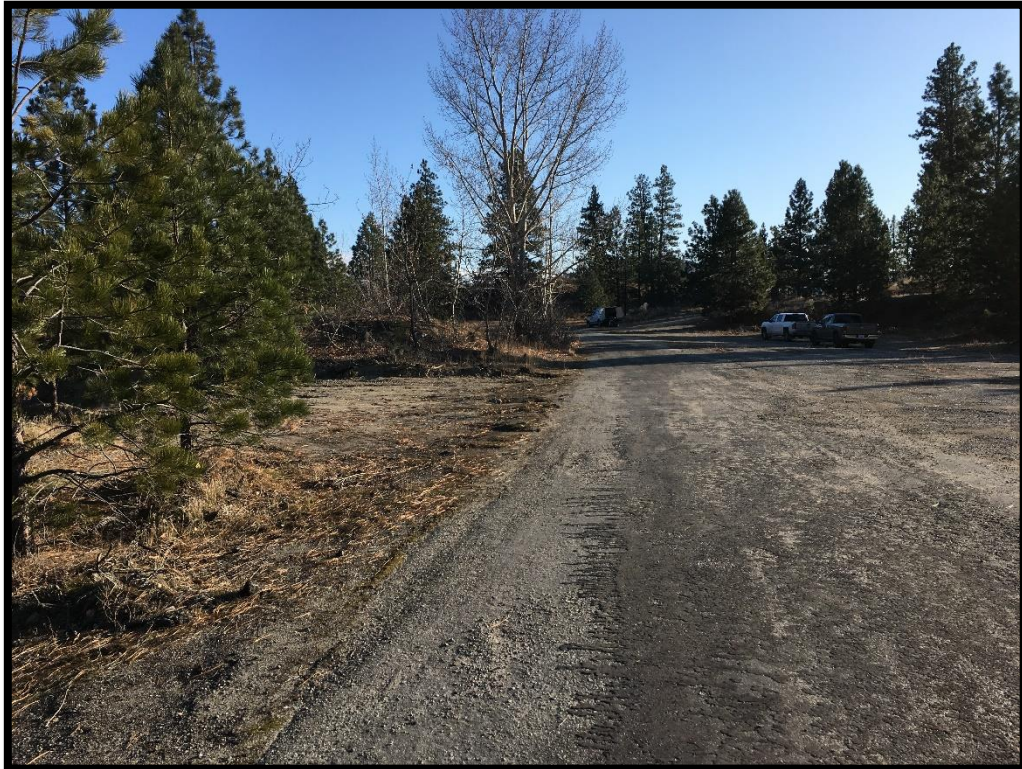
- At the time of the Site visit, there was no evidence of leaks or spills from hazardous/non-hazardous materials.
- The unpaved parking area located south of the haul road was historically used as a storage area of the crush and oil mixture that was mixed along the road.

Photo 2: A view of the haul road and parking area looking east.

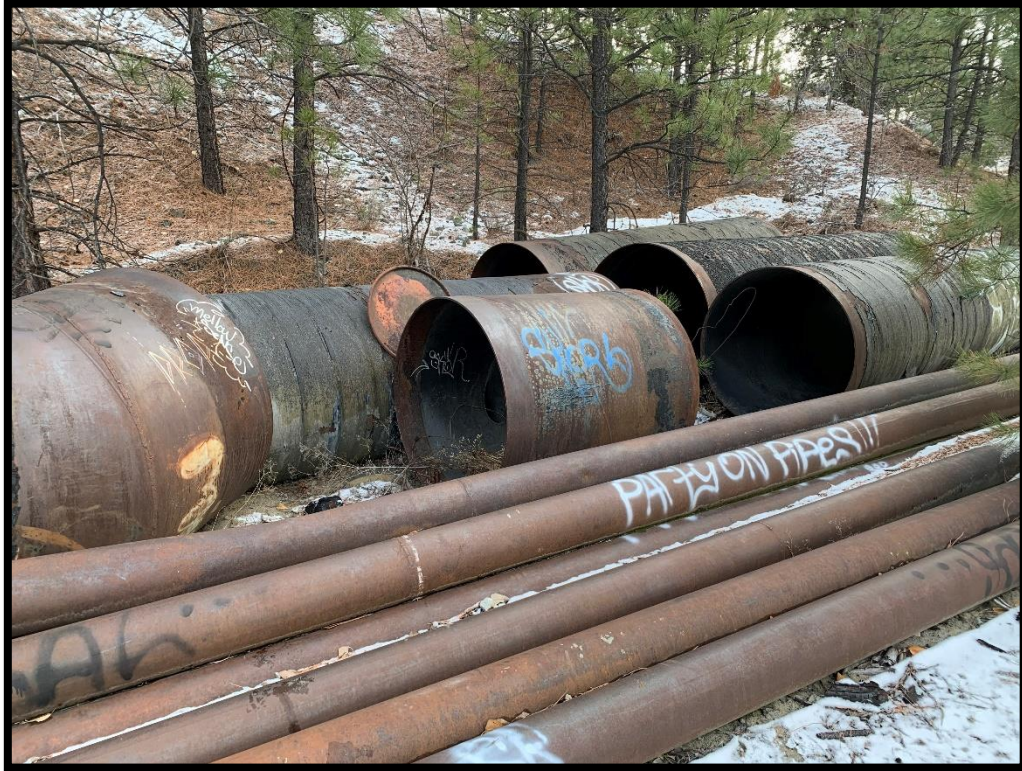
- Non-hazardous waste in the form of steel pipes, concrete, and crushed gravel was observed within the central Site area that was the historical location of the gravel pit. Copper pipe storage was also noted along the east boundary on the rise above the flatlands. Miscellaneous storage was also historically located in the transformer storage area in the southeast portion of the Site.

Photo 5: A view of the metal pipes observed in the central portion of the site.

- General housekeeping throughout the site including removal of various debris piles and disposal of the stored miscellaneous pipes.
 - Depending on the content of the debris piles, hazardous materials sampling of debris and transformer/pipe materials may be required prior to disposal.
- If any environmentally suspect fill material is encountered onsite during any future redevelopment activities, such fill should be characterized prior to disposal offsite or at a permitted facility.
- In the future, if any abandoned USTs are encountered at the Site, such USTs should be decommissioned in accordance with the requirements of the BC Fire Code. A qualified environmental consultant should be retained to document any UST removal activities along with the characterization and disposal of any environmentally suspect material.

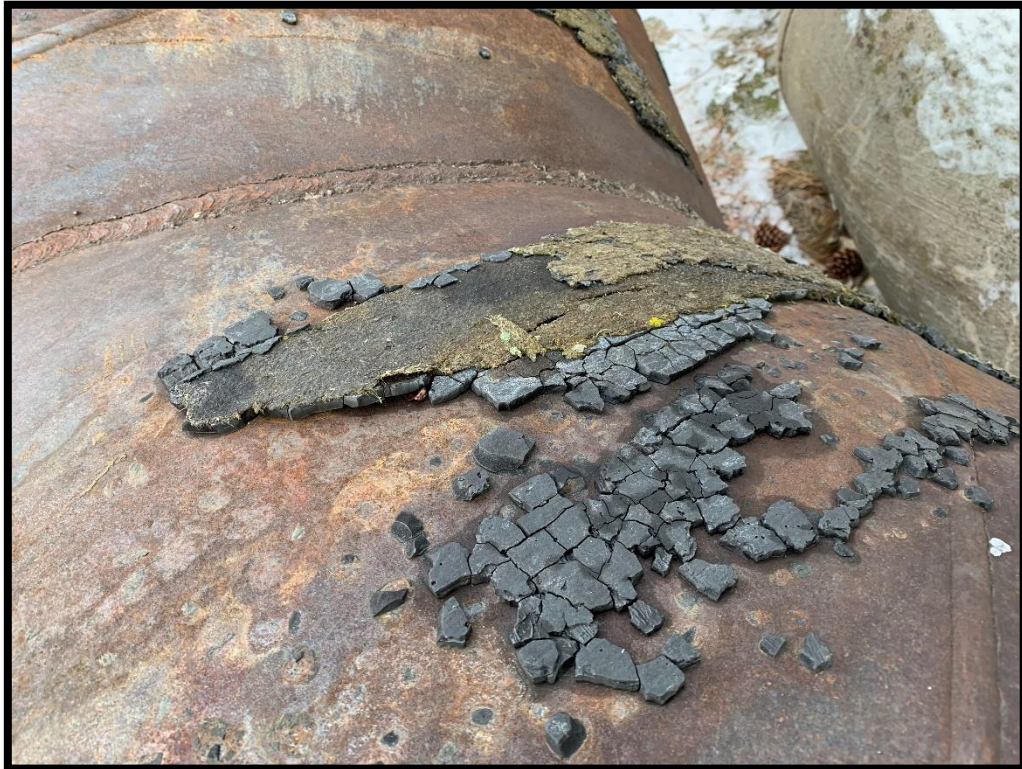
- An area in the southeast portion of the Site was historically used for storage of transformers containing PCBs. The PCBs were historically emptied in this area onto the bare ground surface. The area was also historically used for storage of various items and materials. This area is considered to be of low to moderate potential for environmental concern.
- Two (2) ACM pipes were observed in the historical southeast during the Site visit. During the interview, it was indicated that there was never any cutting of ACM pipes on-Site but there may have been minor storage. These ACM pipes should be appropriately disposed of prior to redevelopment activities.

Photo 6: A closeup of the material on the pipes that is potentially ACM wrap.

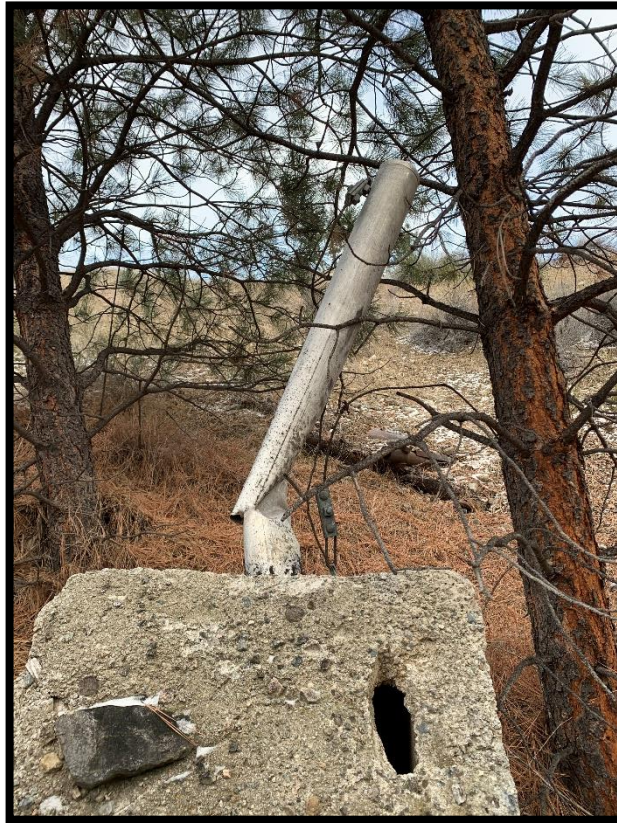
Photo 7: View of a lead pipe and concrete block found on site.

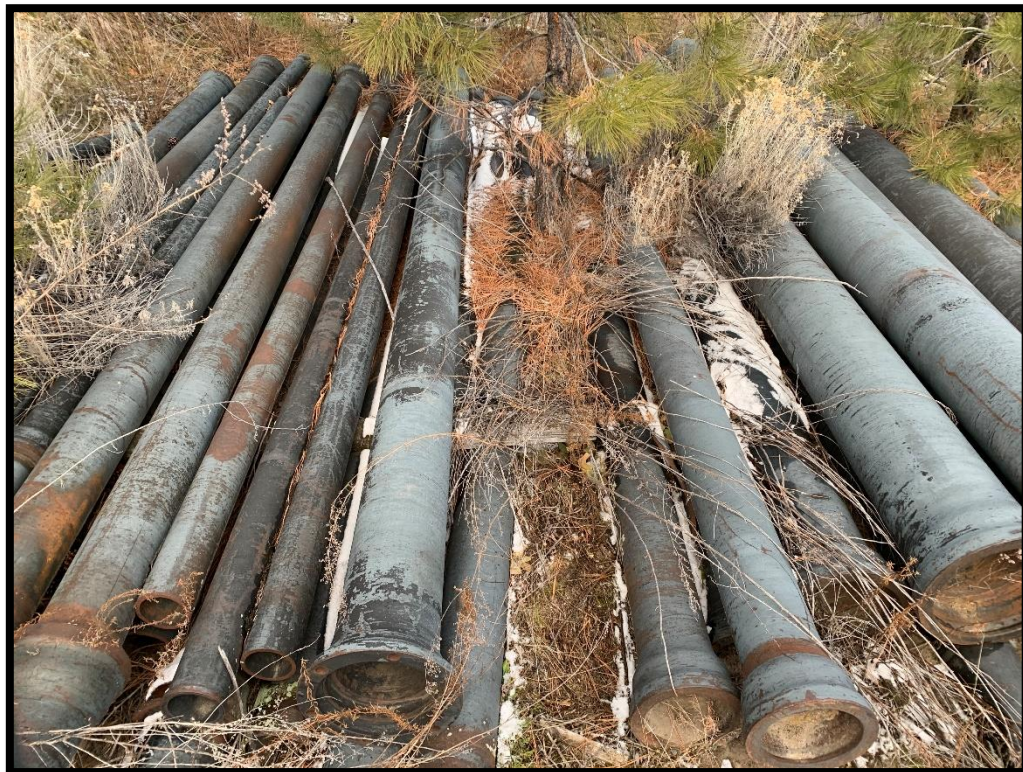
Photo 8: Another pile of metal pipes observed along the east boundary of the site.

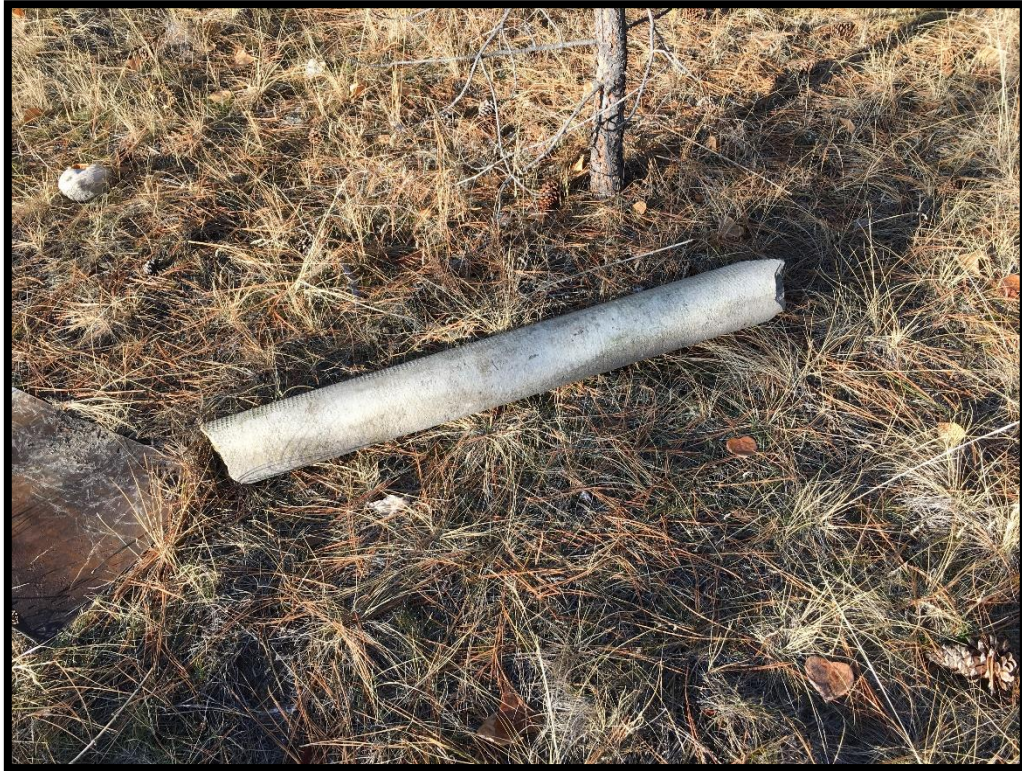
Photo 9: View of an asbestos-containing pipe observed in the southeast portion of the site. Another piece of ACM pipe was also observed within close proximity.

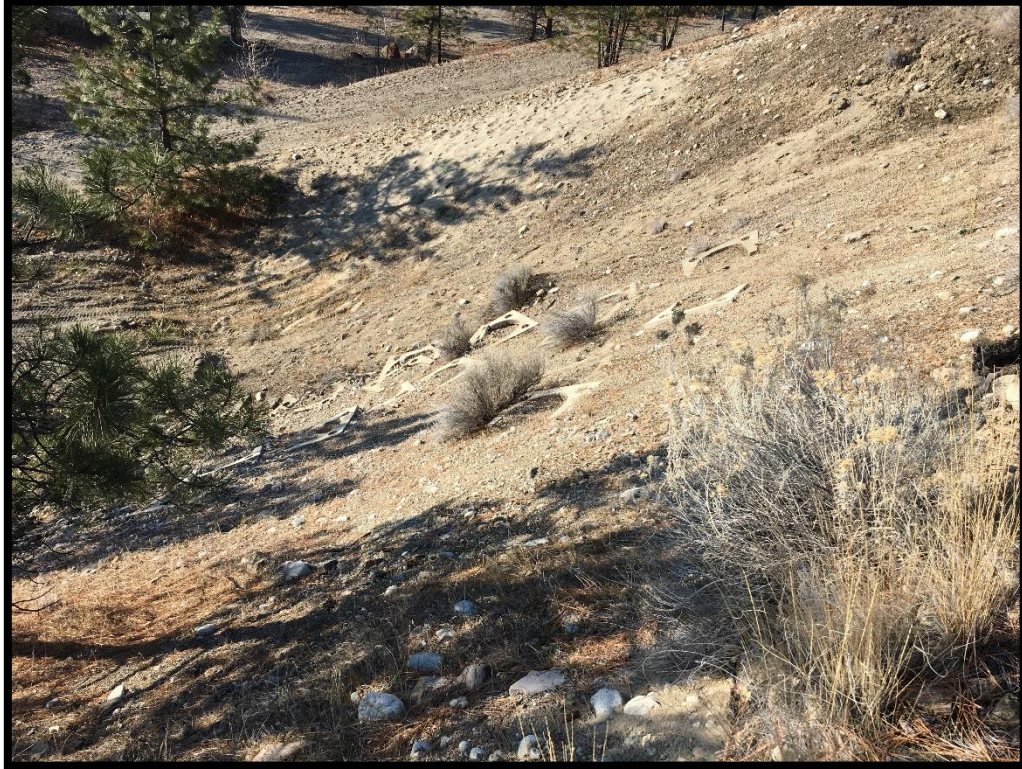
Photo 11: View of parts of the irrigation flume that were disposed of on-site.

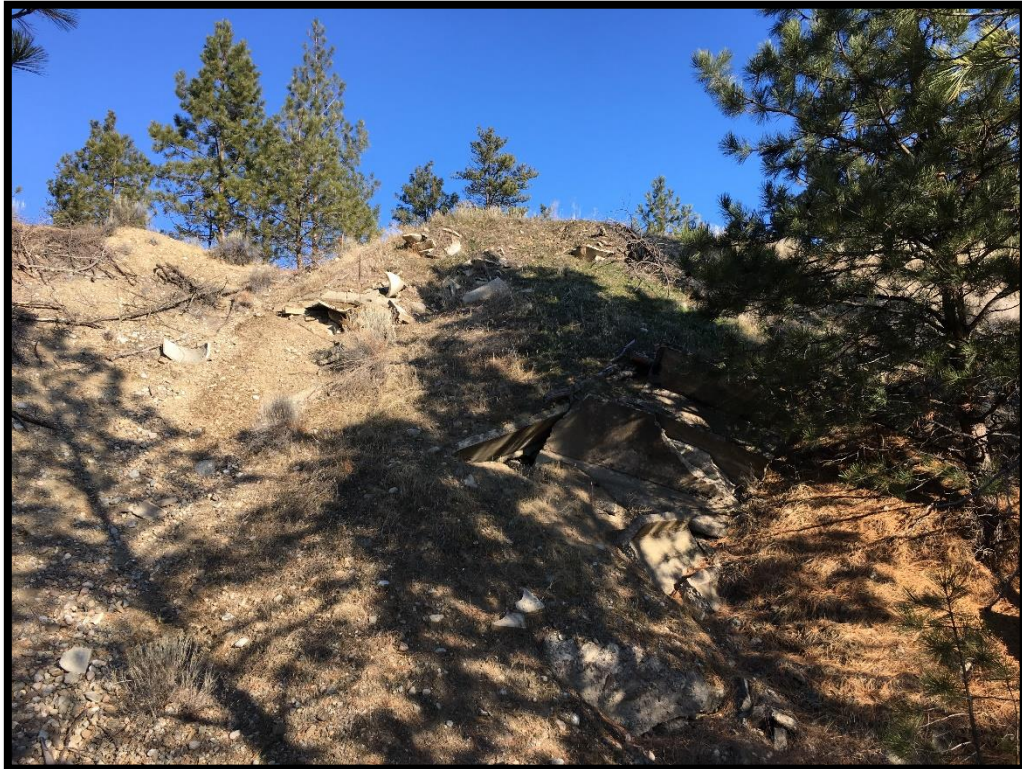
- They were not aware of any spill or stain areas on the Site which need to be brought to the attention of WSP.
- The retirees indicated that there were a few areas on-Site that were historically used for concrete disposal/storage. Other than these areas, they were not aware of any current or historical waste disposal areas.

Photo 12: A view of buried concrete on-site located in the central storage area along the north boundary.

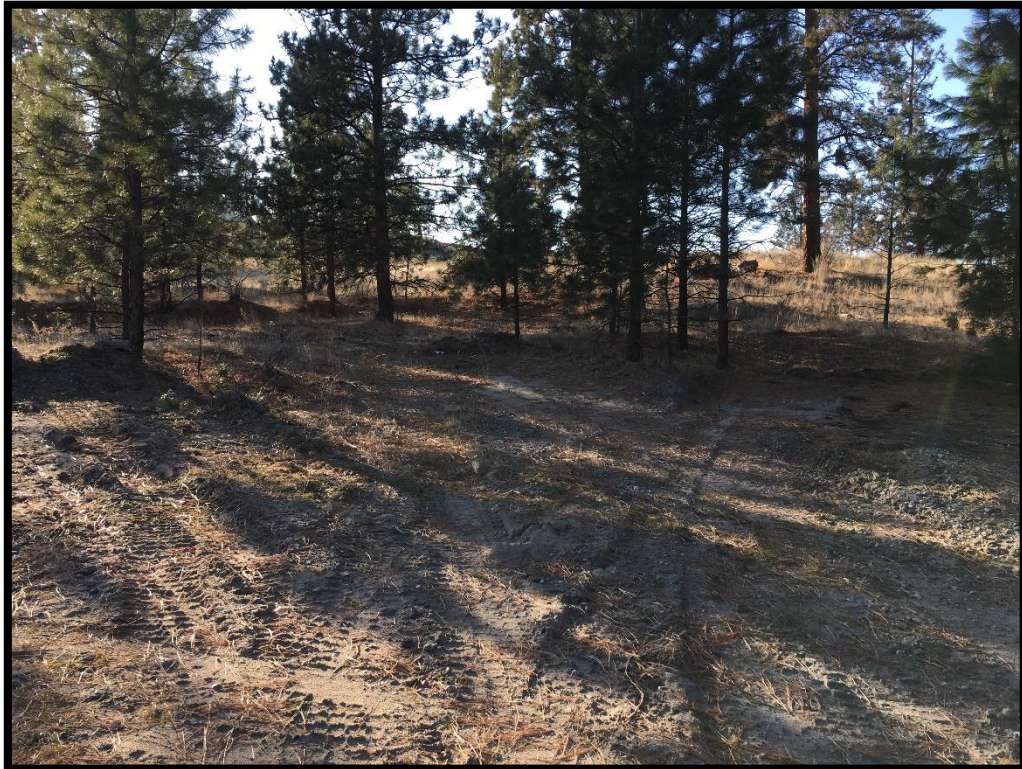
Photo 14: An overview of the storage area where transformers were stored and emptied.

Based on the reviewed information and current Site conditions, a sub-surface investigation in the form of a Stage 2 Preliminary Site Investigation in the area of identified APECs is recommended at the Site.
