REPORT

District of Summerland

Eneas Creek Assessment

April 2019

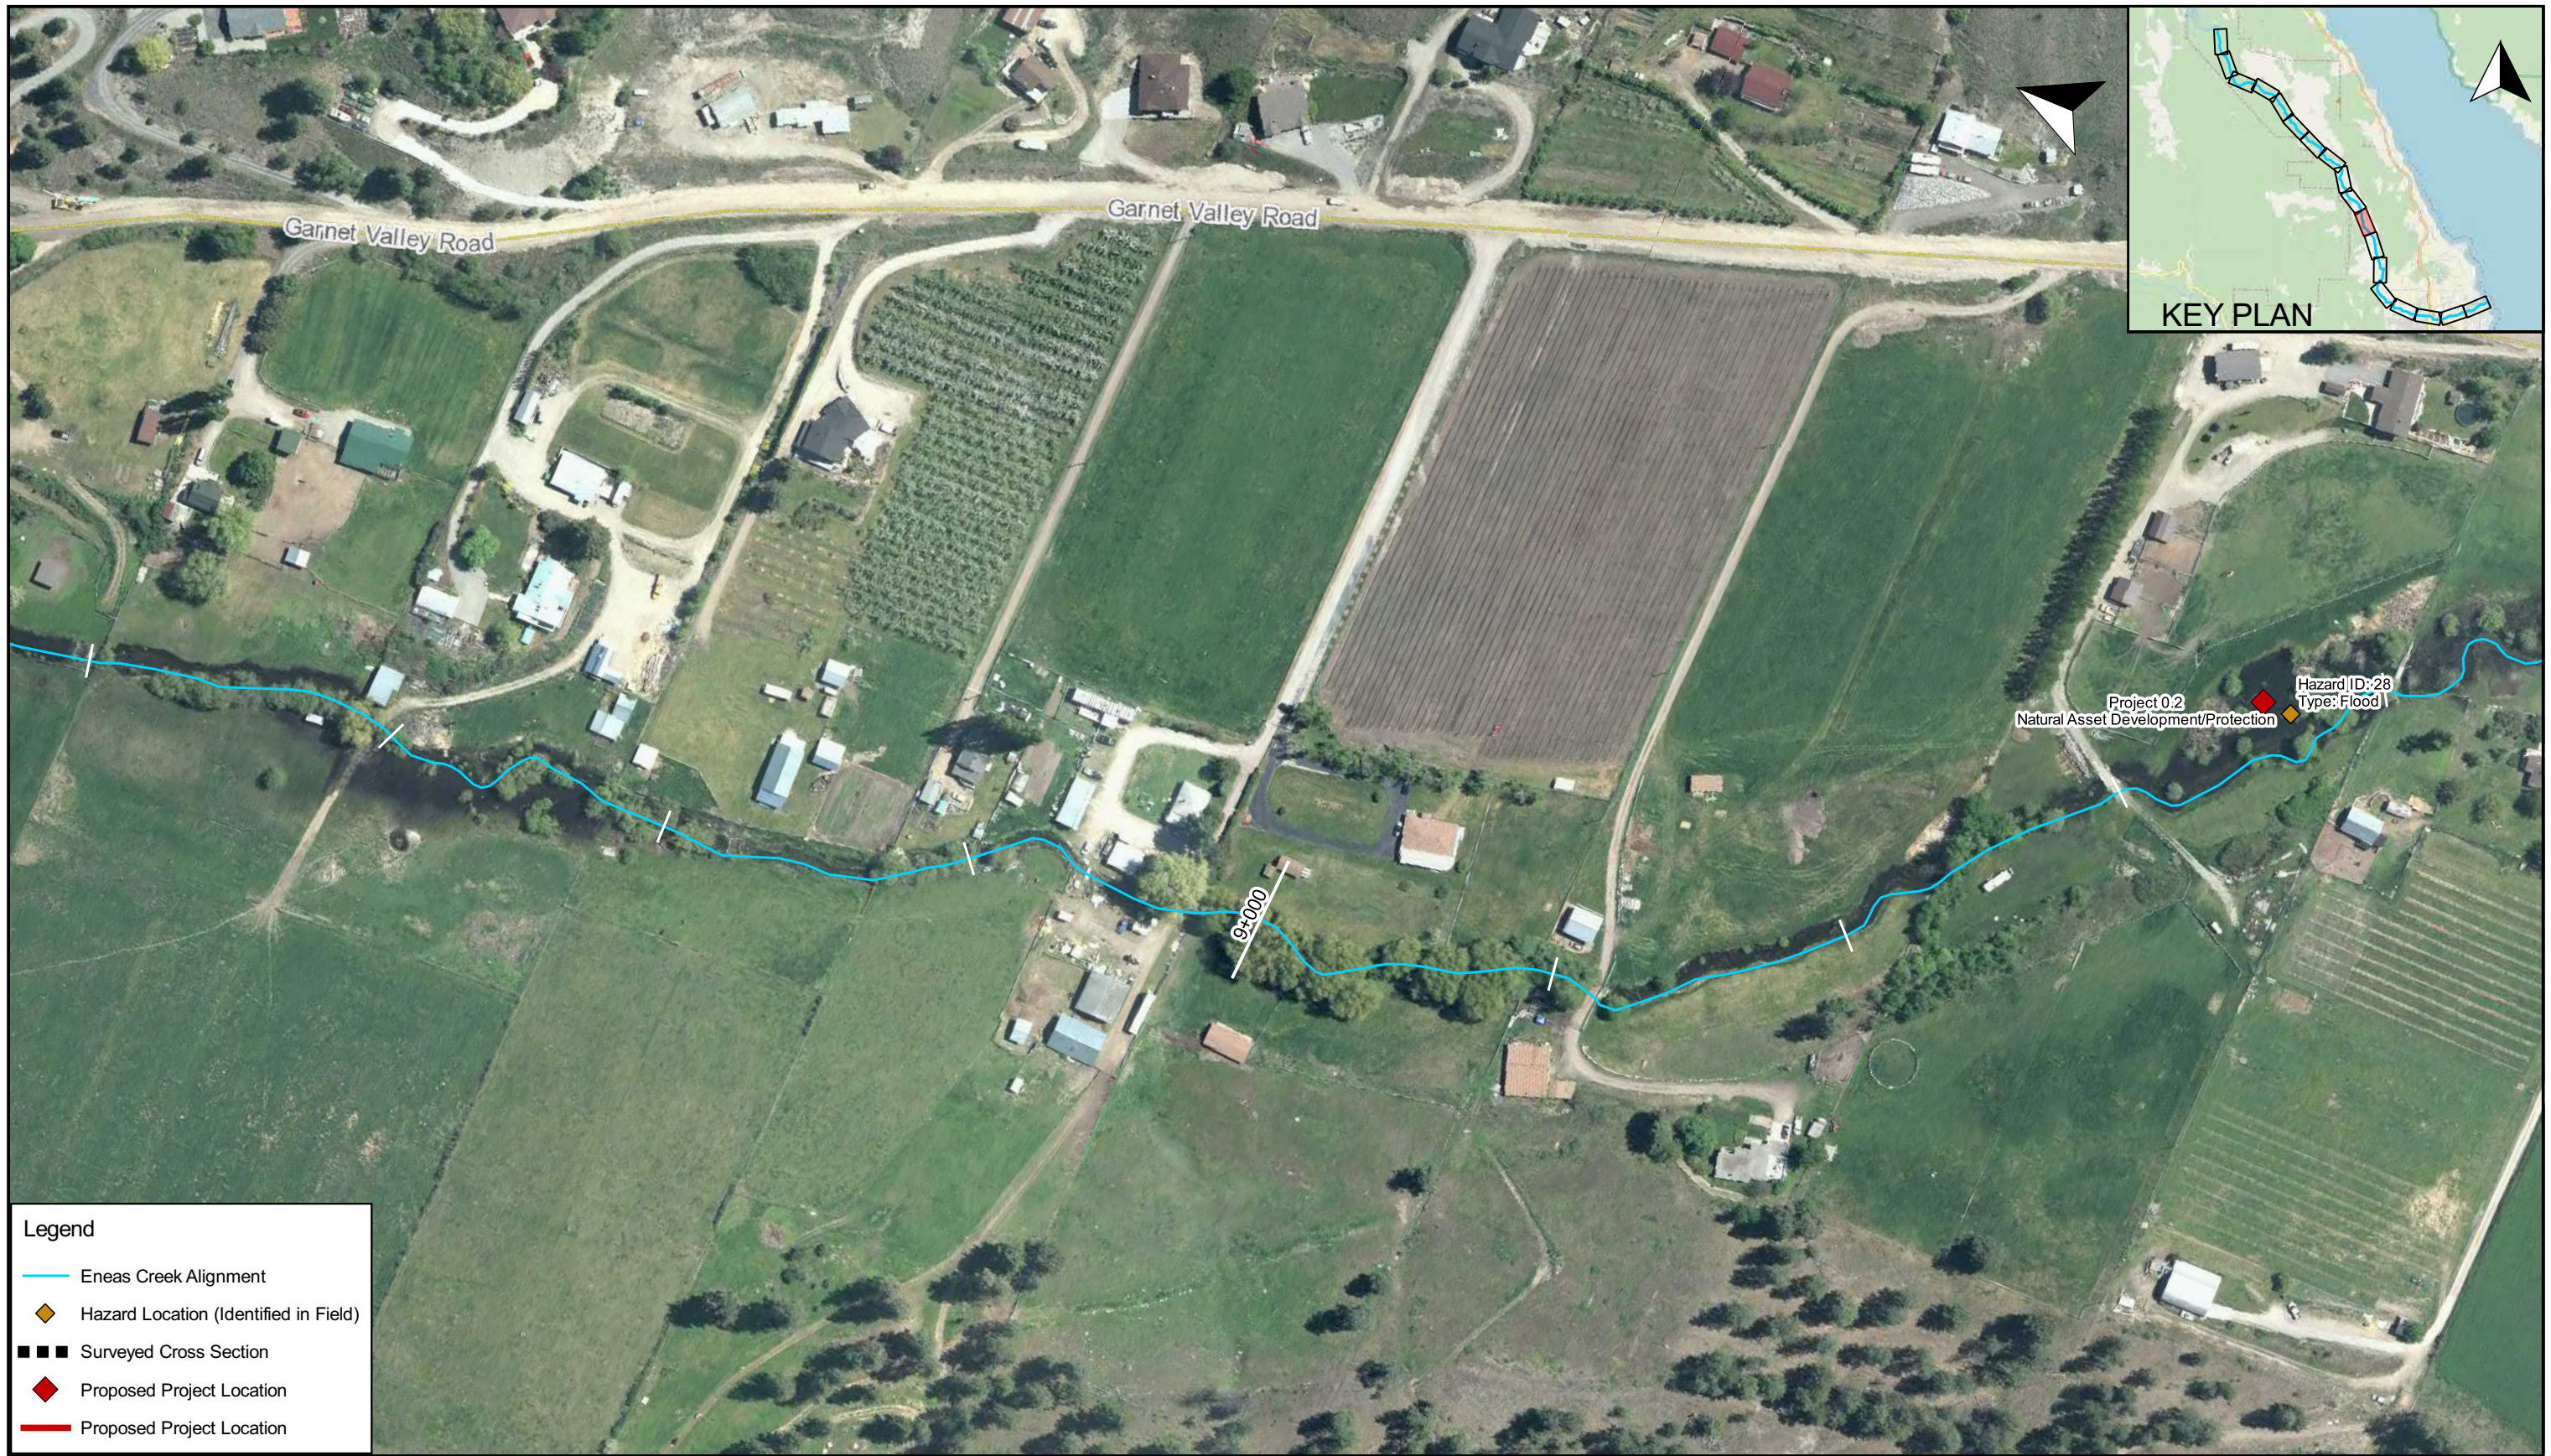
Project 0.2
Natural Asset Development/Protection

Hazard ID: 28
Type: Flood

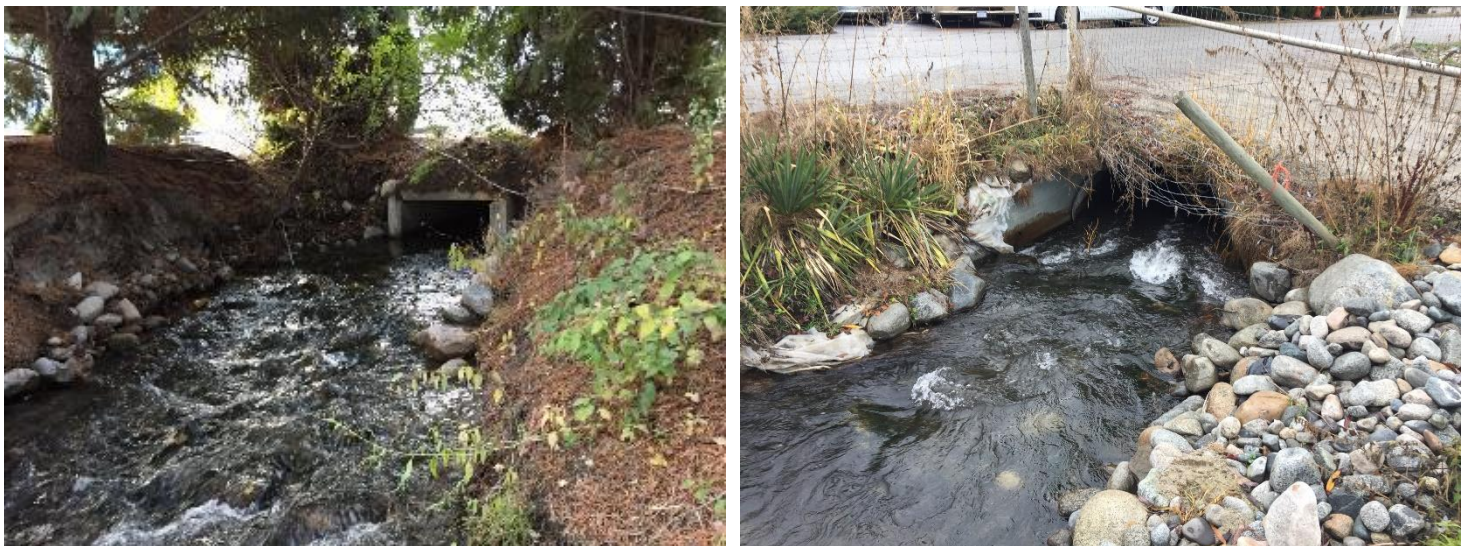
Figure – Public Crossing (Victoria Rd. N Culvert Outlet, and Garnet Ave Inlet)

Proposed Works: Regular Inspections of Culverts is recommended to pre-emptively manage potential issues.

- Start/continue an inspection program on all culverts along the creek, remove potential blockages
- Inspect for potential culvert failures
- Inspect for erosion upstream and down stream of the crossings

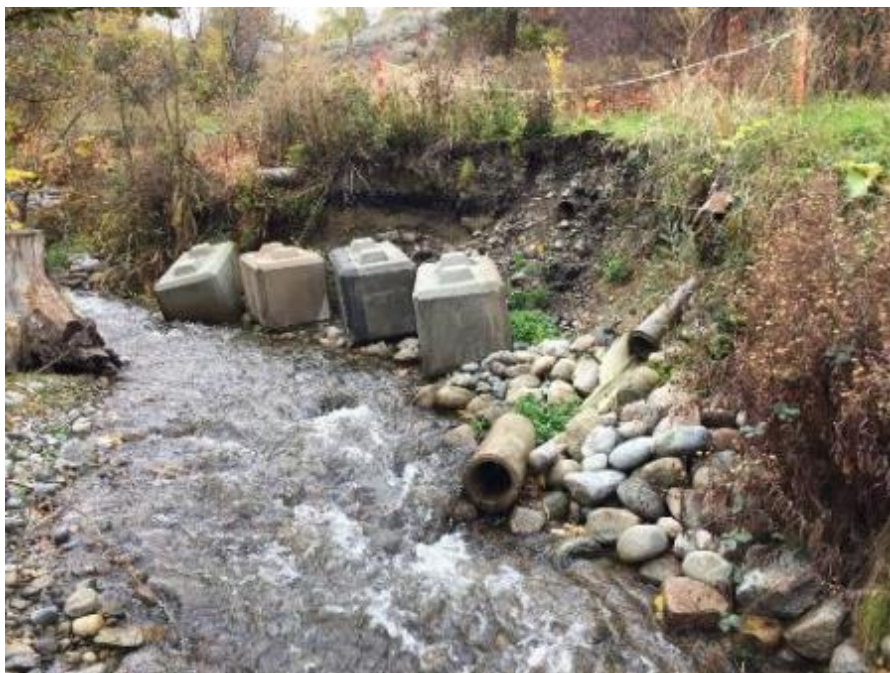
Figure – Lock Blocks and Bank Erosion

Location Chainage: Sta. 15+150

Proposed Works: Remove lock blocks and replace with riprap and planting where possible. Outlet drain pipes out of the slope to prevent future saturation of the bank and sluffing. These pipes are drain pipes that appear to be installed to mitigate an old slide section across Peach Orchard Road.

- This section needs some mitigation to prevent further encroachment towards the road, and to make this area safer for all users.
- Due to the steepness of this section, velocity of the water, and potential erosive capabilities it is recommended to remove the temporary works and permanently stabilize the corner.

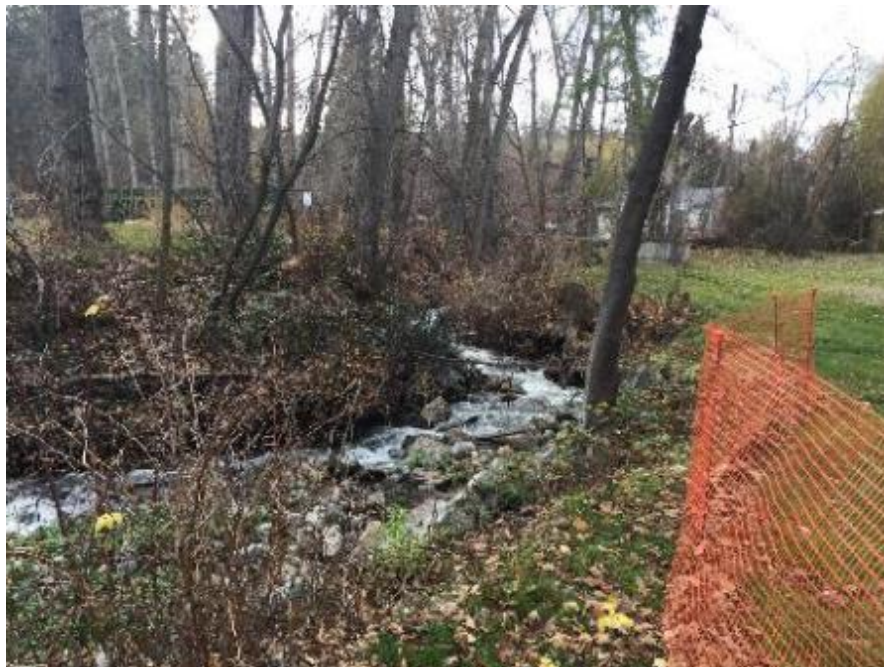
Figure – Creek Through Campground

Location Chainage: Multiple locations through campground (Sta. 15+400 shown)

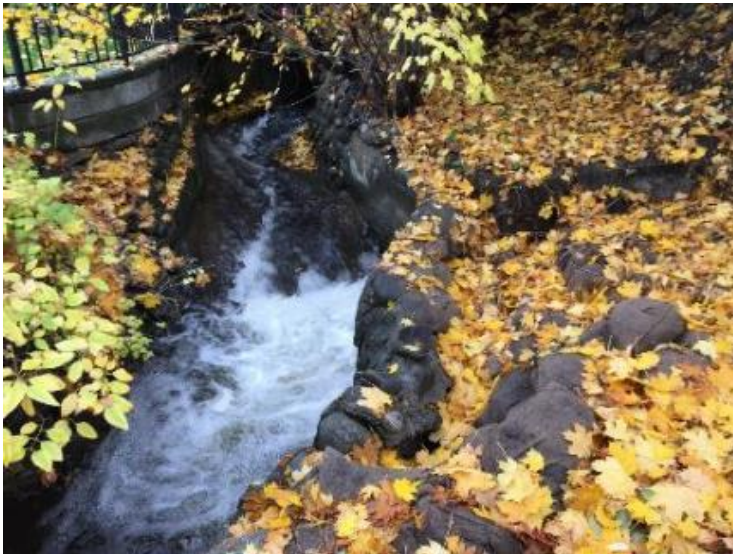
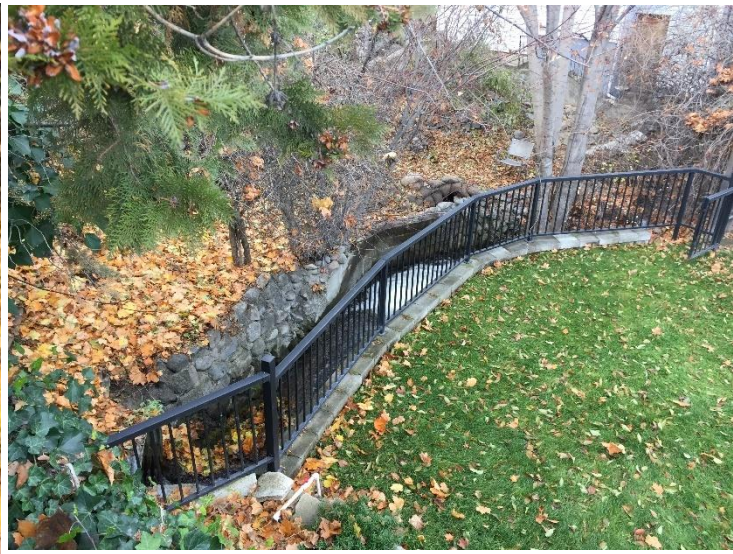
Figure – Sinkhole and Wall Undermining

Location Chainage: Sta. 15+650

- If the velocities stay high the erosive force will continue and the potential for wall failure is high and due to the proximity of the 2 houses there is a high risk of the creek encroaching on the structures.

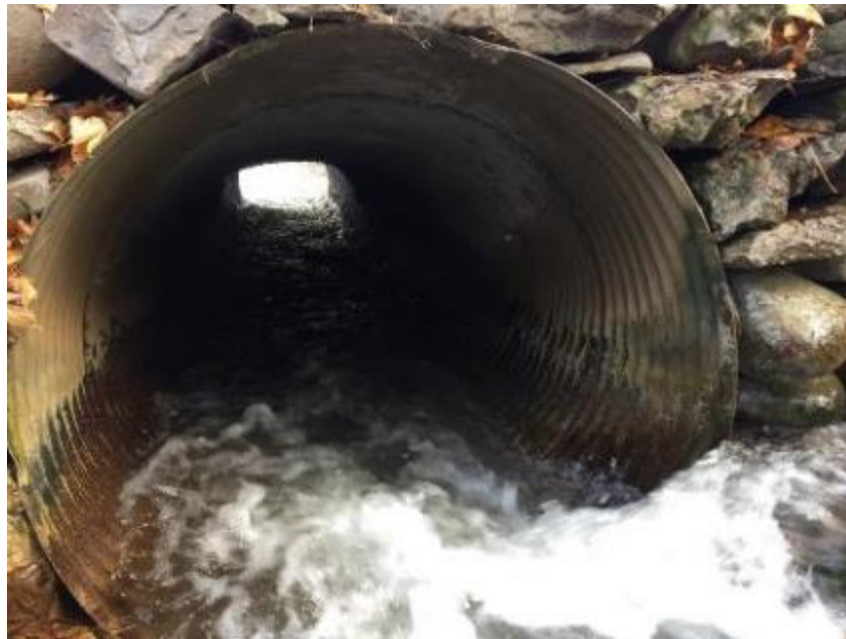
Figure – Pohlman Road Culvert

Location Chainage: Sta. 15+710

- It is unknown if this culvert was installed like this but it is concerning and the risk of failure could be significant to the properties downstream.

Proposed Works: Replace deformed culvert.

- Replace Culvert

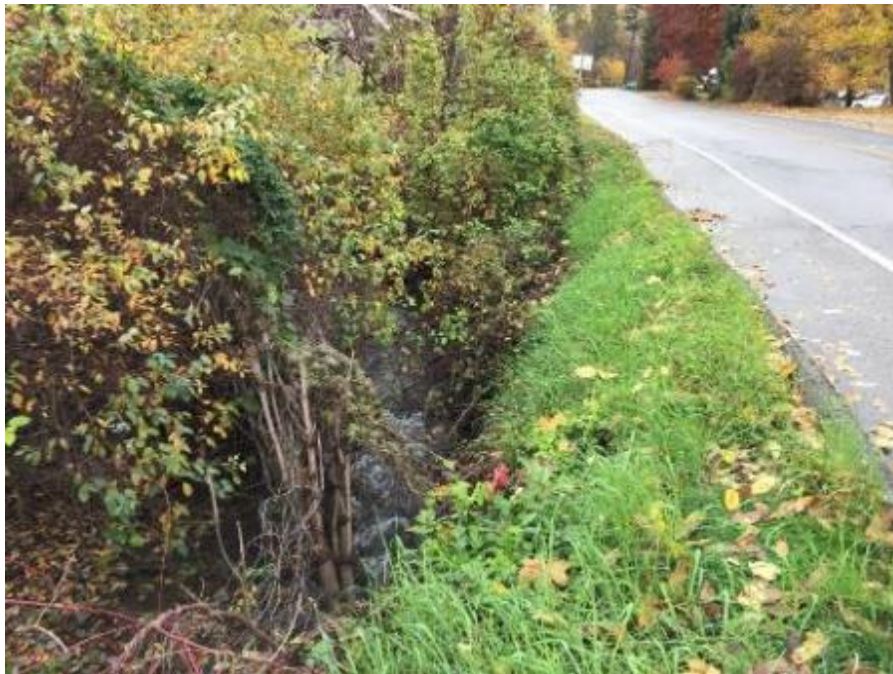
Figure – Bank Erosion near Road Embankment

Location Chainage: Multiple locations (Sta. 15+580 shown)

- Due to the steepness of this section and erosive capabilities it is recommended to stabilize the corner so the creek doesn't keep encroaching towards the road.

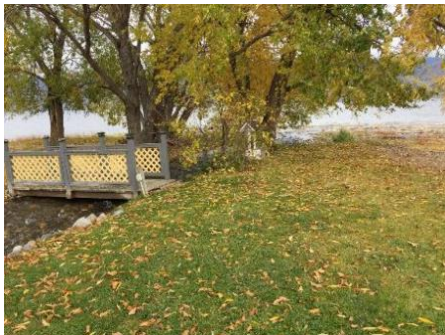
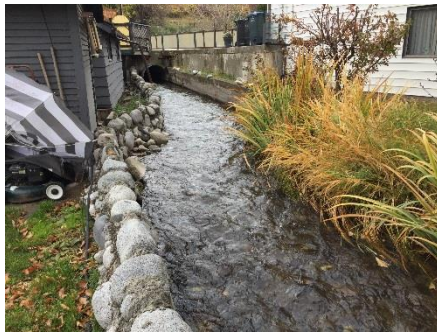
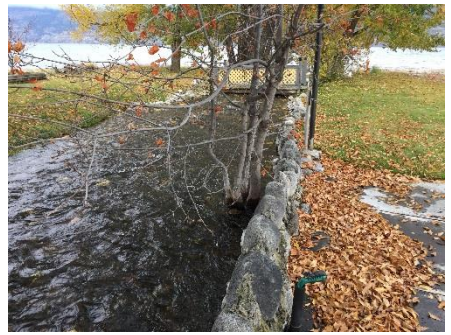
Figure – Outlet to Okanagan Lake (Fall 2018)

Location Chainage: Sta. 15+430

- Due to the sedimentation the outlet to the lake has increased in elevation threatening the neighboring properties, if nothing is done, flooding damage is expected.

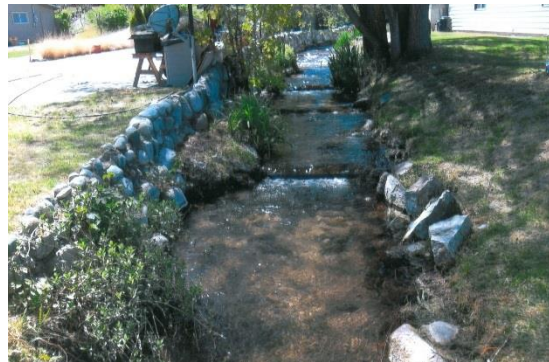
Figure – Outlet to Okanagan Lake (approximate date 2013)

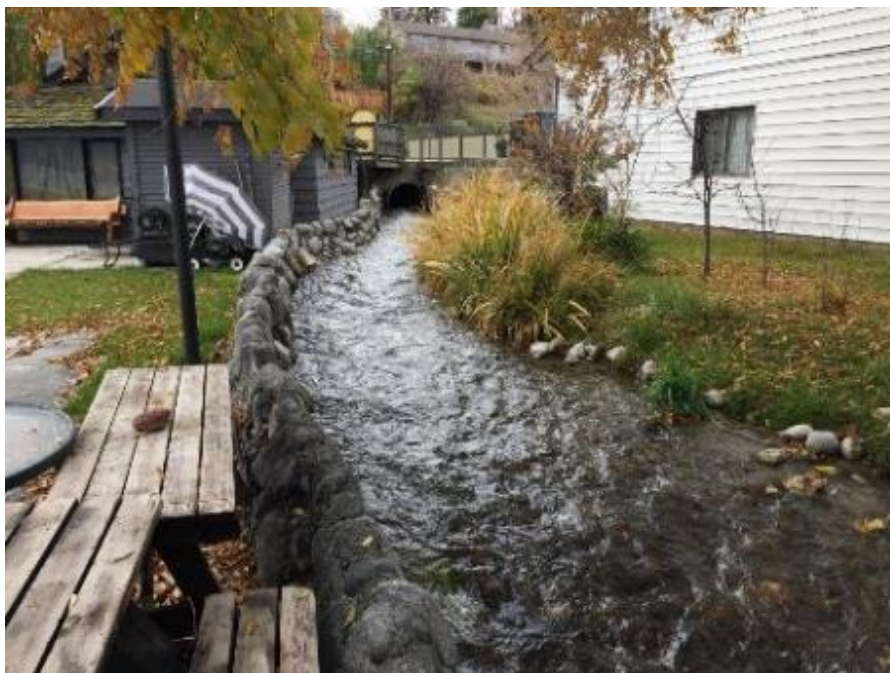
Figure – Channel between Lakefront Properties

Location Chainage: Sta. 15+870

- Due to the sedimentation the outlet to the lake has increased in elevation threatening the neighboring properties, if nothing is done, flooding damage is expected.

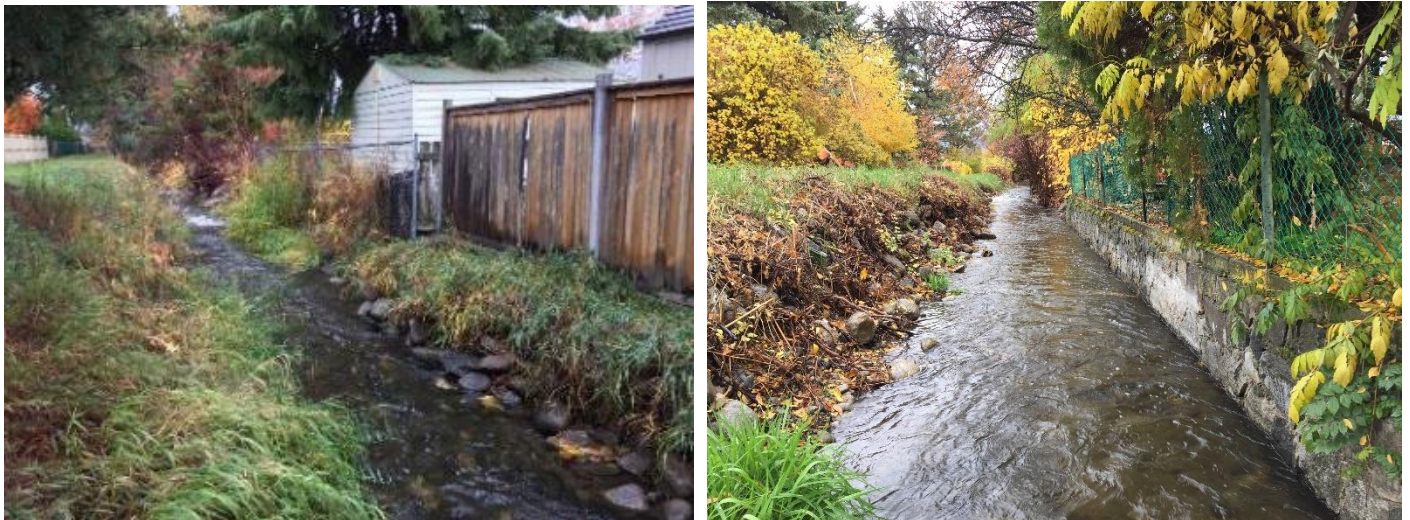
Figure – Existing Channel

- Widen channel, while supporting tree growth and habitat. This will allow flows to meander or for a secondary flood channel to develop so that high flows widen, have less depth and less velocity, therefore cause less flooding and erosion concerns.
- Maintain Access or access agreements through private lots
- Recommend a phased approach to start this, as 2km of creek is too much to address in one project. Phase in 100 – 500m sections.

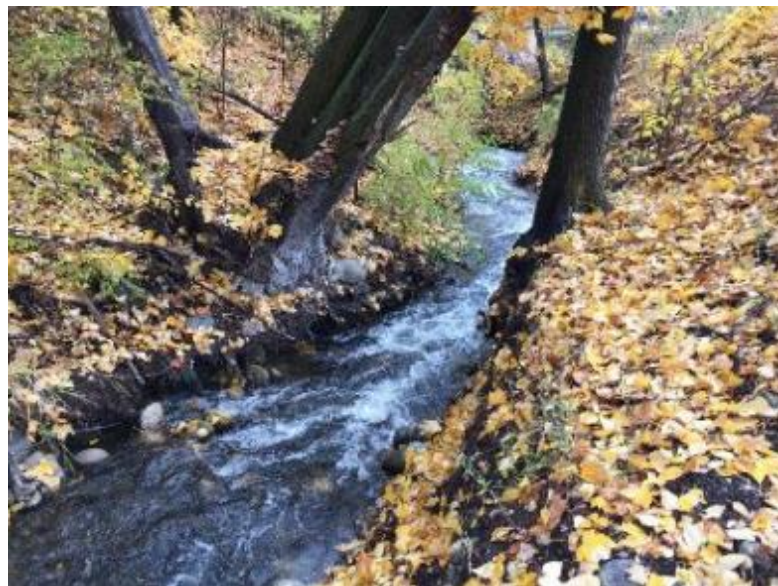
Figure – Channel Erosion

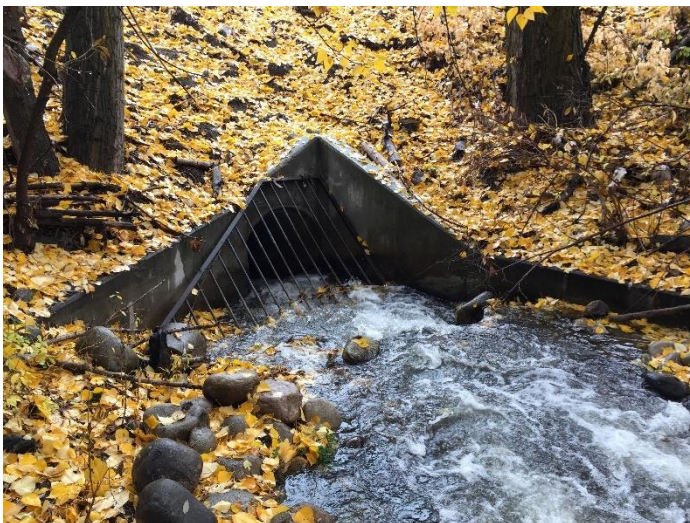
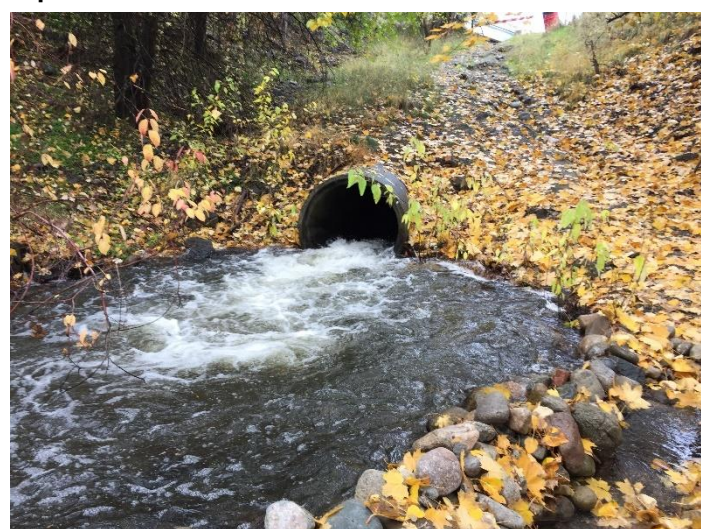
Figure – Inlet and Outlet

- There are concerns that due to the high risk nature and age of this pipe that it should be video inspected to confirm its integrity as the pipe ages.
- If replacement or rehabilitation is needed several options are available including replacement, sliplining, pipe bursting, and other lining options.

Proposed Works: Inspection of a critical culvert crossing such as this is important to ensure its continued service, and prepare for any repairs or maintenance that may be required

- Complete a camera inspection of the inside of the pipe to check for deterioration, or excessive erosion.

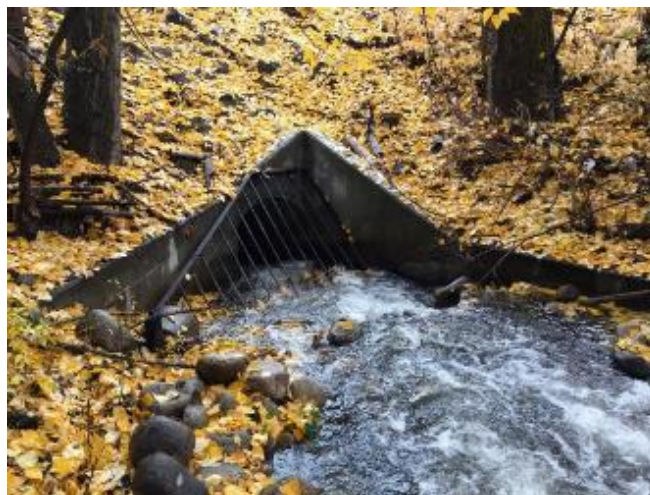
Figure – Culvert under Hwy 97 Inlet

- Improve inlet conditions, install a pre-headwall grizzly to capture most of the debris upstream keeping the headwall clear.
- Create better maintenance access by constructing a road close to the inlet to allow the grizzly to be maintained and kept clear of debris

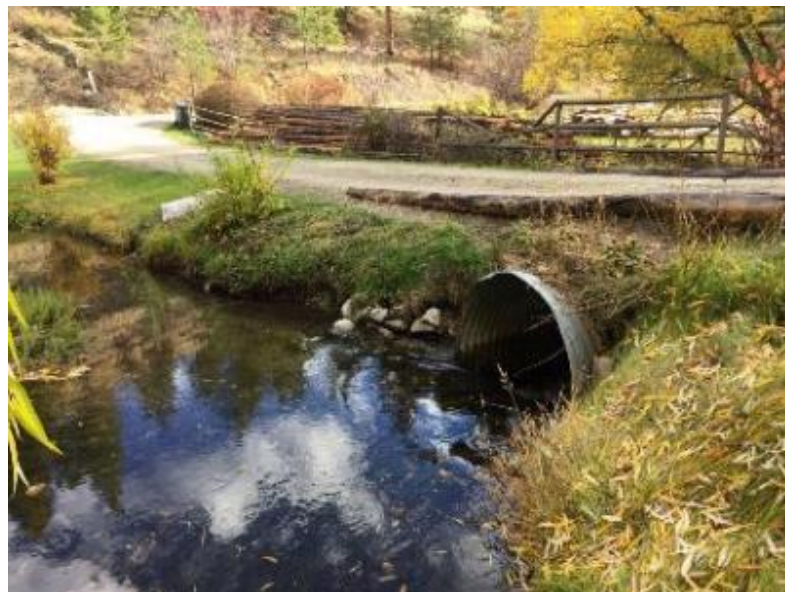
Figure – Culvert Inlet

Location Chainage: Sta. 3+970, 28412 Garnet Valley Road

- Increase inlet capacity, by removing manmade weir prior to high flows,
- Increasing capacity by improving inlet conditions by constructing a headwall and tapering culvert to the slope or a suitable slope of ~2:1.
- Add rocked section of road at overflow point to create a high level spillway to allow a safe release of water instead of sandbagging

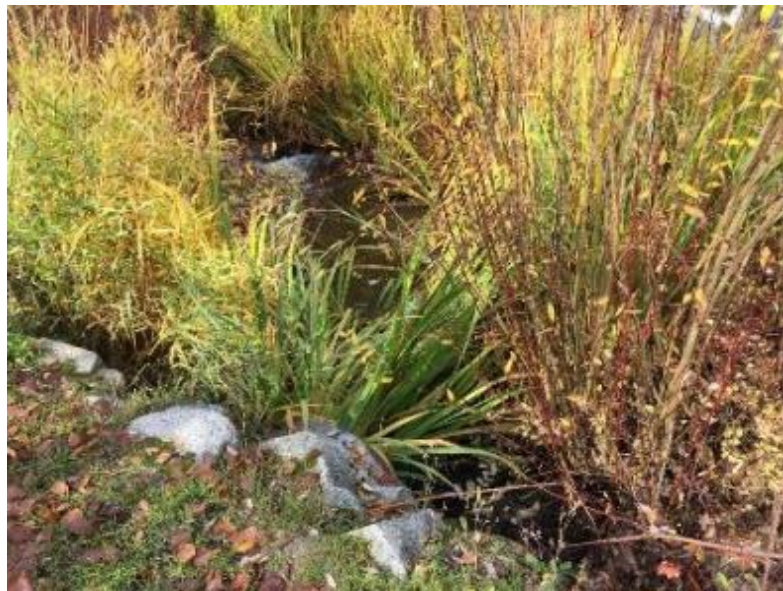
Figure – Culvert Inlet

Location Chainage: Sta. 4+830, 27088 Garnet Valley Road shown

Proposed Works: Increase culvert capacity, improve flow conditions and decrease erosion downstream

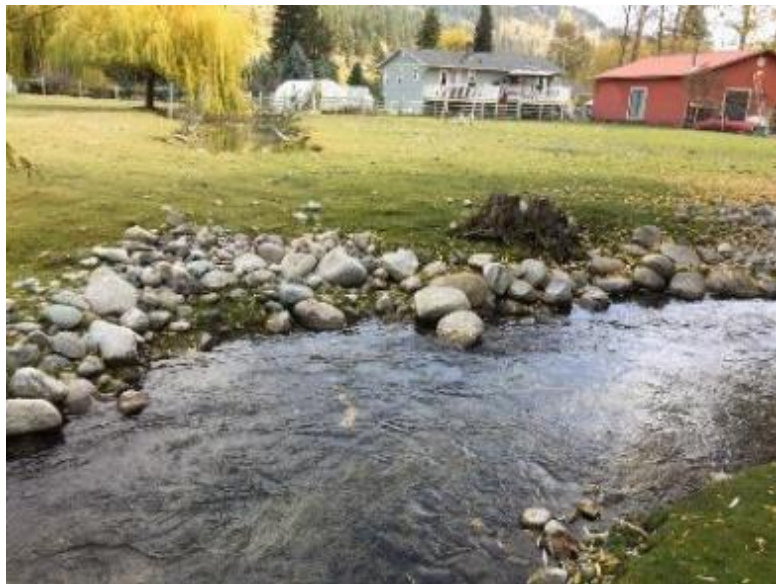
Figure – Natural Overflow Route

Location Chainage: Sta. 7+440

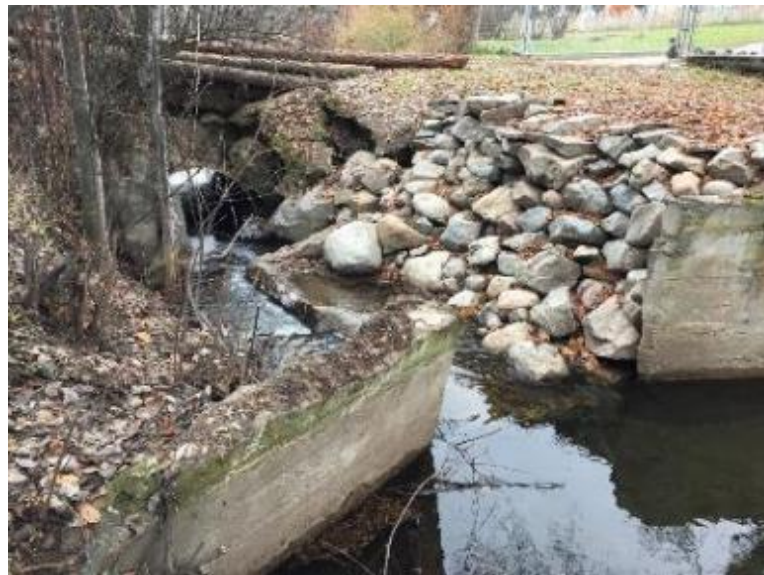
Figure – Creek Obstruction

Location Chainage: Sta. 9+750

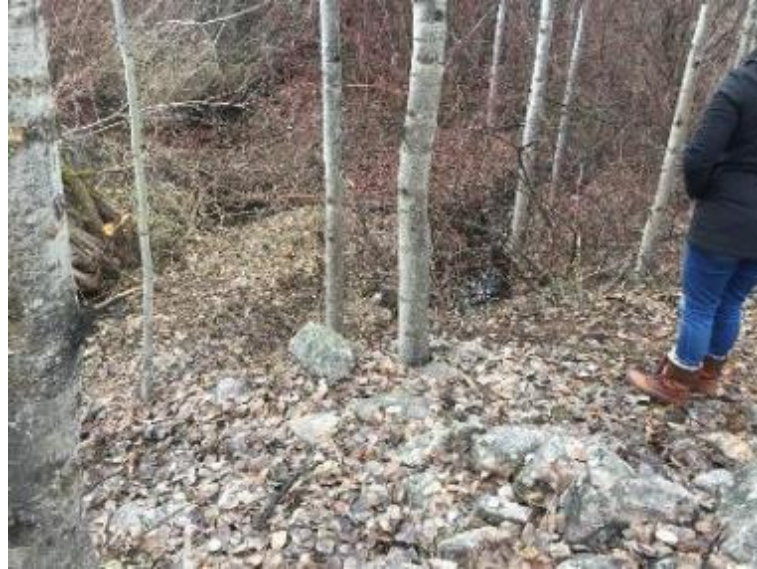
Figure– Creek Build Out Confining Creek

- Confinements such as these cause flows to back up causing additional water levels upstream.

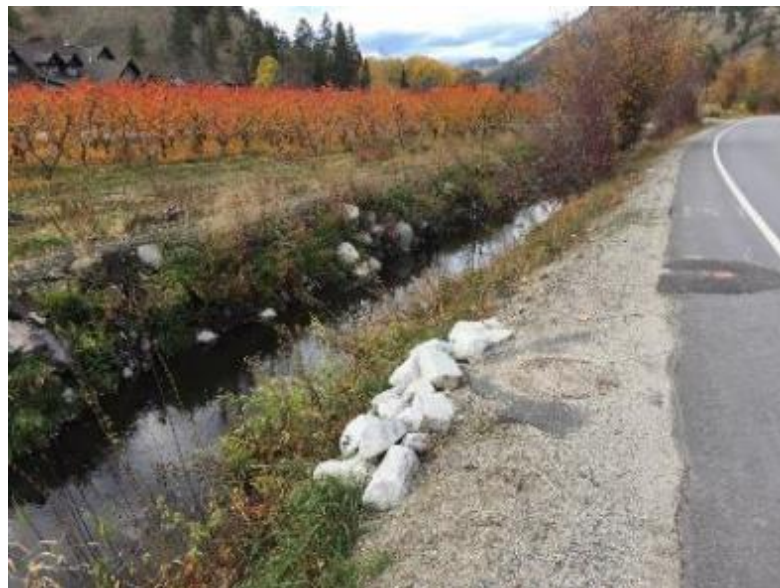
Figure – Creek Berm

Location Chainage: Sta. 10+700 to 11+000

- Concerns exist if these fail, then the creek flows may cause increased damage, above a natural flooding state, since the water can't get back into the creek safely, or since flows are deeper and more sudden.
- Concerns with structures like these also exist, since these deepen the water in the channel, and increase the creek impacts to both banks.
- These can also lead to increased sediment into the creek and cause future water levels to increase due to the creek bed being filled in.

Proposed Works: Remove Private Berms building up creek banks, as there is risk that these will fail and cause additional damage down stream since they trap the flood waters behind and may not have a safe route back to the channel and may affect neighboring properties or neighboring structures. These if they are being constructed should be built set back from the channel and only protect a single property.

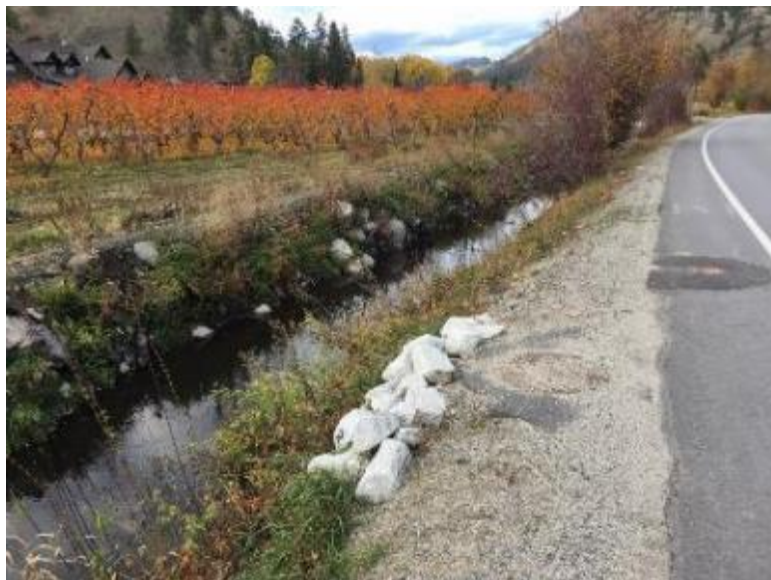
Figure– Creek Realignment

Location Chainage: Sta. 10+750

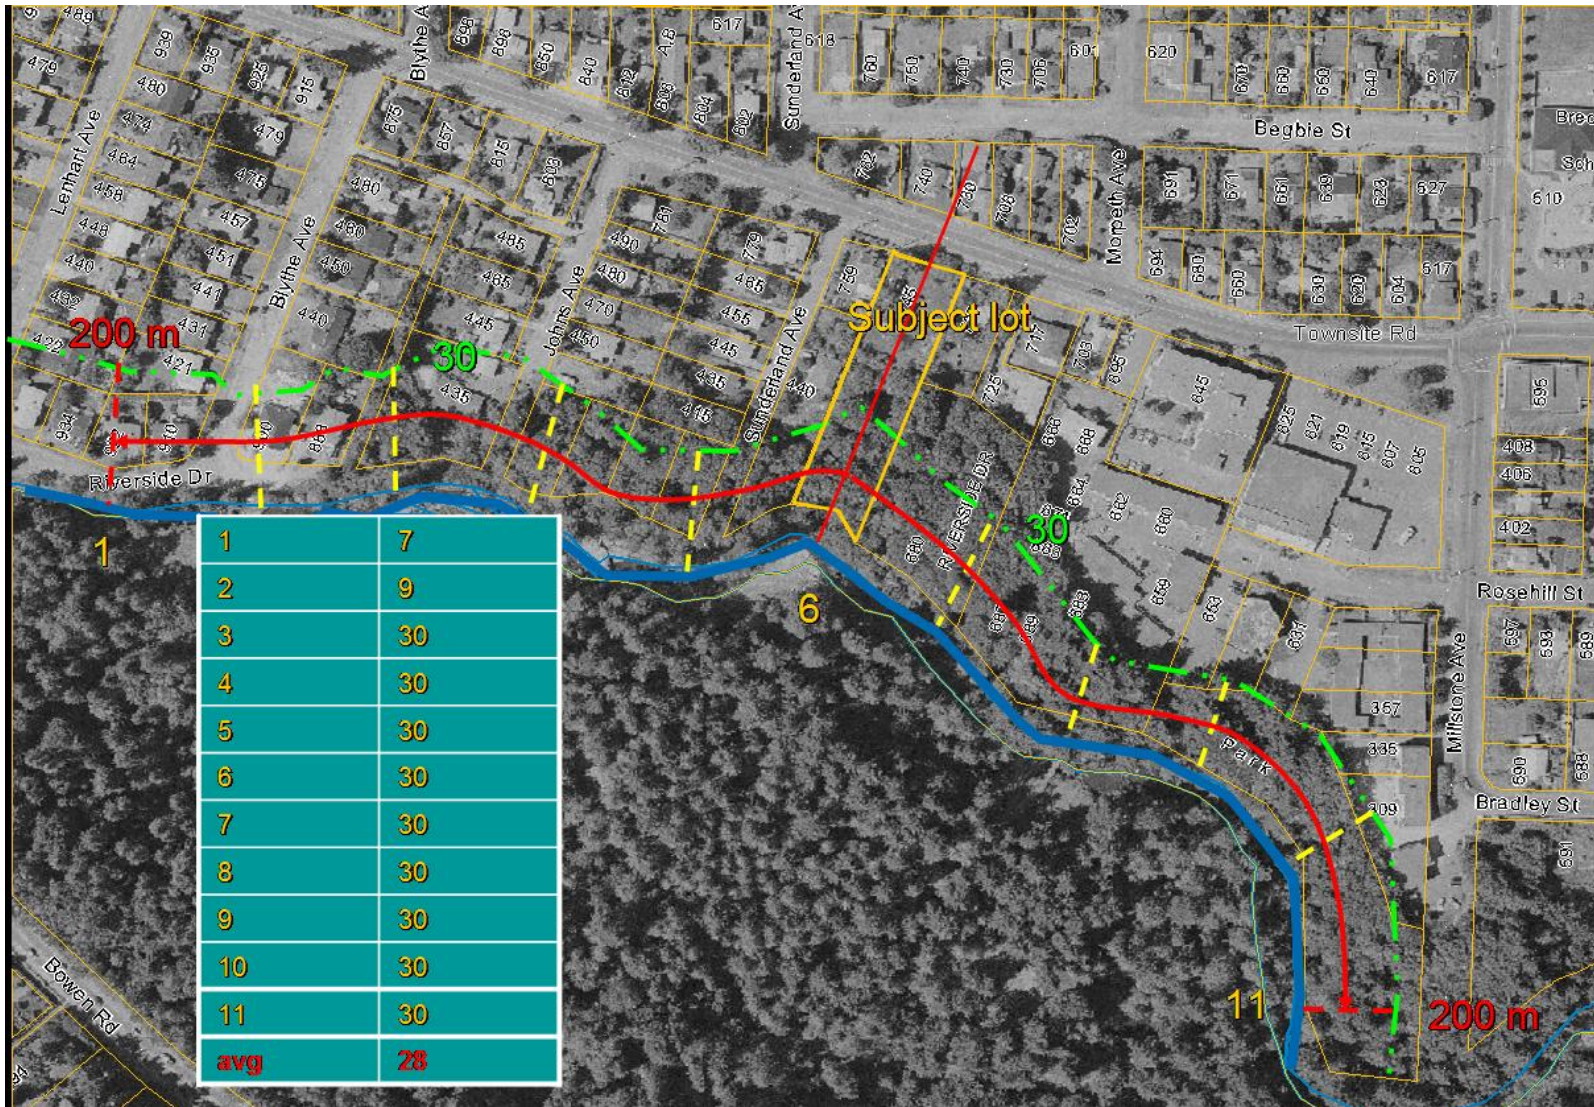
Figure 2-1: Example of determining of vegetation category for Simple Assessment
