### District of Summerland

#### Thirsk Dam Inspection Spillway Piezometer Data Review

August 2016

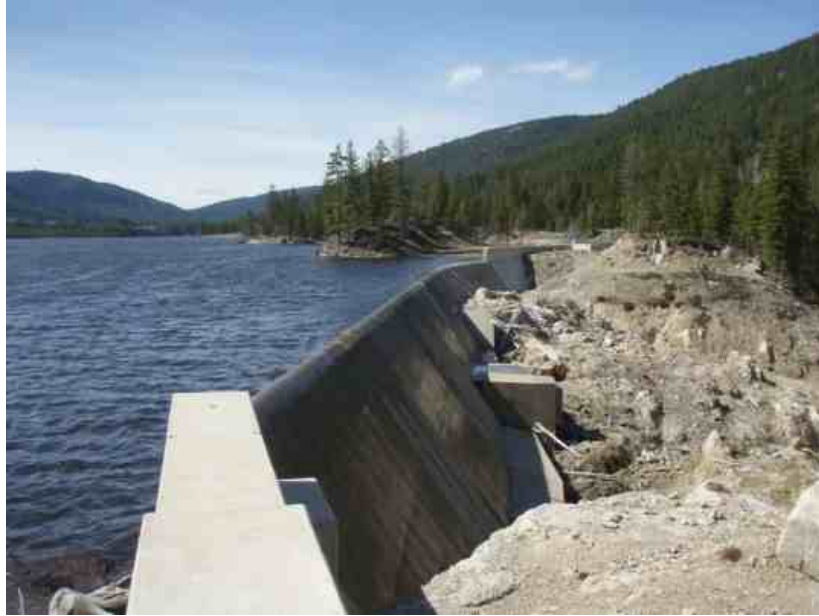
**Photo 1**  
**Spillway – Viewed from the East**

Observations from a visual inspection of the downstream face of the spillway and the spillway gallery were noted. The spillway was found to be generally in good condition with no specific concerns identified. The gallery drains all appeared to be operational with a very small flow rates measured at 2.4 litres/minute.

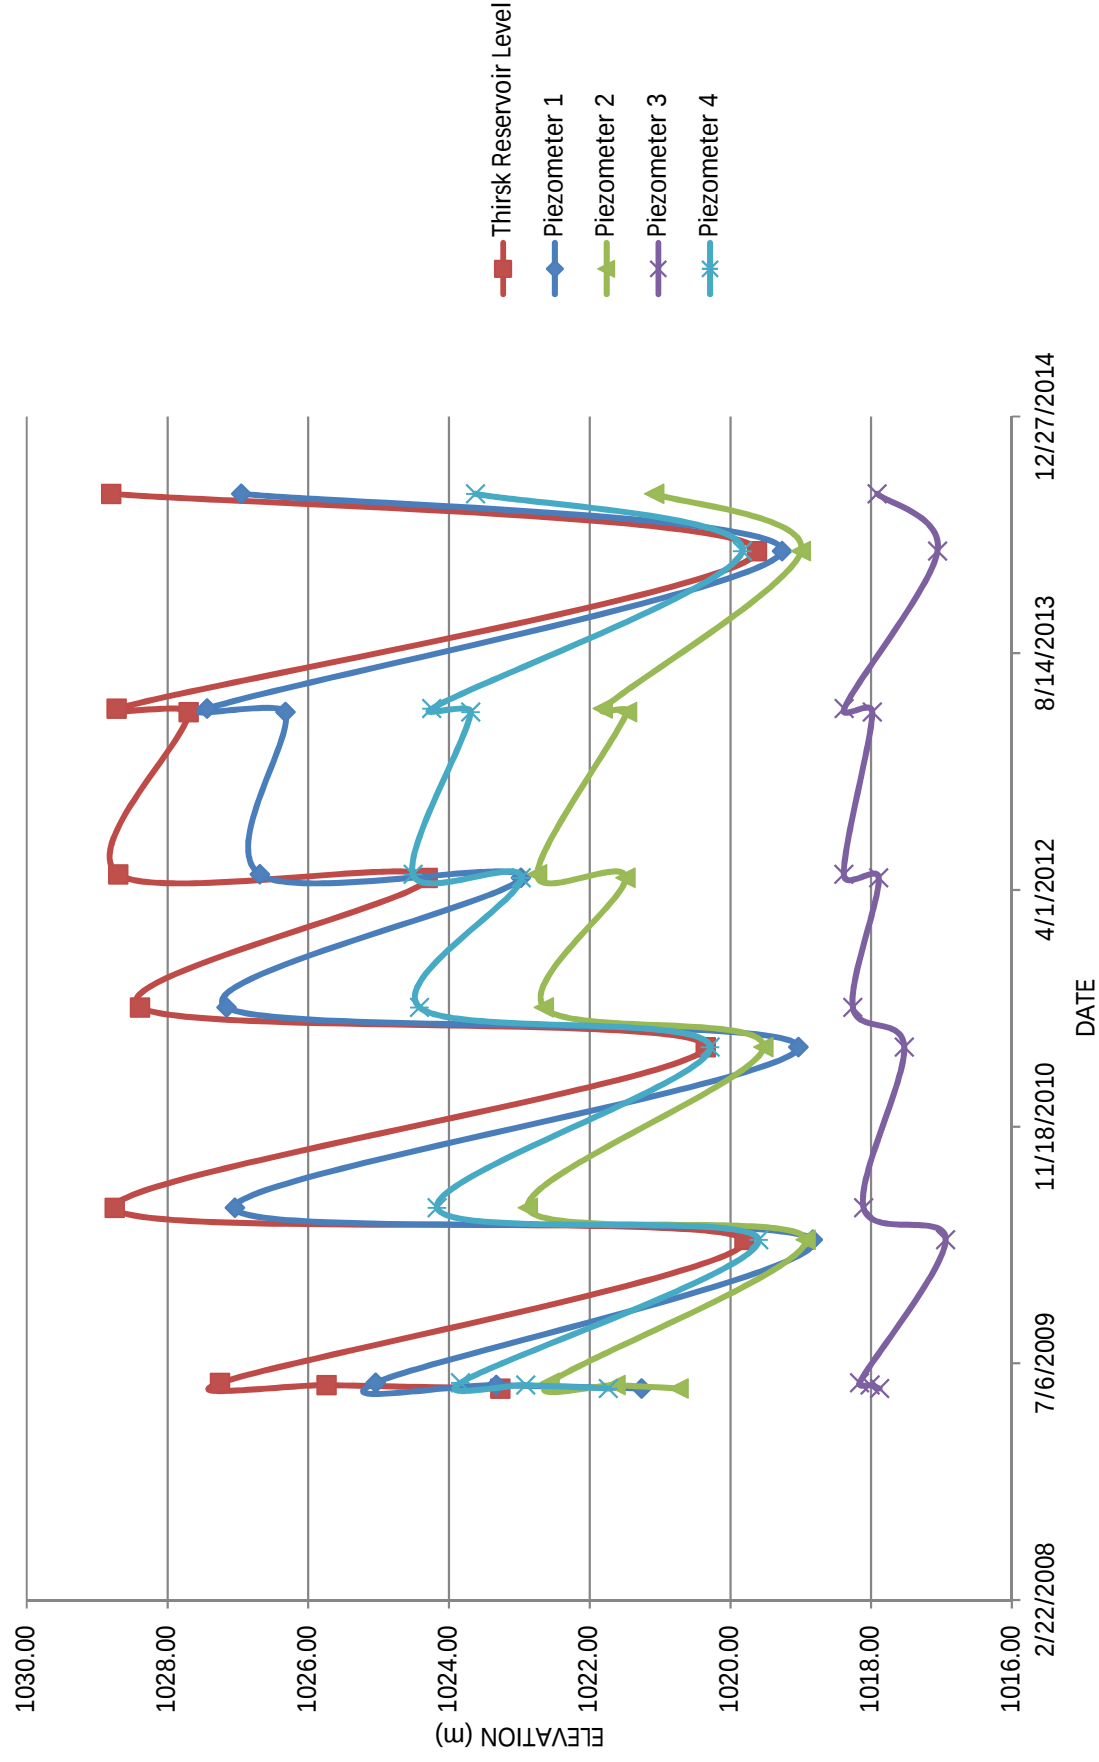
# BLOCK 12

- The hydrostatic uplift under Block #12 is significantly greater than the design uplift. In fact, it appears that the drains and grout curtain are ineffective under Block #12 at reducing the hydrostatic uplift.
- The hydrostatic uplift under Block #14, although slightly different in shape is about the same magnitude as the design uplift.

Although not indicated in the table above, our analysis indicates that Block #12 has inadequate stability for usual hydrostatic conditions, if the anchors are ineffective (as conservatively assumed in the original design). However, Block #12 performance factors are acceptable, with plugged drains, if the rock anchors are fully effective for all load conditions including usual hydrostatic.

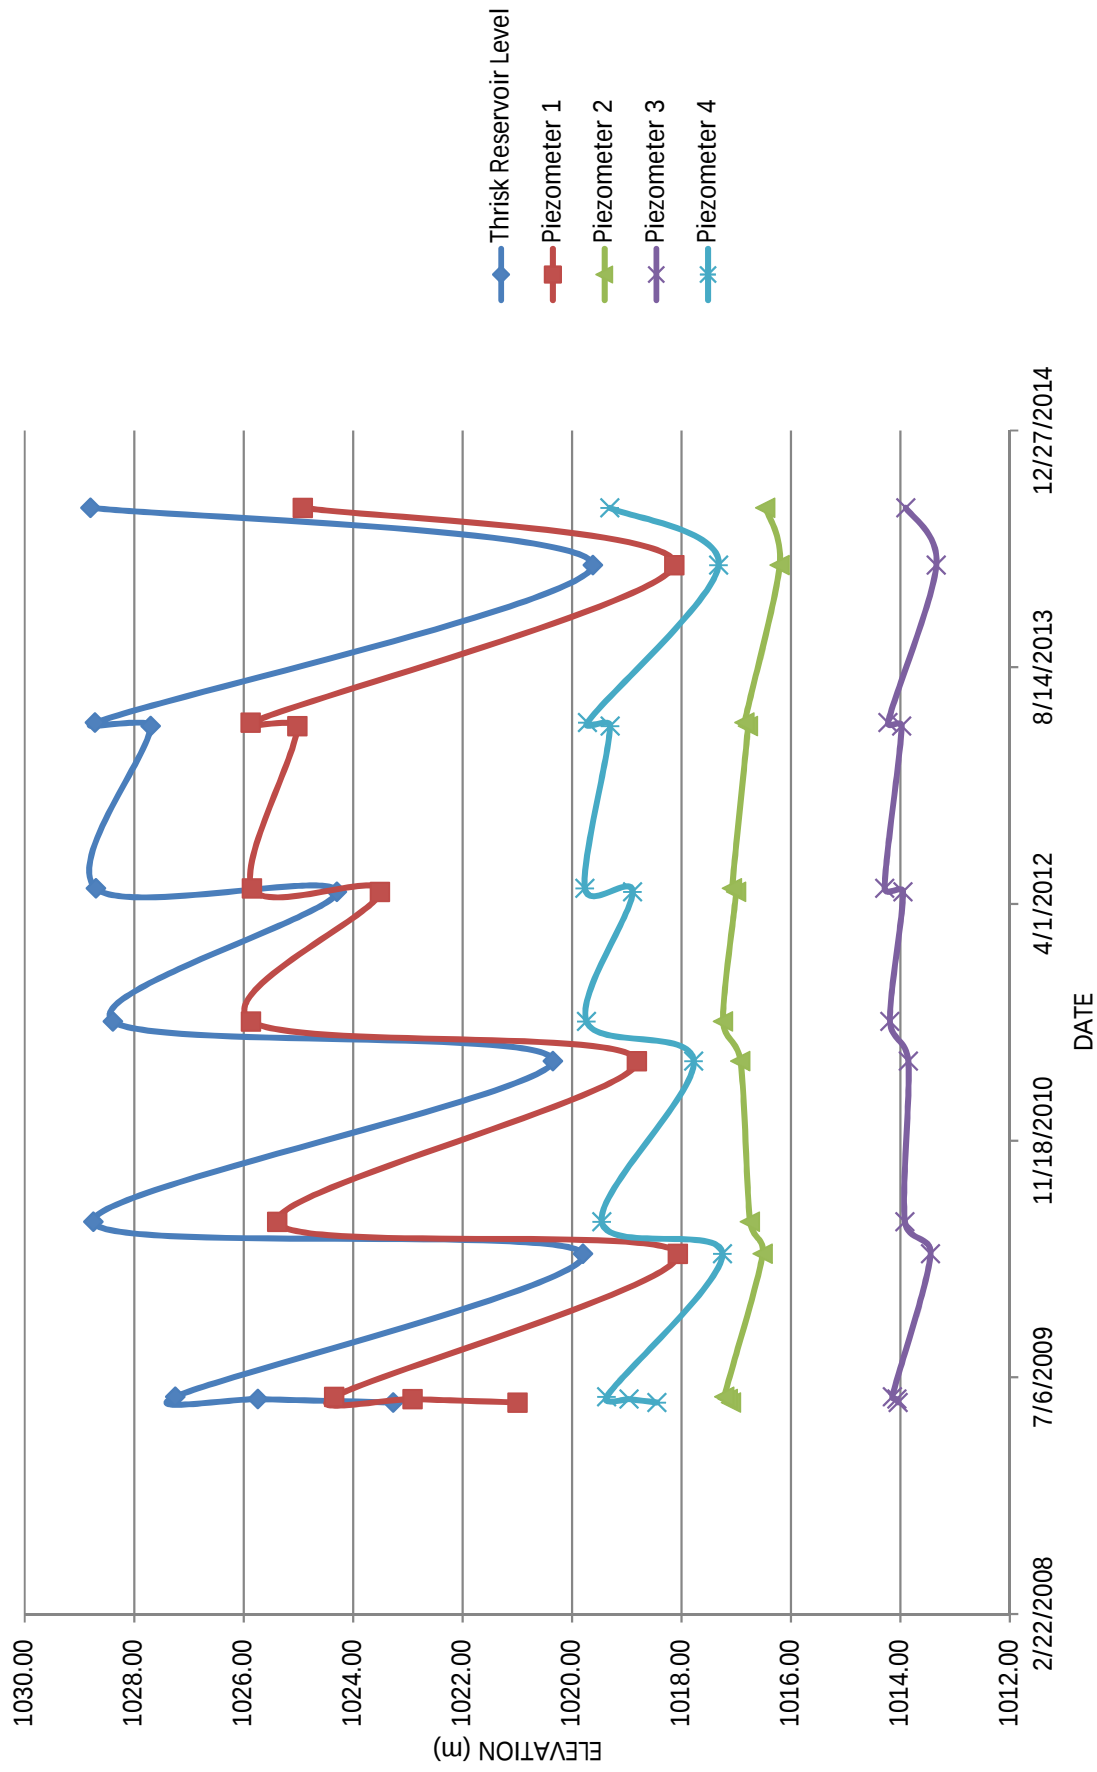
# BLOCK 14

The highest block, Block #14, has drains that are working effectively and the stability of this block meets the original design assumptions (i.e. it is stable for the usual hydrostatic condition with no anchors and the other load conditions with anchors).
