PERPETUAL SLIDE SUMMERLAND, BRITISH COLUMBIA

Geotechnical and Hydrogeological Study

Report Number: 1417553-001-R-Rev1

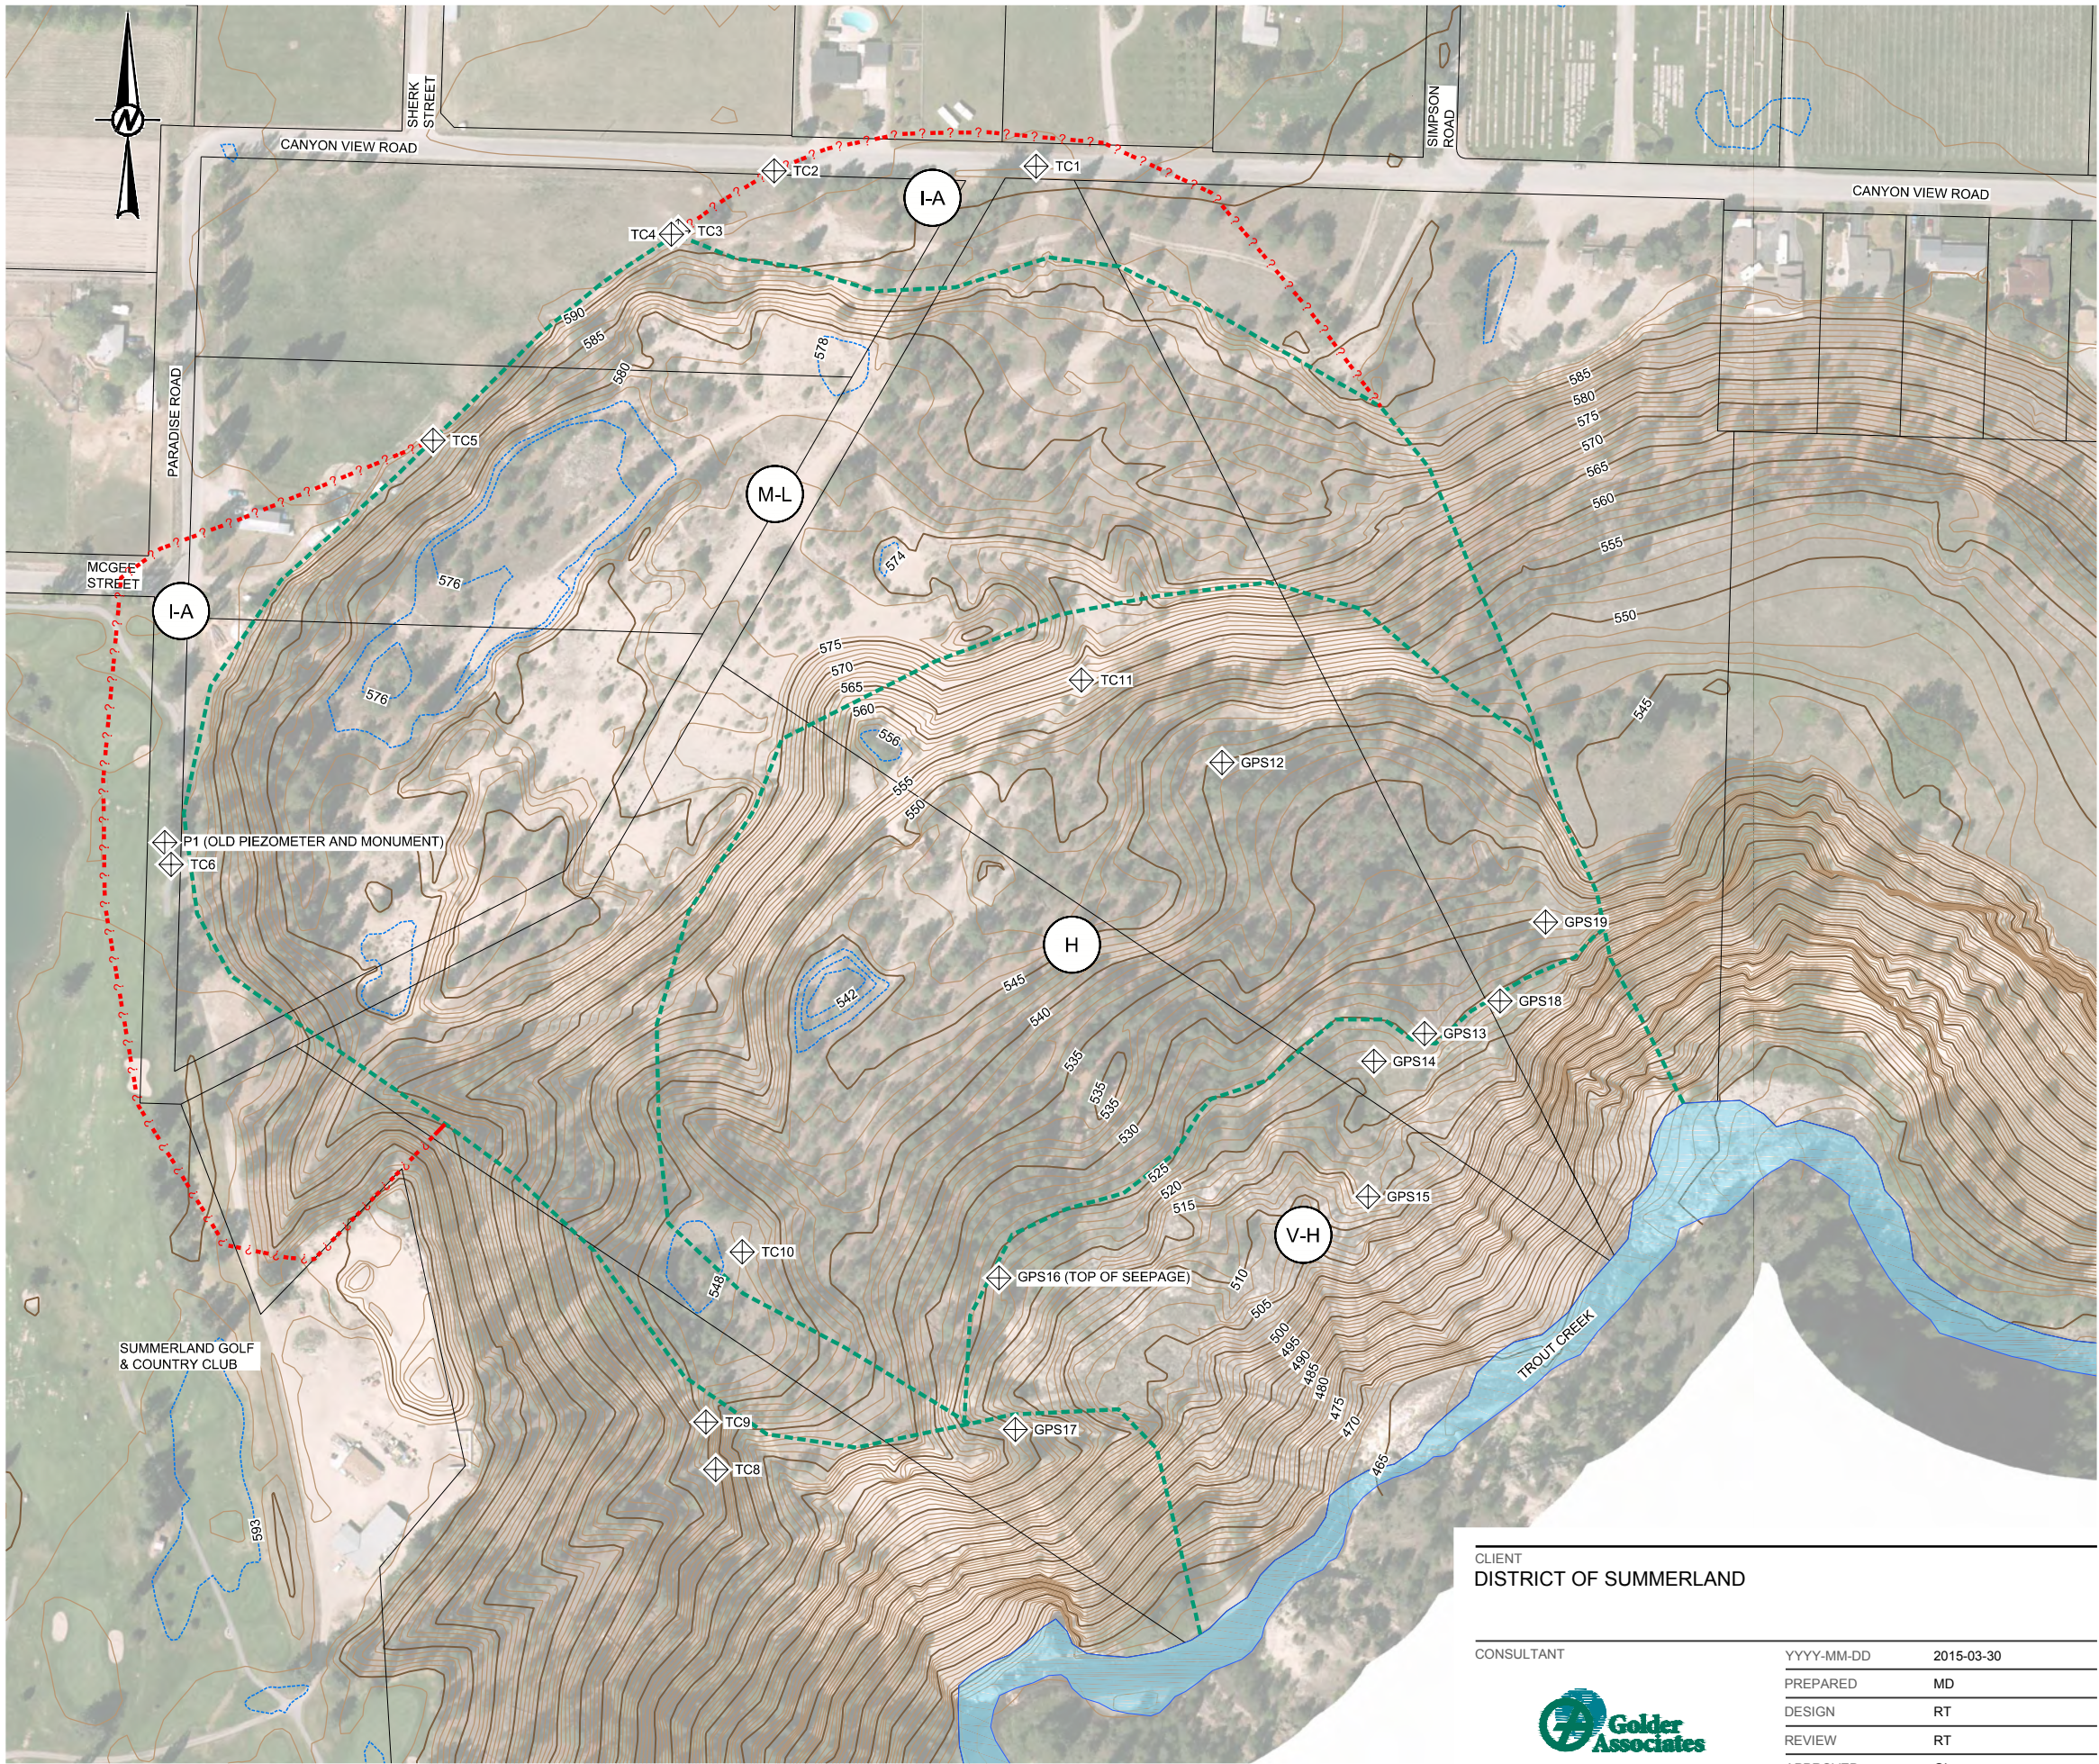
Based on the results of the slide reconnaissance together with comments provided by DoS and the golf course, Golder identified slide zones based on the level of observed slide activity together with the magnitude of ground surface displacements. Based on the slide angle and activity information Golder recommended that a preliminary setback zone be established along the crest of the existing head scarp that extends back for a distance of at least 50 m. The preliminary setback distance should be reviewed pending the results of a proposed monitoring program and detailed field investigation that is discussed in detail within the report.
