# FINAL REPORT

## Facility Condition Assessment Summerland Arena & Curling Club Complex

8820 Jubilee Road East,  
Summerland BC, V0H 1Z5

Date: July 13, 2022  
Project No.: 20211925

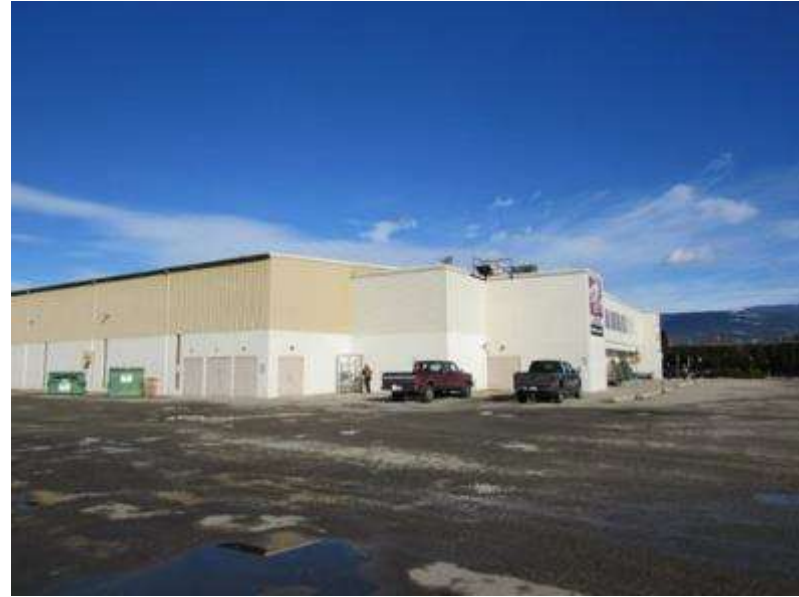
**Photo #A4:** Exterior cladding, windows, door - southwest elevation.

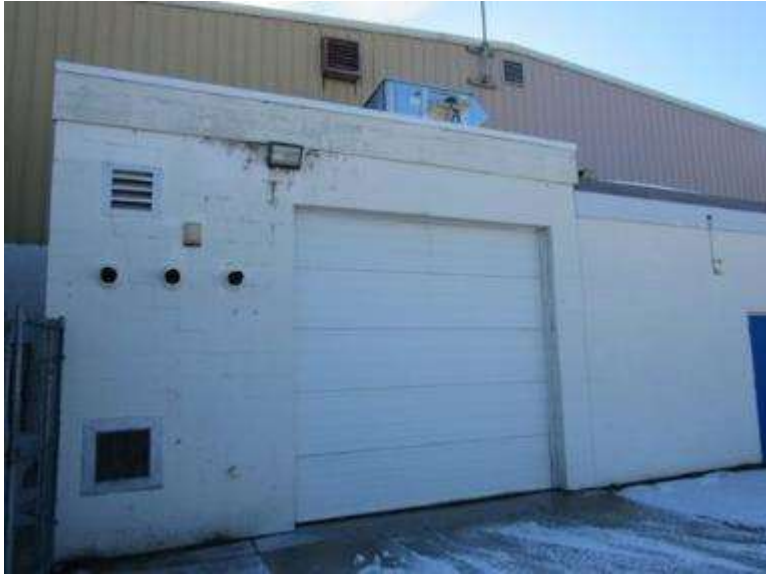
**Photo #A7:** Typical overhead door.

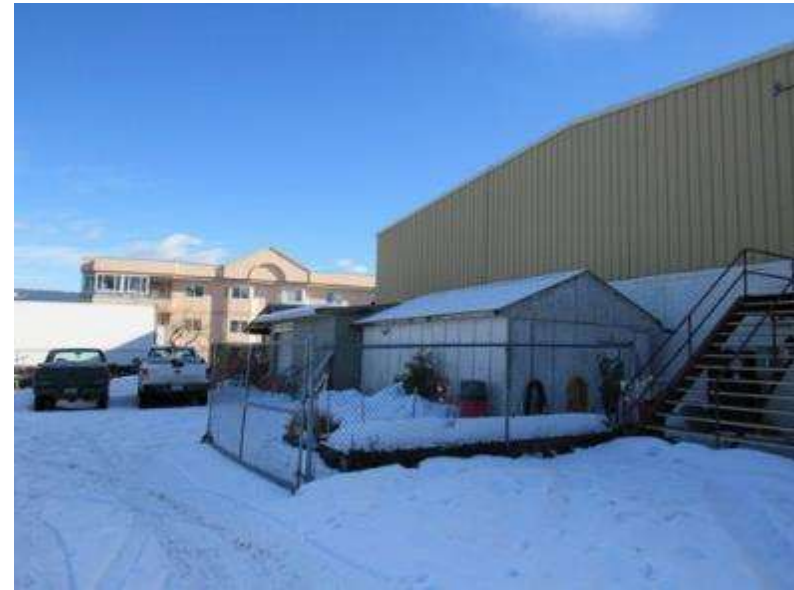
**Photo #A8:** Ancillary Building and Chain rink fence and Hockey Rink egress stair.

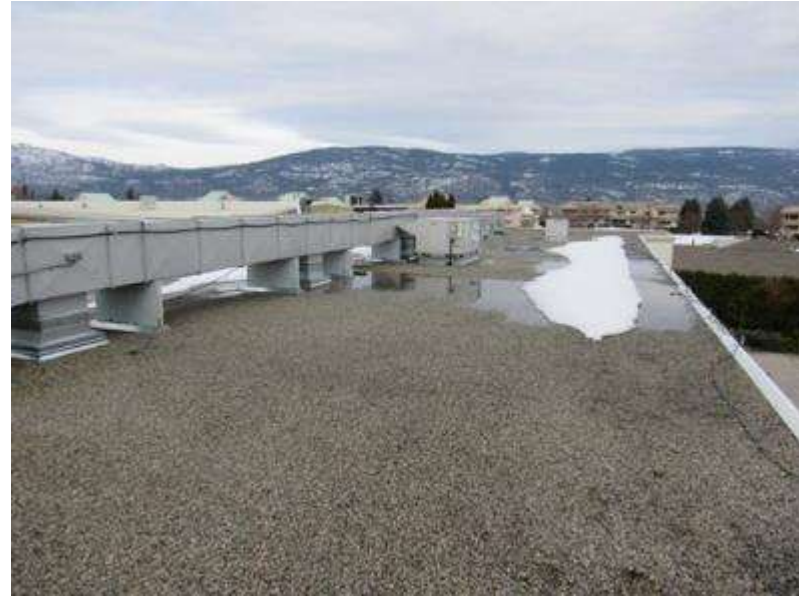
**Photo #A24:** Flat roof with BUR.

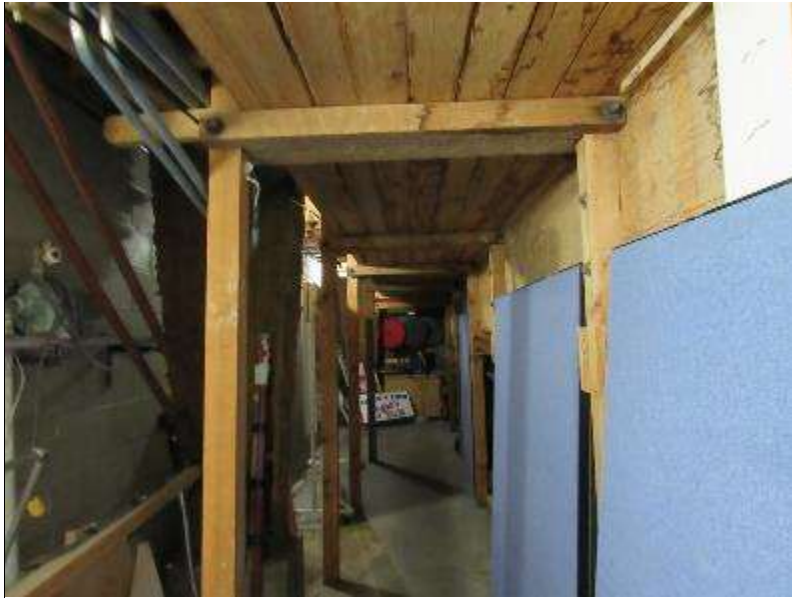
**Photo #S9:** Exposed framing in storage room under bleacher areas.

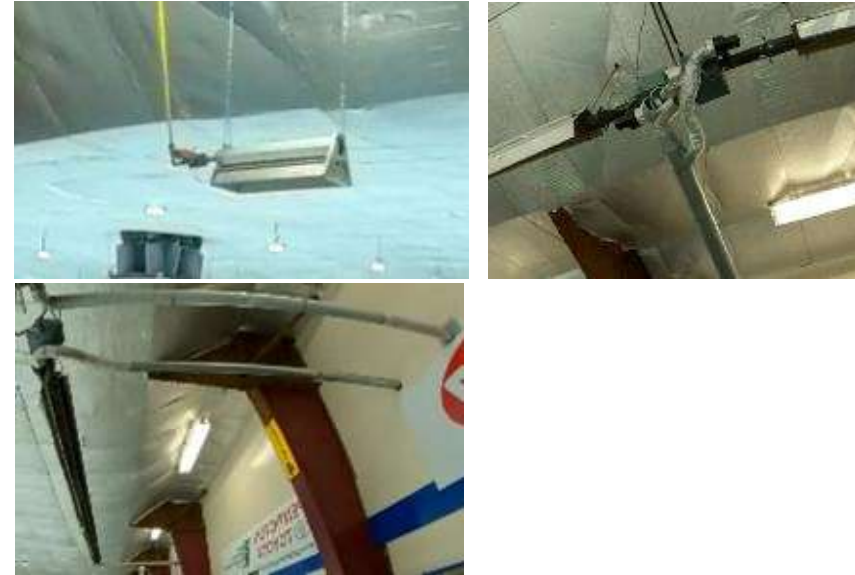
**Photo #M12:** Infrared heaters in Ice Rink area (Typical).

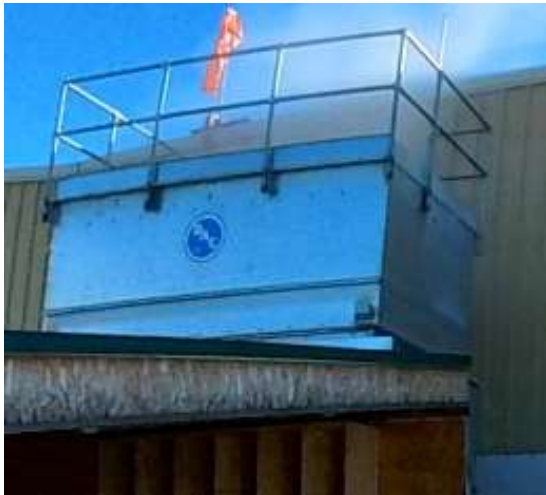
**Photo #M13:** Evaporative Condenser.

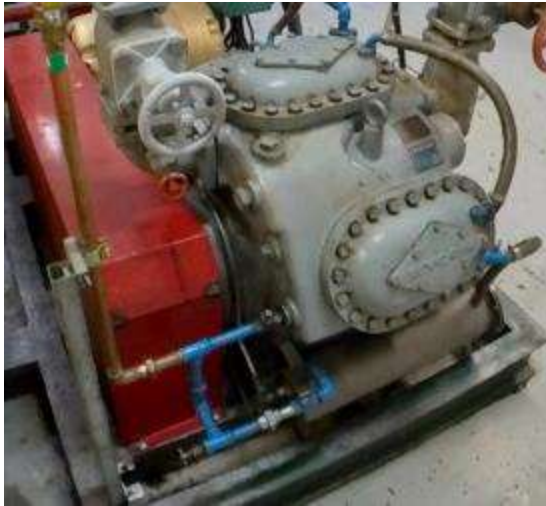
**Photo #M15:** Compressor (Typical).

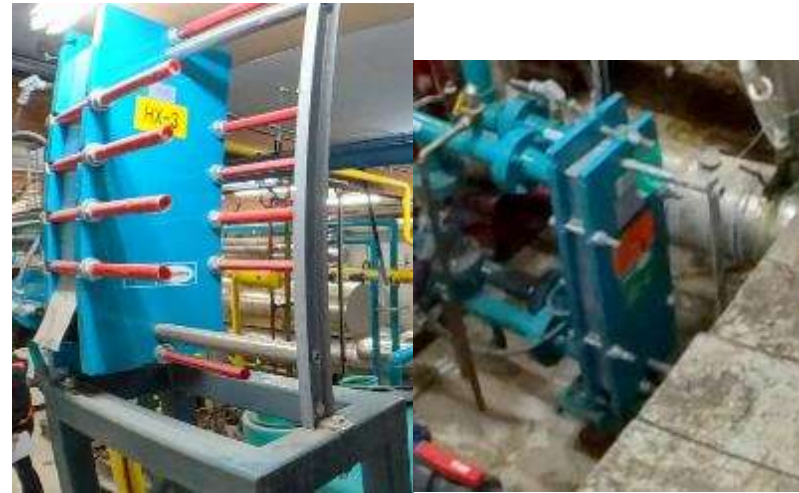
**Photo #M16:** Heat exchangers.

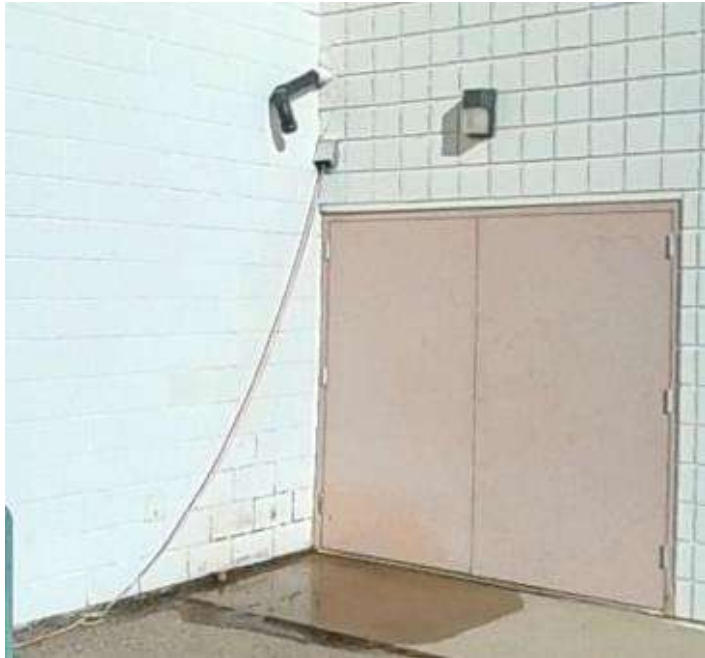
**Photo #M25:** Drainage issue at SW building corner.

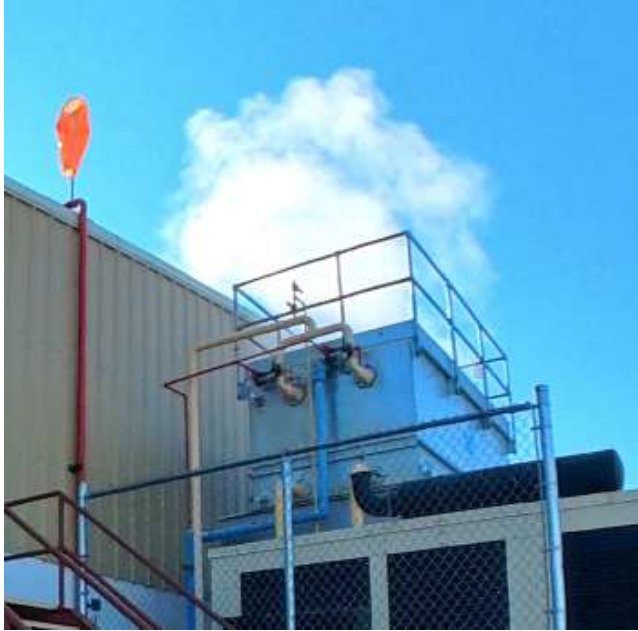
Photo #M35: Excessive heat rejection through Evaporative Condenser.

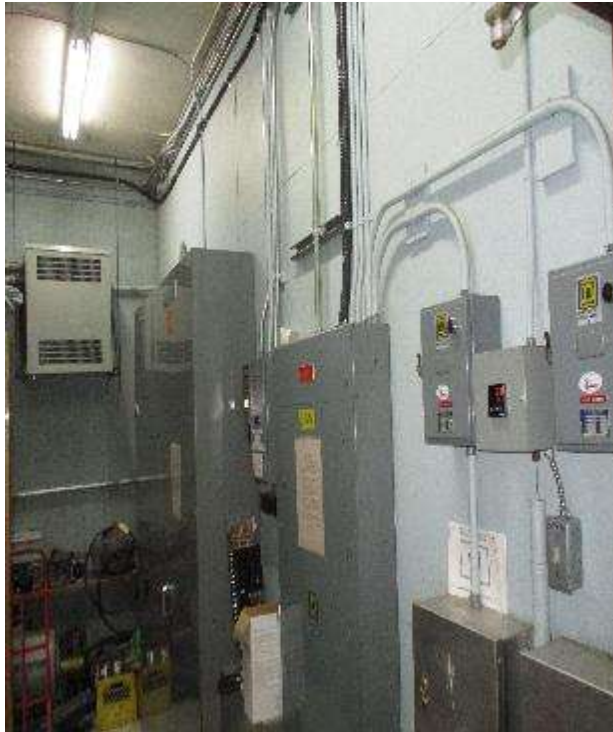
I.D#	SYSTEM/COMPONENT	DESCRIPTION	CR	Cat.	COMMENTS/ASSESSMENT
E02.1	Main Distribution	~1976: One main Square D main switchboard is in the main electrical room. Rating: 600 A, 600 V 3-Phase, 4-Wire	4	C	Complete thermal scans of switchboard to confirm condition. (See Note 7B). Maintenance: Recommend to schedule scans semi-annually. Complete torquing of mechanical bolts to bussing.
E02.2	Primary Distribution Disconnection Switches	~1976 and various: Disconnection Switches for mechanical equipment are provided in the Compressor/Ammonia room. Make: Square D and Siemens Rating: 20-400 A, 600 V	4	C	No concerns observed or reported. (See Note 7B).
E02.3	Sub Distribution Panels	~1976: One (1) SQUARE D - distribution panel is located in the main electrical room 600Y/347V, 400-A, 3-phase, 4-wire for plant and HVAC systems power. ~1976: Eight (8) SQUARE D - brand panels are located at various parts of the building. These are	4	C	Complete thermal scans of switchboard to confirm condition. (See Note 7B). Maintenance: Recommend to schedule scans semi-annually. Complete torquing of mechanical bolts to bussing.

**Photo #E1:** Mai Electrical Room. (Transformer, switchboard, panels and disconnect.)

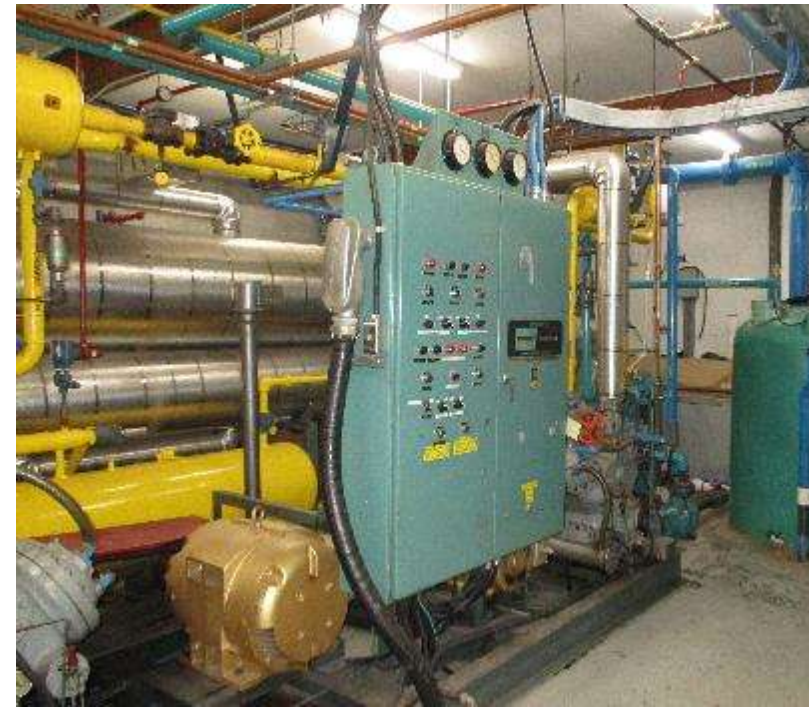
**Photo #E2:** Ice Plant Control Panel.

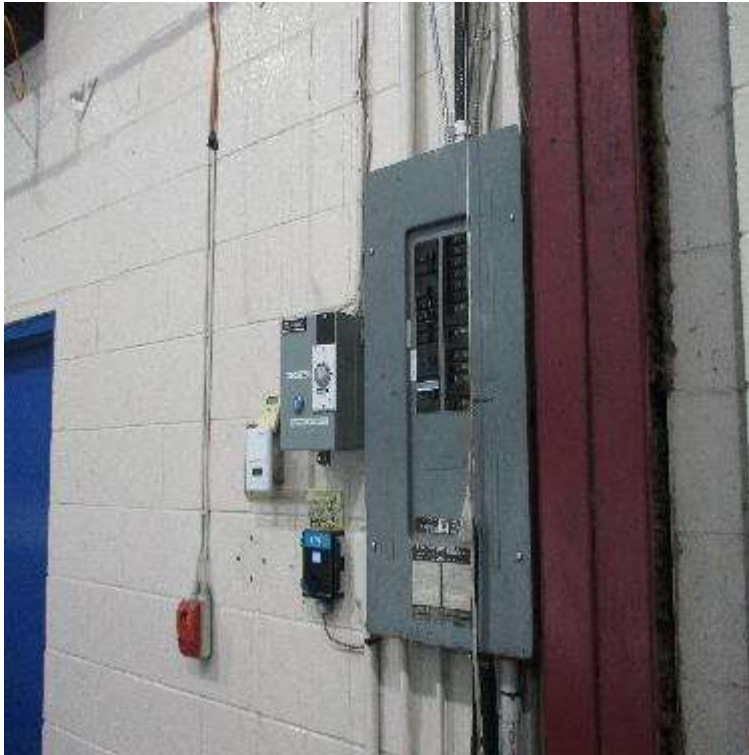
**Photo #E3:** Sub distribution Main Panel board - 200Y/120V located outside of maintenance room.

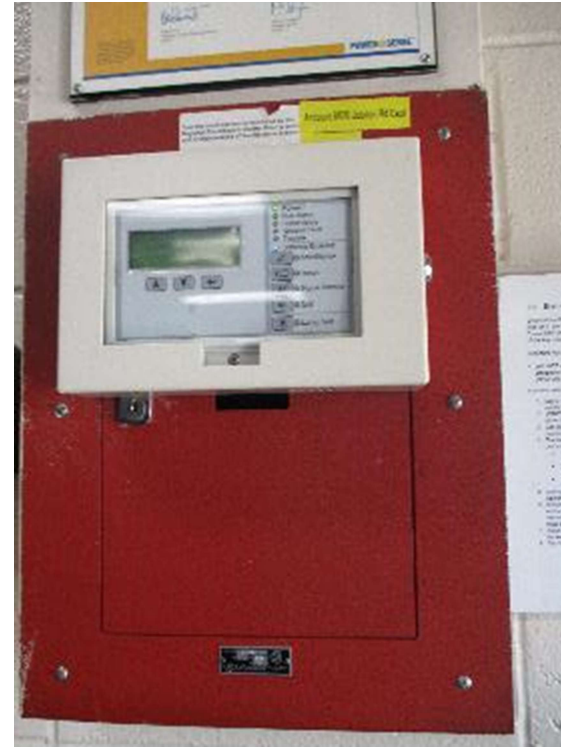
**Photo #E4:** Fire Alarm Annunciator at main entrance.

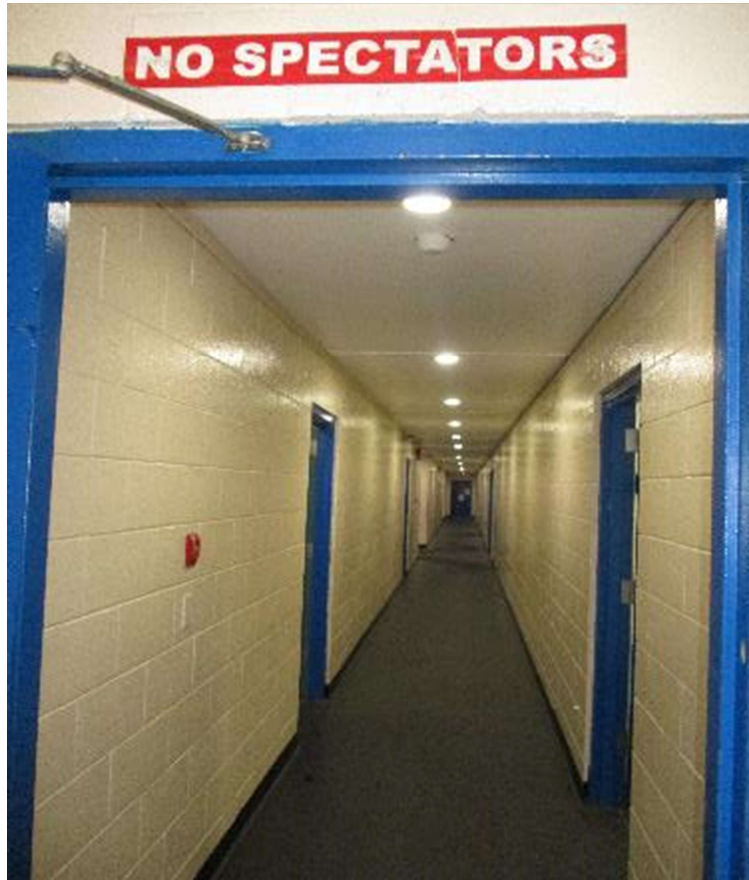
**Photo #E5:** Typical change rooms recessed Pot Lights

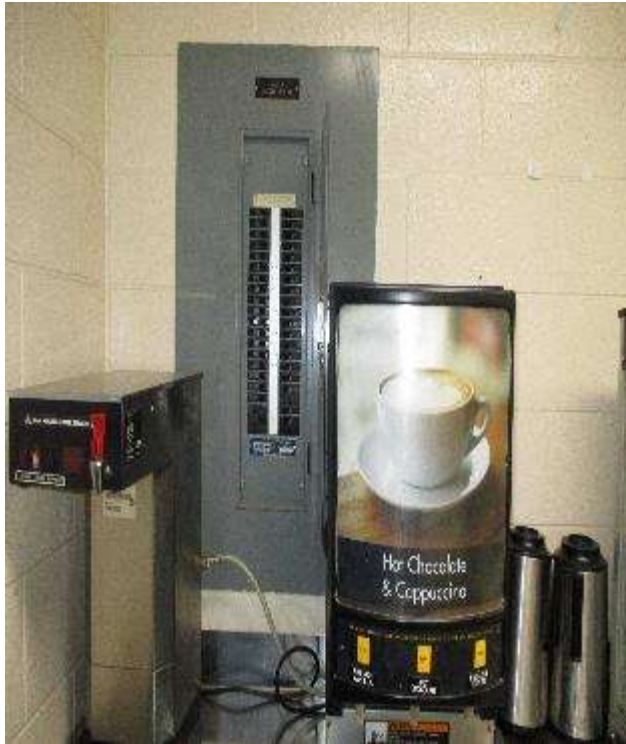
**Photo #E7:** Subpanels in Concession Area 120/208V.

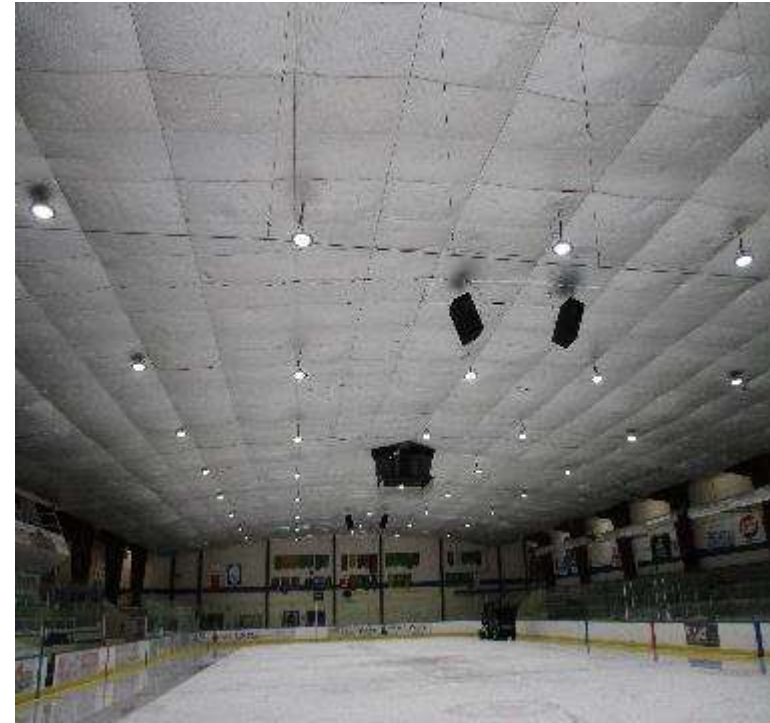
**Photo #E8:** Suspended LED lights located in the Ice Arena Rink.

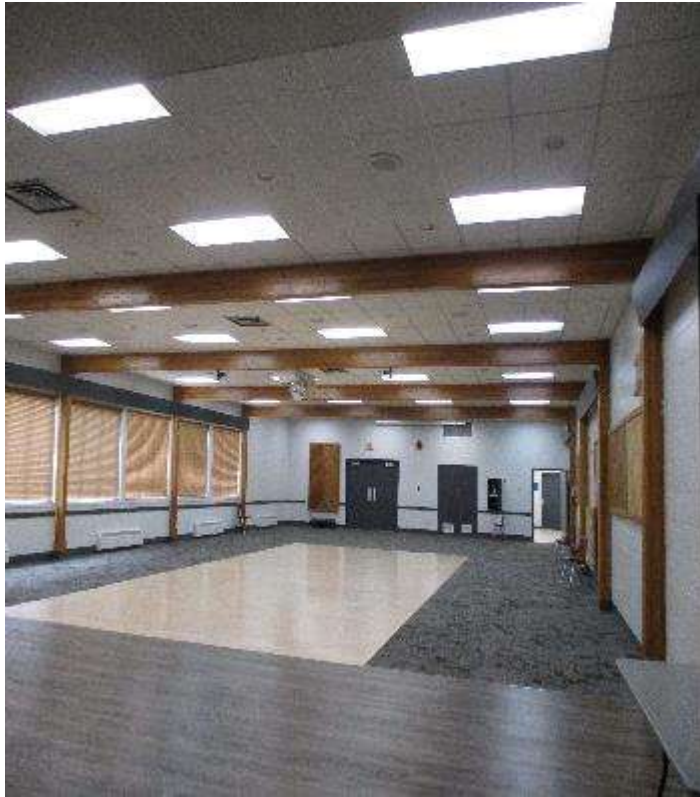
**Photo #E9:** Typical Events area LED recessed lighting and Pot Lights

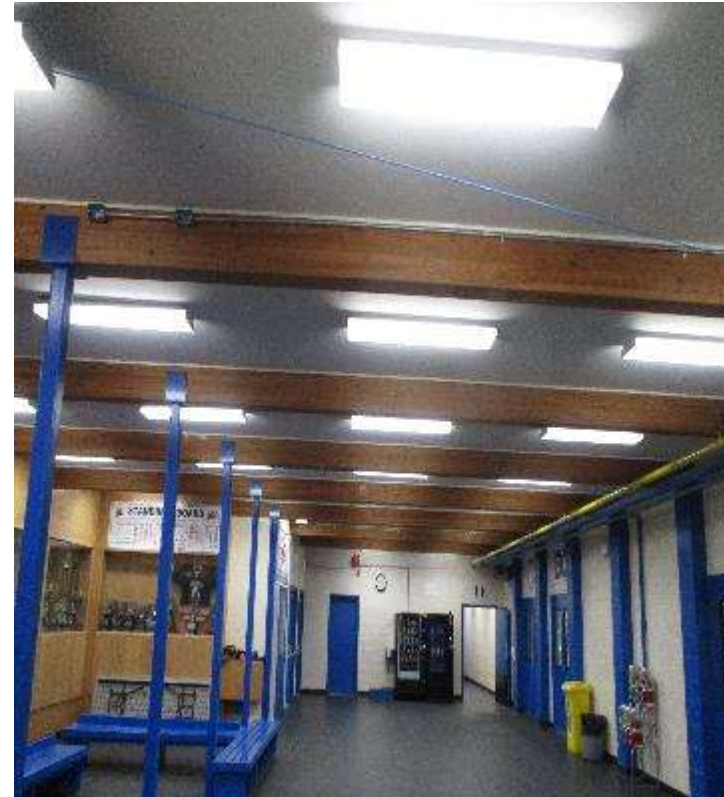
**Photo #E10:** Typical fluorescent strip lights in Lobby.

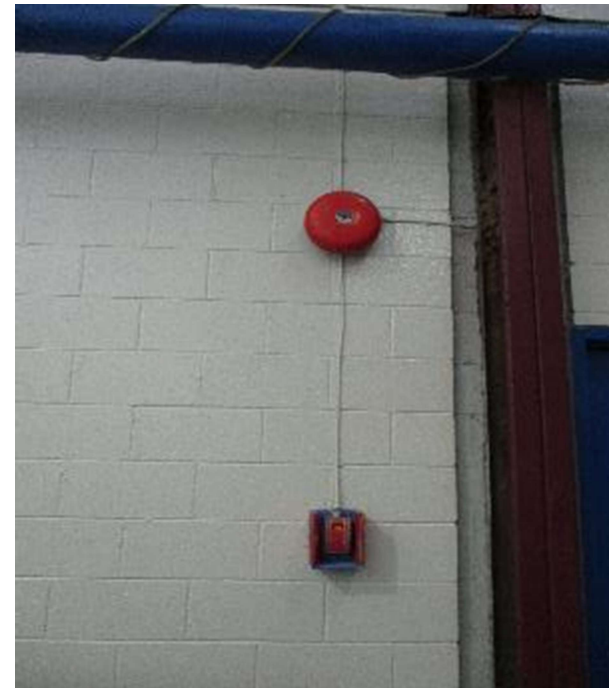
**Photo #E12:** Typical fire alarm pull station and bell in the building.

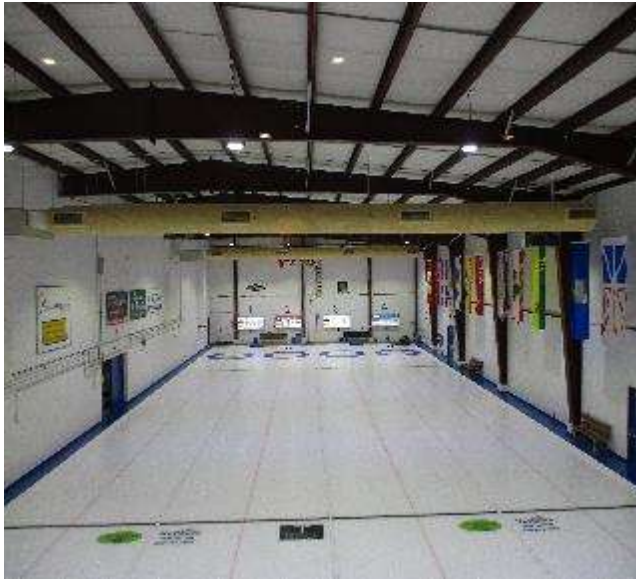
**Photo #E13:** Curling rink suspended LED lighting.

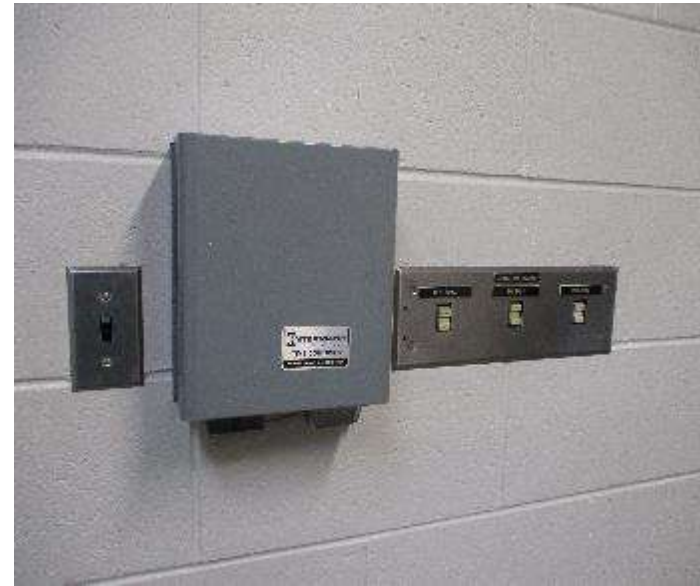
**Photo #E14:** Typical curling rink lighting control timer and switch bank

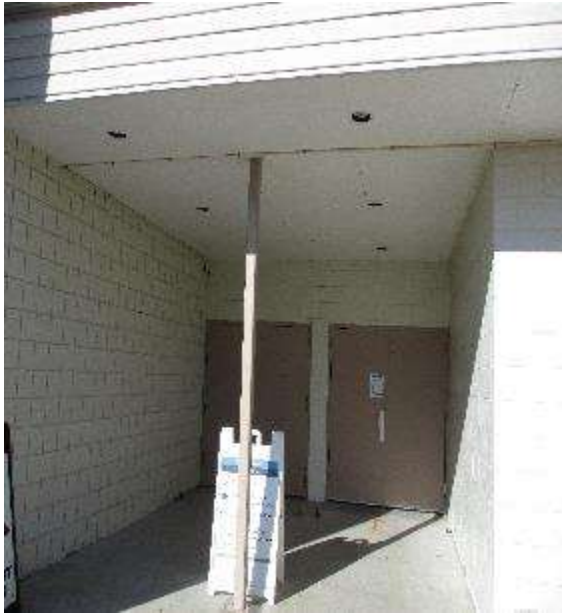
**Photo #E15:** Typical soffit mounted exterior lighting in the building- wall mounted units similar.

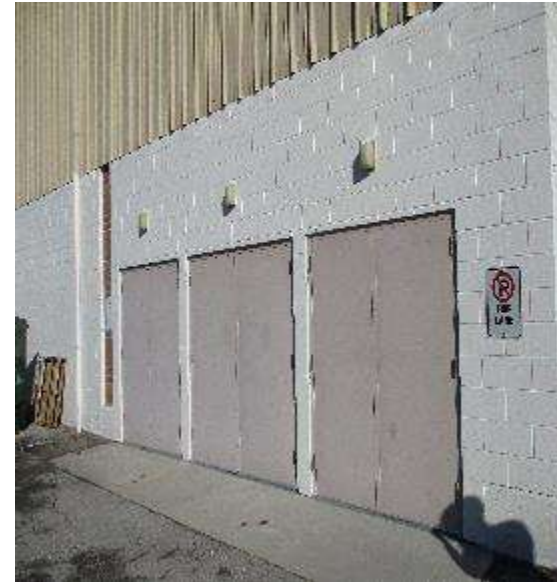
**Photo #E16:** Roof mounted LED lights installed in every elevation of the building.

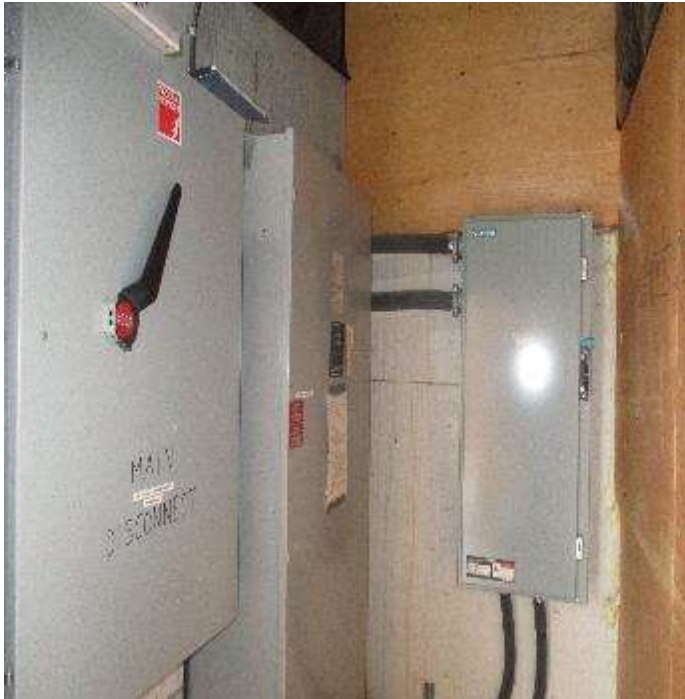
**Photo #E17:** Emergency distribution, transfer switch and panel.

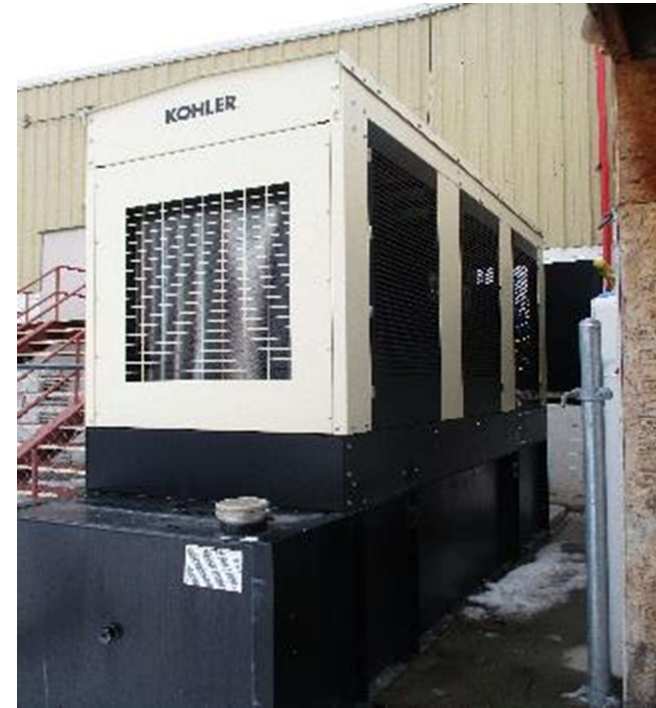
rated at 208Y/120V, 200-A, 3-phase, 4-wire for plug loads.			
E02.4	Emergency Generator	-2006: A skin-tight enclosure 350kW packaged Kohler Unit is located on Exterior. Supporting distribution is located in an adjacent shed including a 800A transfer switch. 600/347V 3phase.	4	C	No concerns observed or reported (See Note 7B). Maintenance: 1. Monthly testing minimum of 1hr 2. Semi Annual Inspection and Testing 3. Annual inspection and testing minimum 2hr
E02.5	Distribution Transformers	-1976: Three (3) dry type distribution transformers are installed in the electrical room, rated at 15kVA, 75 kVA, and 112.5KVA respectively rated 600-208Y/120 V, 3-phase.	4	C	Provide Energy Efficient transformers to comply with NRCAN 2019. Transformers have a life span typical of 30 years (See Note 7B). Maintenance: Recommend to schedule scans semi-annually.
E02.6	Motor Starters	-Various: Motor starters for mechanical equipment are provided in the Compressor/Ammonia Room. Make: Various Rating: Various	4	C	No concerns observed or reported. (See Note 7B). Maintenance: Recommend to schedule scans semi-annually.

**Photo #E18:** Packaged Exterior Generator.
