PROPERTY CONDITION ASSESSMENT

Summerland Aquatic and Fitness Centre

13205 Kelly Avenue
Summerland, BC, V0H 1Z0

Project No.: 155618238

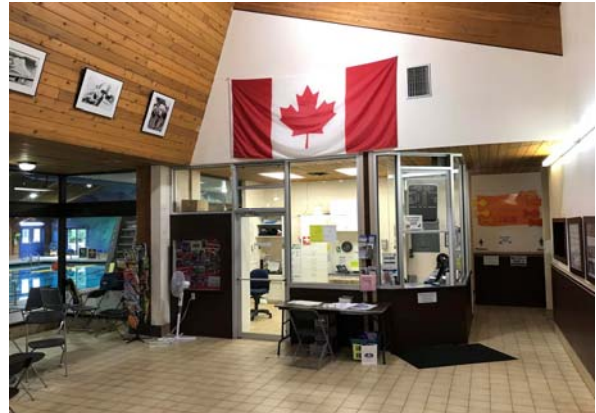
Photo A2
View of entrance reception and guard room.

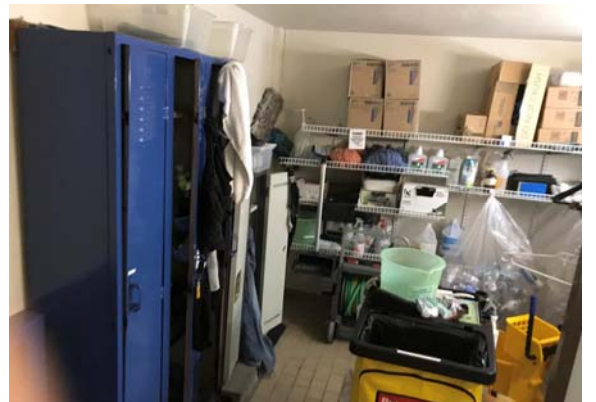
Photo A4
View of the staff men's washroom. The water closet has been removed.

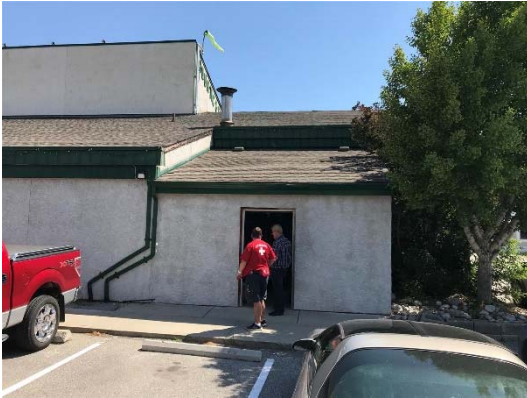
Photo A7
View of storage room added to exterior of the building.

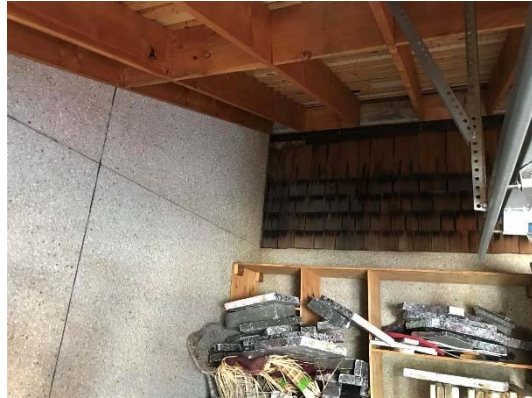
Photo A8
View inside storage area looking toward exterior wall of original facility.

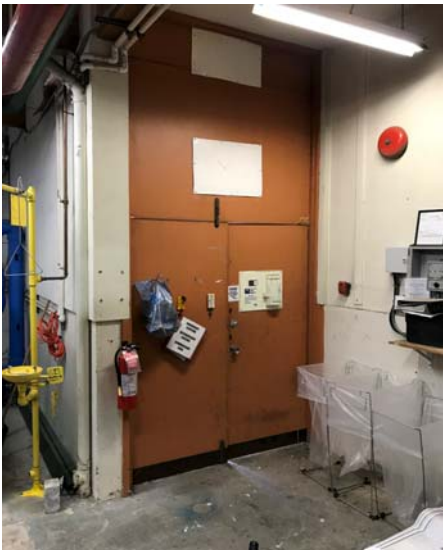
Photo A11
View of South mechanical room exterior door.

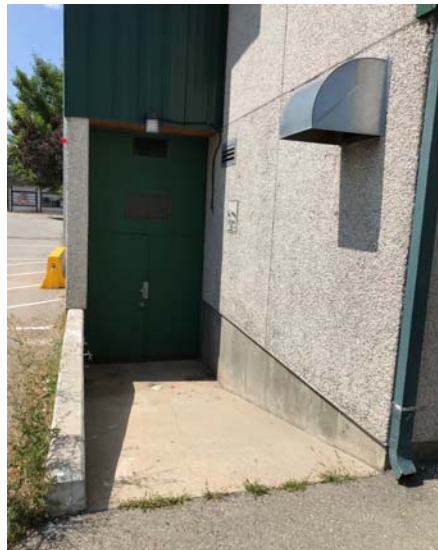
Photo A12
View of South mechanical room exterior door.

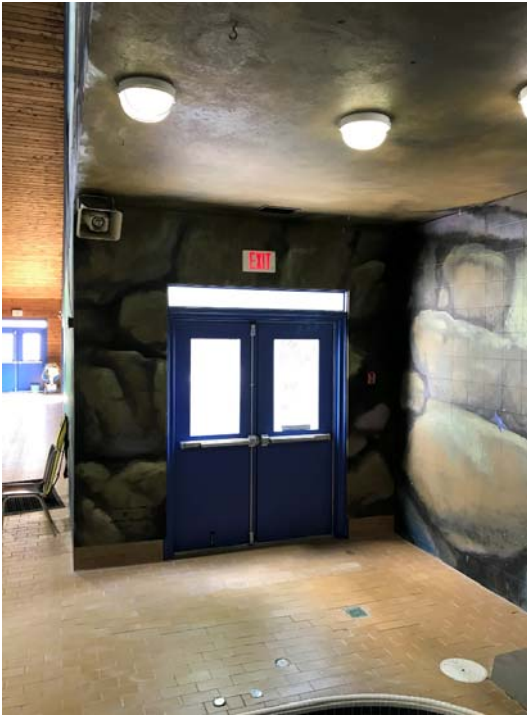
Photo A13
Interior view of South pool exit doors.

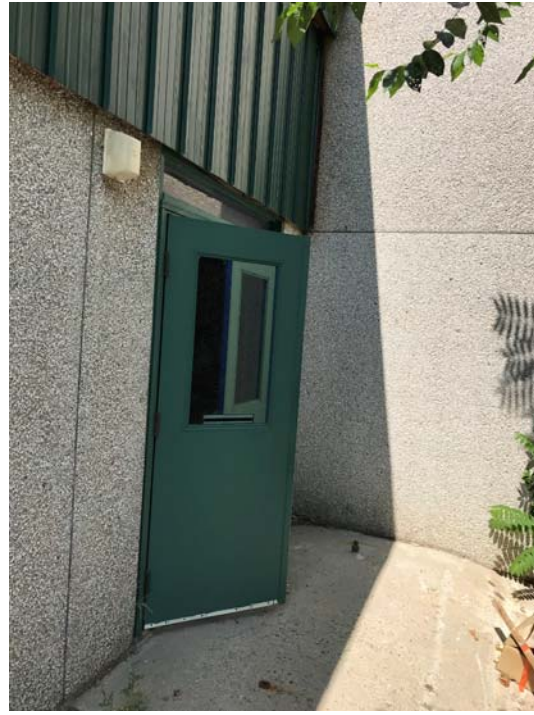
Photo A14
Exterior view of South pool exit doors.

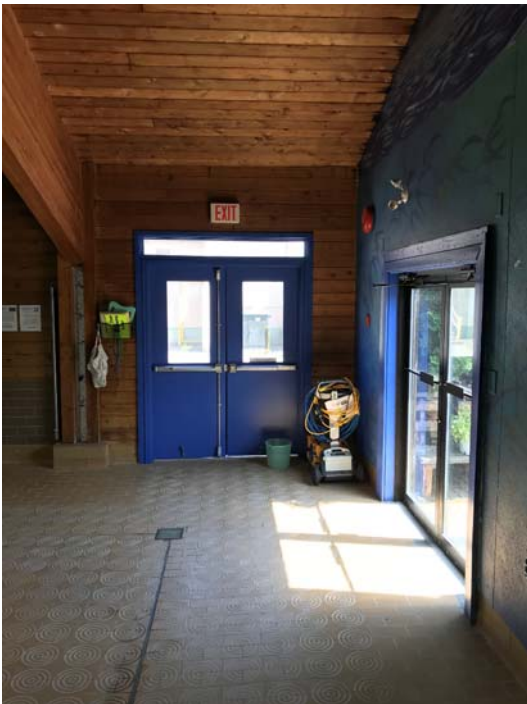
Photo A15
Interior view of South-East pool exit doors.

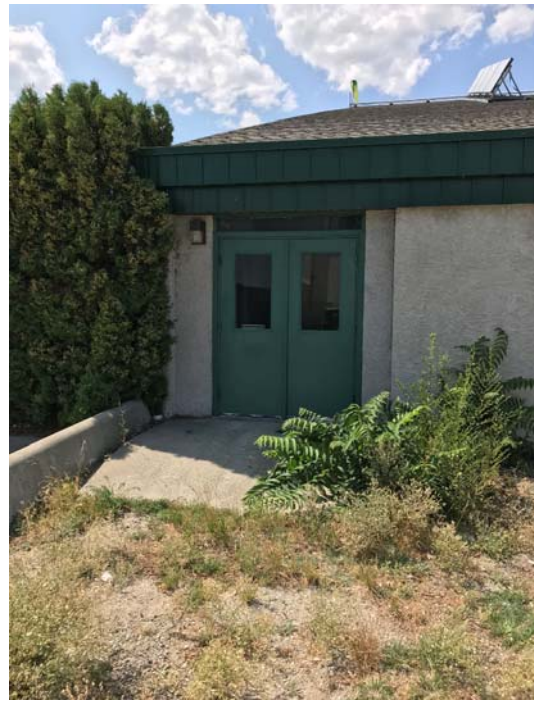
Photo A16
Exterior view of South-East pool exit doors.

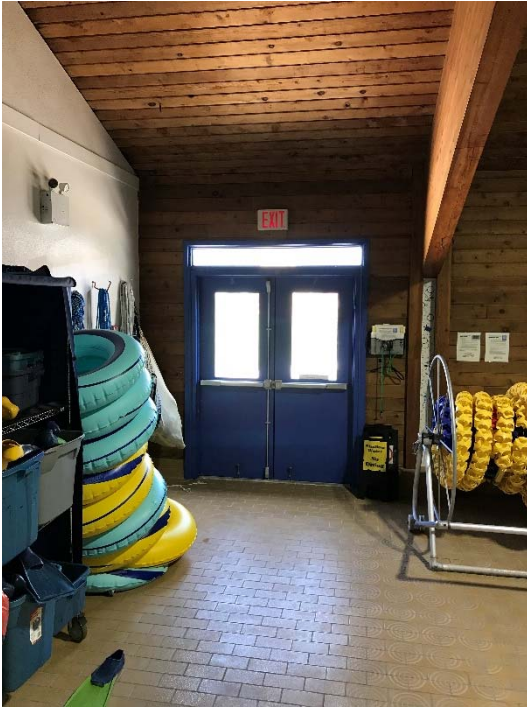
Photo A17
Interior view of North-East pool exit doors.

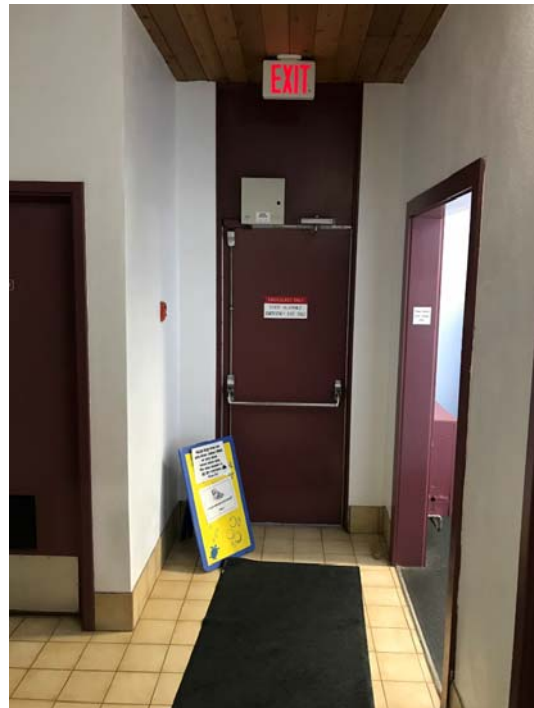
Photo A20
Interior view of exit door at West side of fitness room.

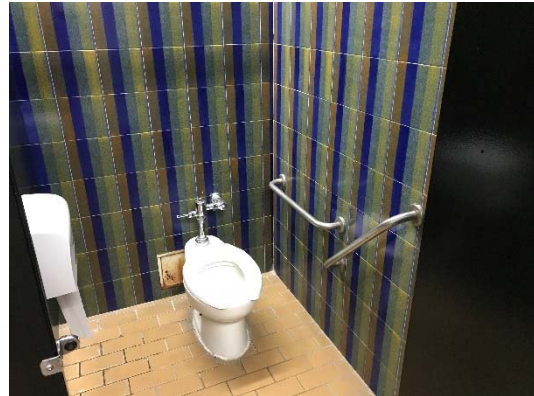
Photo A22
View of typical barrier free water closet in pool area.

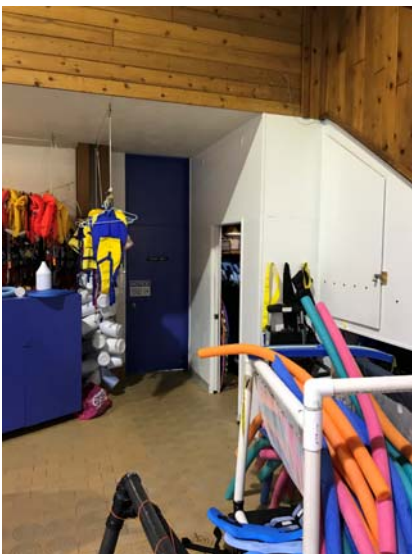
Photo A25
View of equipment room added under stairs.

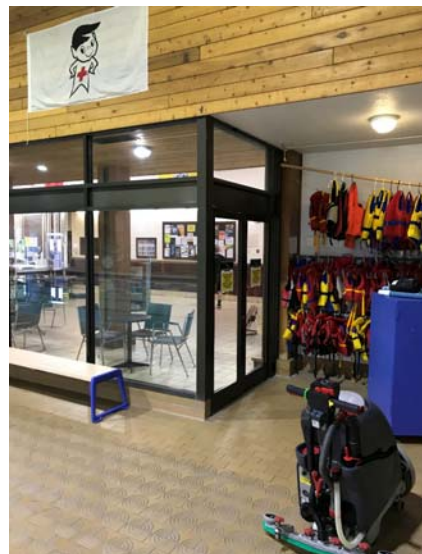
Photo A 26
View from pool area toward public viewing area.

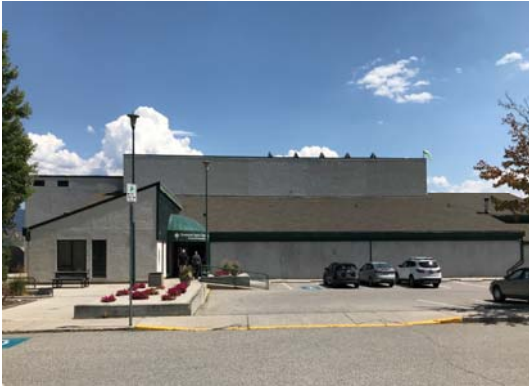
Photo S1
View of West elevation and main entrance.

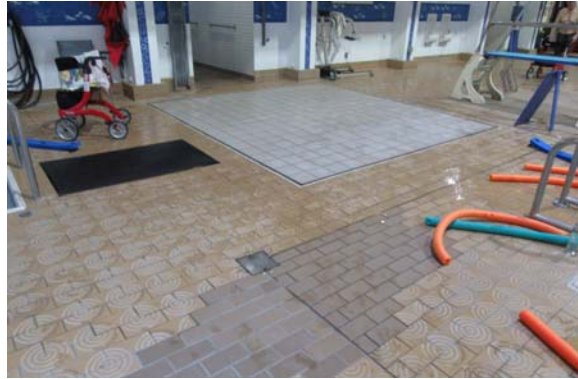
Photo S2
View of pool deck tiles

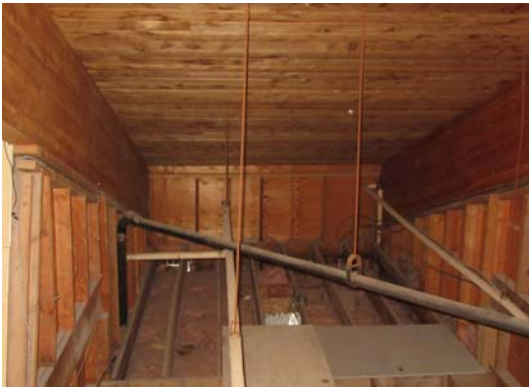
Photo S5
Framed ceiling now serves as mechanical service mezzanine.

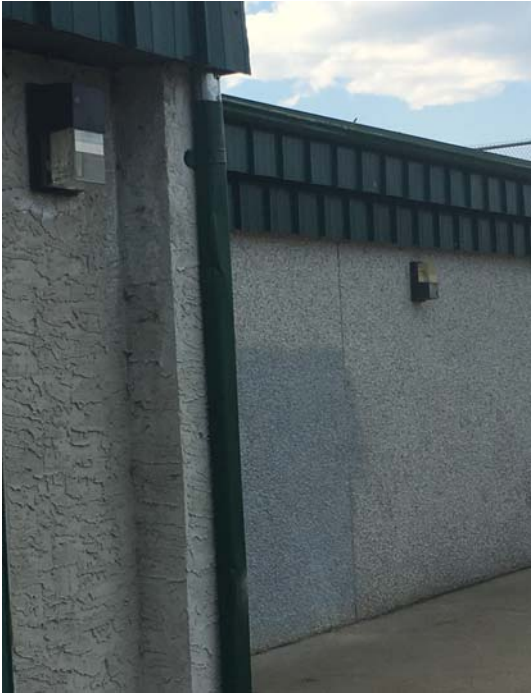
Photo E7
Exterior Lighting

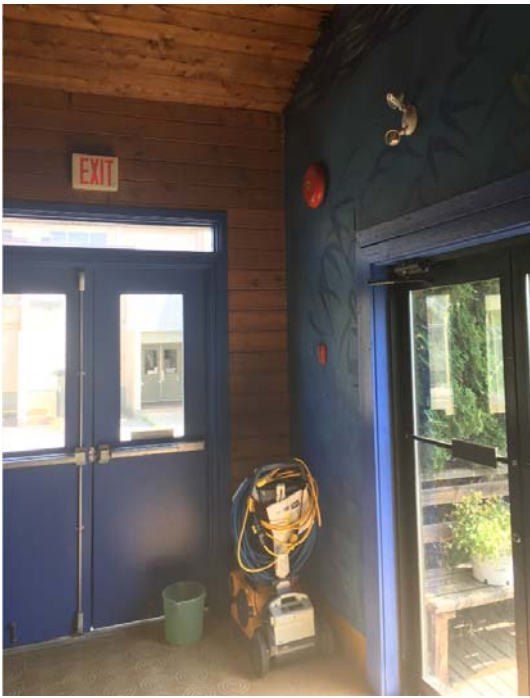
Photo E8
Exit Emergency Light / FA Bell /FA Pull station

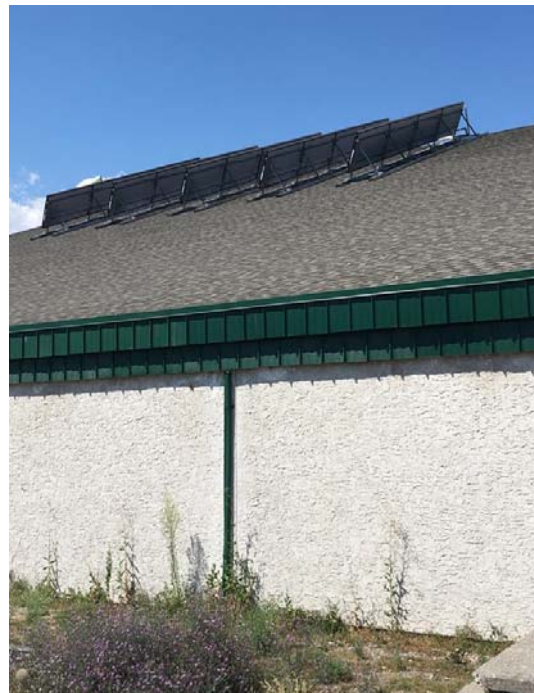
Photo E13
Solar Panels

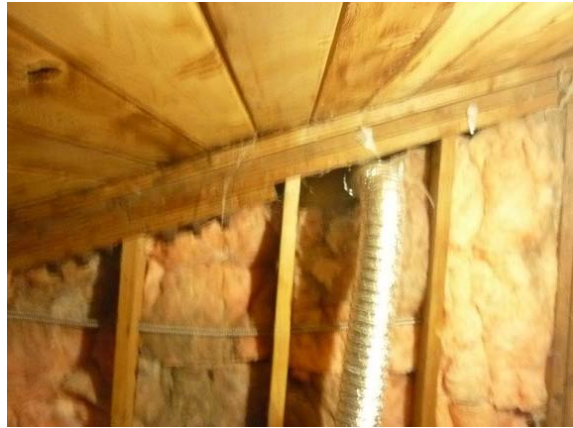
Photo Env7
Wall Penetrations

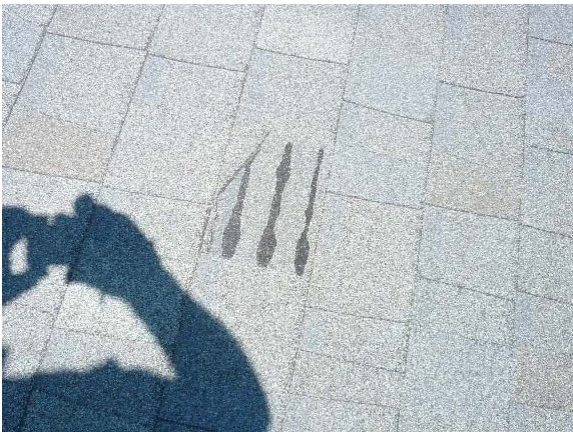
Photo Env8
Roof Shingles

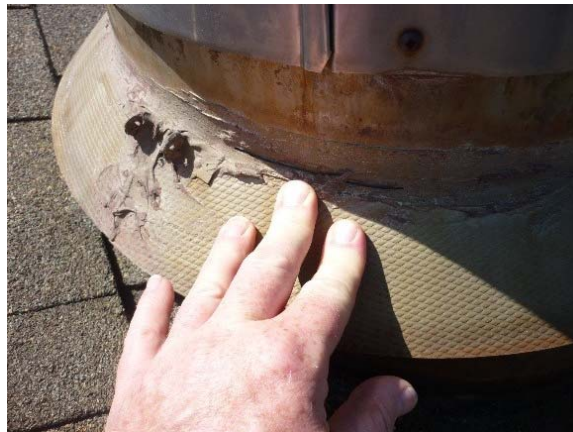
Photo Env9
Roof Penetrations

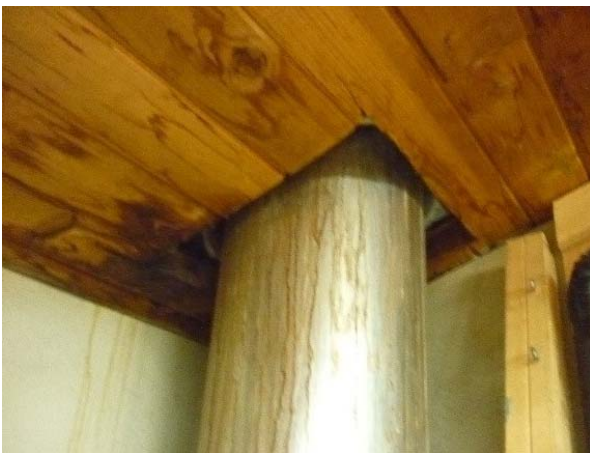
Photo Env10
Roof Penetrations

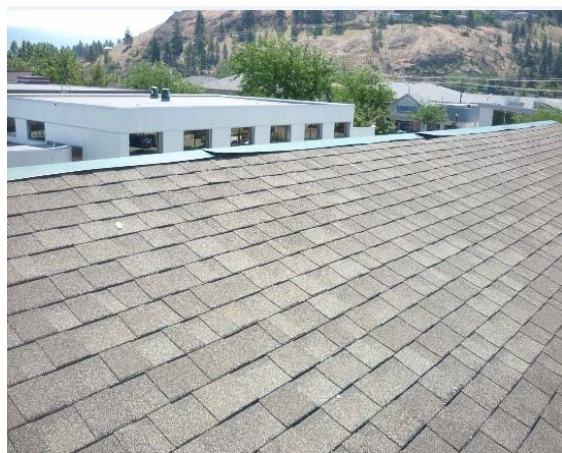
Photo Env11
Roof Flashing

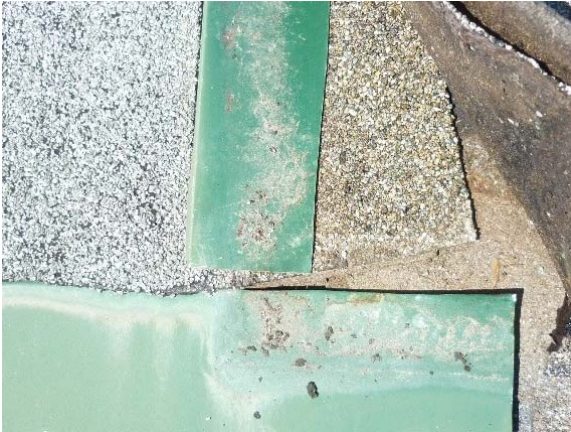
Photo Env12
Roof Flashing

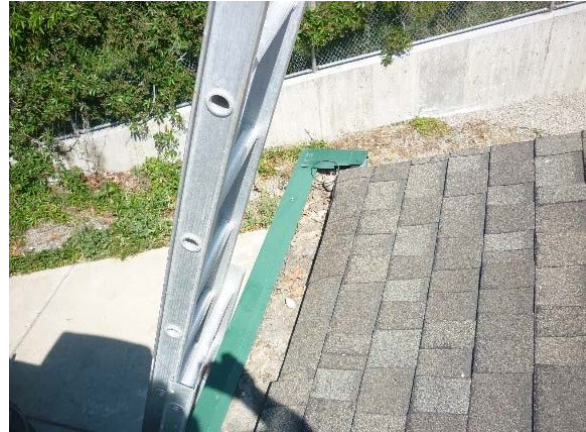
Photo Env13
Gutters and Downspouts

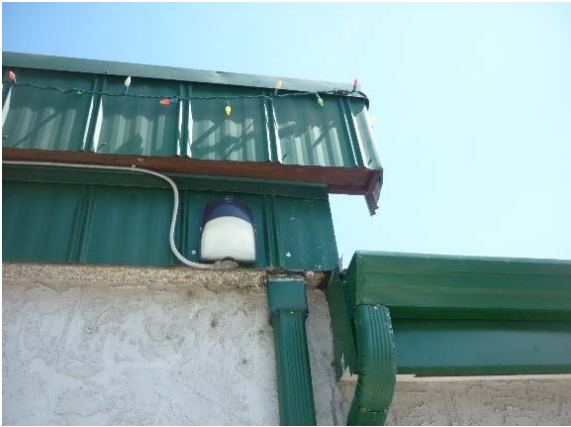
Photo Env14
Gutters and Downspouts

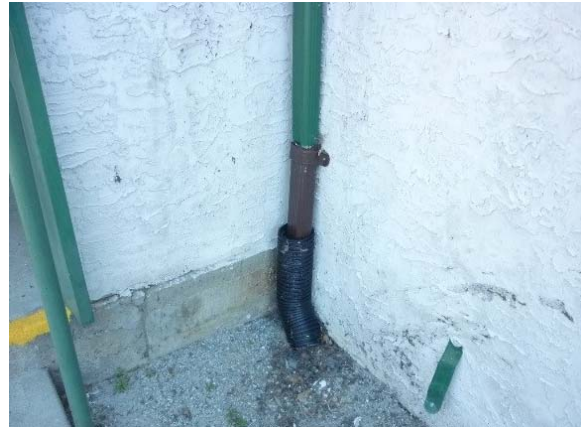
Photo Env15
Perimeter Drains

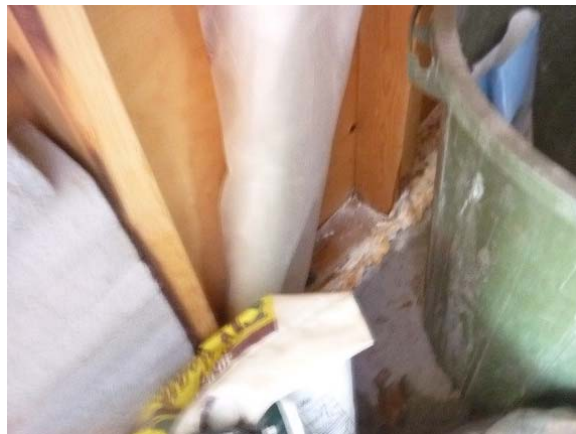
Photo Env23 (photo provided by District)
Storage Shed

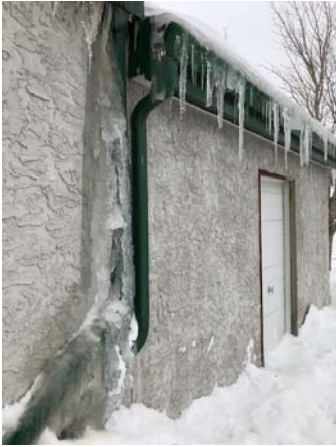
Photo Env23a (photo provided by District)
Storage Shed

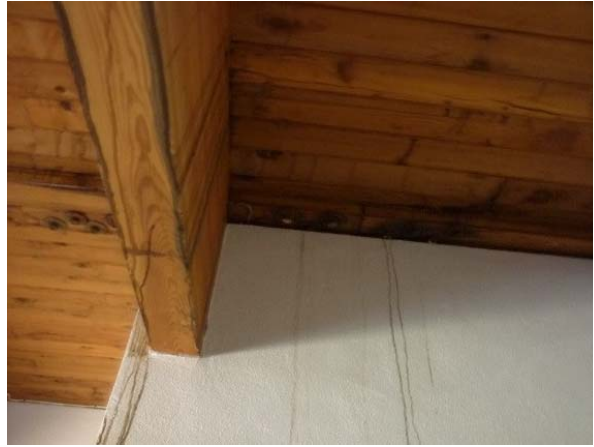
Photo Env24 (photo provided by District)
Pool Area to mezzanine wall

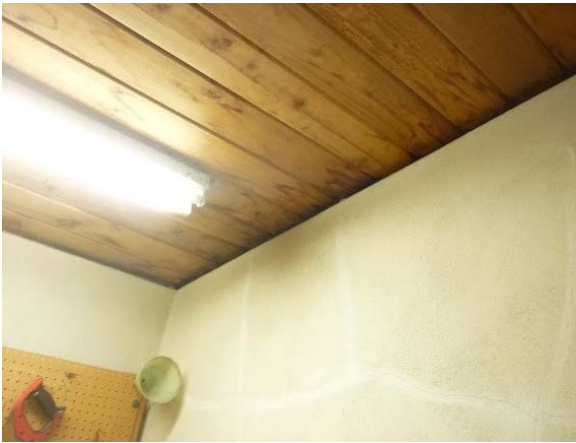
Photo Env25
Attic Space

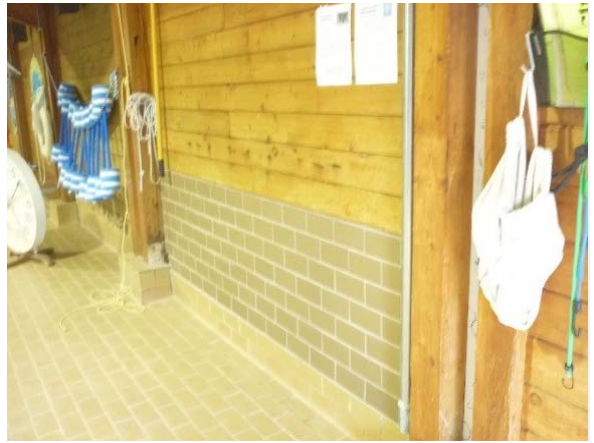
Photo Env26
Pool Deck Perimeter Walls
