Fletcher Paine Associates Ltd.

Consulting Geotechnical and Materials Engineers

Geotechnical Investigation and Report
Summerland Watermain Replacement Projects
District of Summerland, B.C.

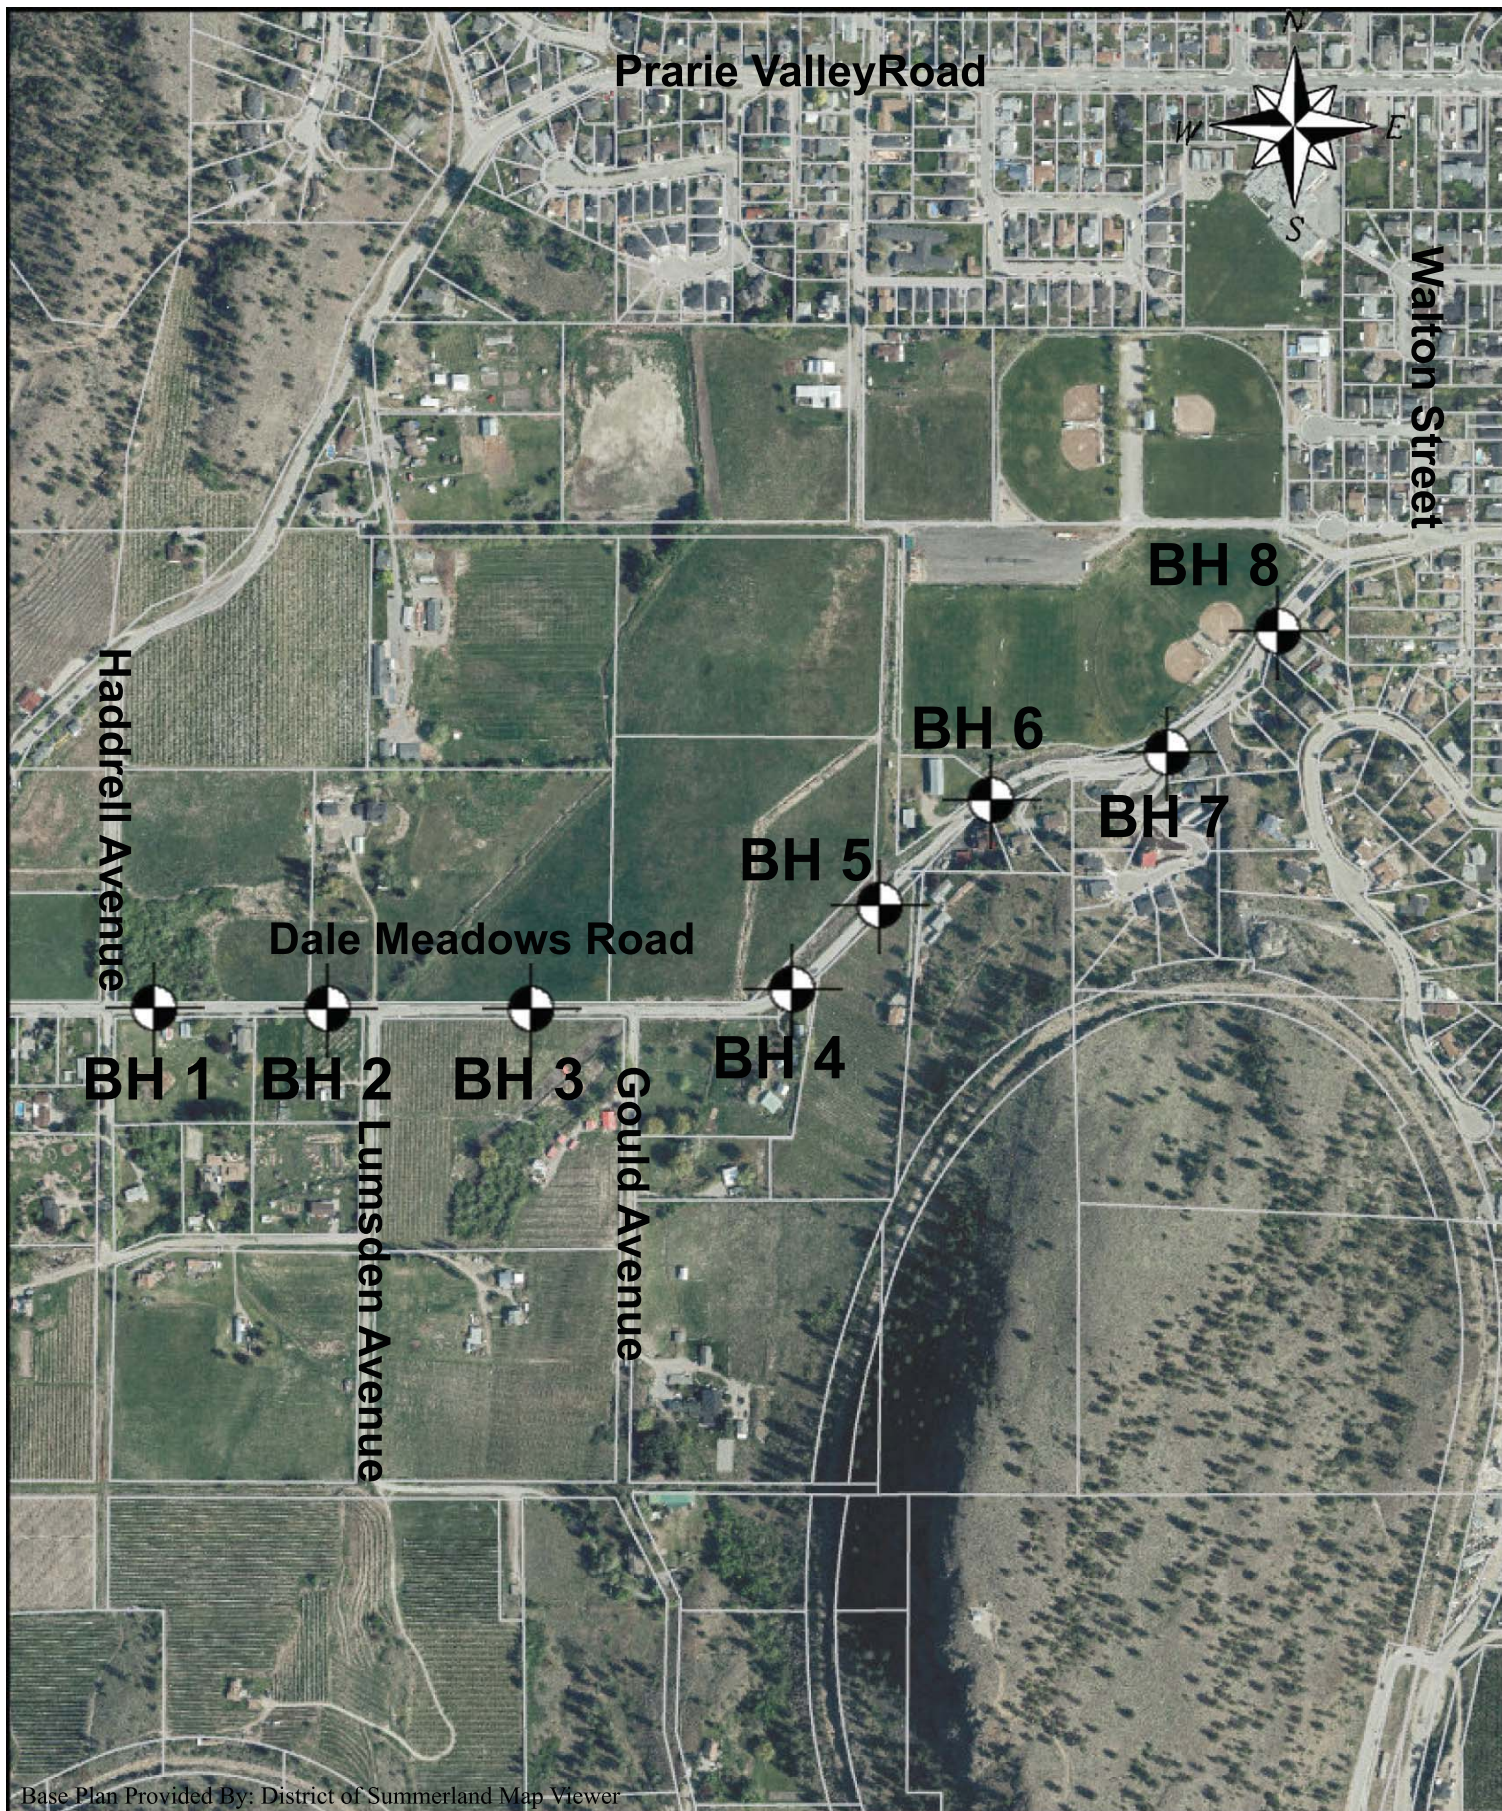
Figure: 6671 - 2

Borehole Location Plan A

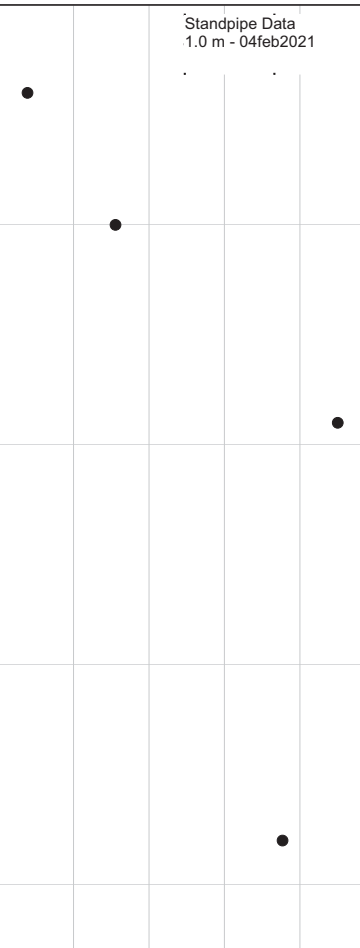
ASPHALT - 100 mm			40	<div>Standpipe Data 1.0 m - 04feb2021</div>

FILL sand, gravelly, some silt, compact, brown, damp	1

SAND AND SILT peaty, loose, grey, dark brown, wet	2
