**2022 Drinking Water Quality Annual Report**  
**Facility No. 14-105-00001**

**Date Submitted: June 23, 2023**

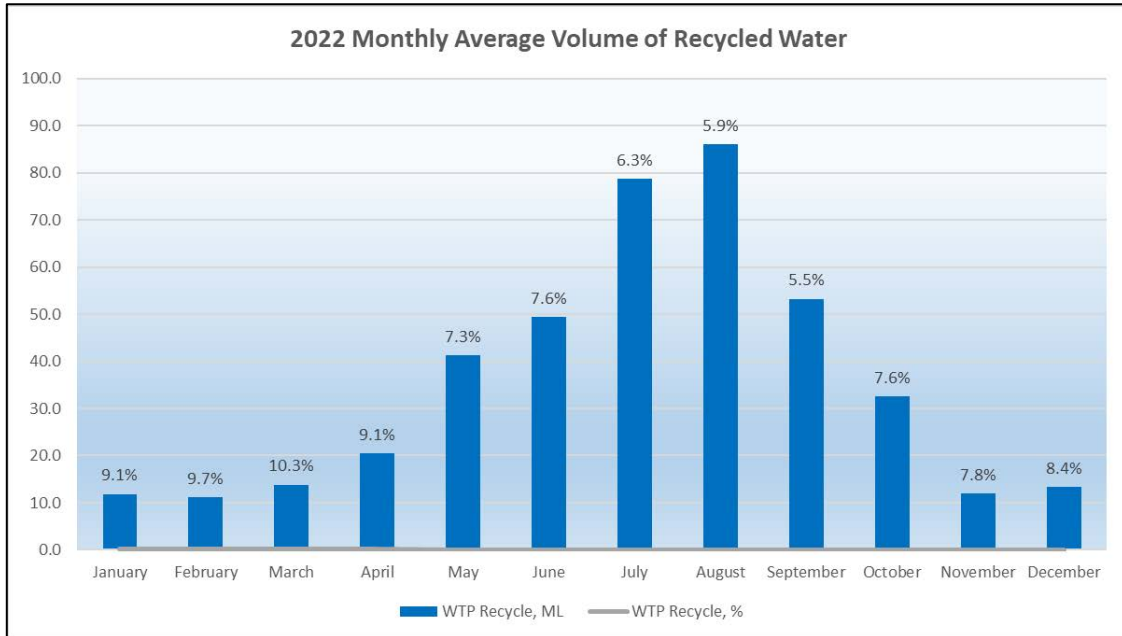
The recycled supernatant from the settling ponds is gravity fed back to the treatment process. This innovative design involves recycling up to 10% of the supernatant back to the front of the process for re-treatment. This significantly improves the water use efficiency of the process and makes it the first water plant in Canada to

utilize this technology. The following graph indicates the monthly average volume of water recycled back to the raw water tank.

Historical sampling results indicate that recycled water contributes very little to the amount of coliforms, colour, turbidity, Cryptosporidium oocysts and Giardia cysts returned to the head of the plant. Lab results for the recycled water indicates better water quality characteristics than that of the raw water from Trout Creek.

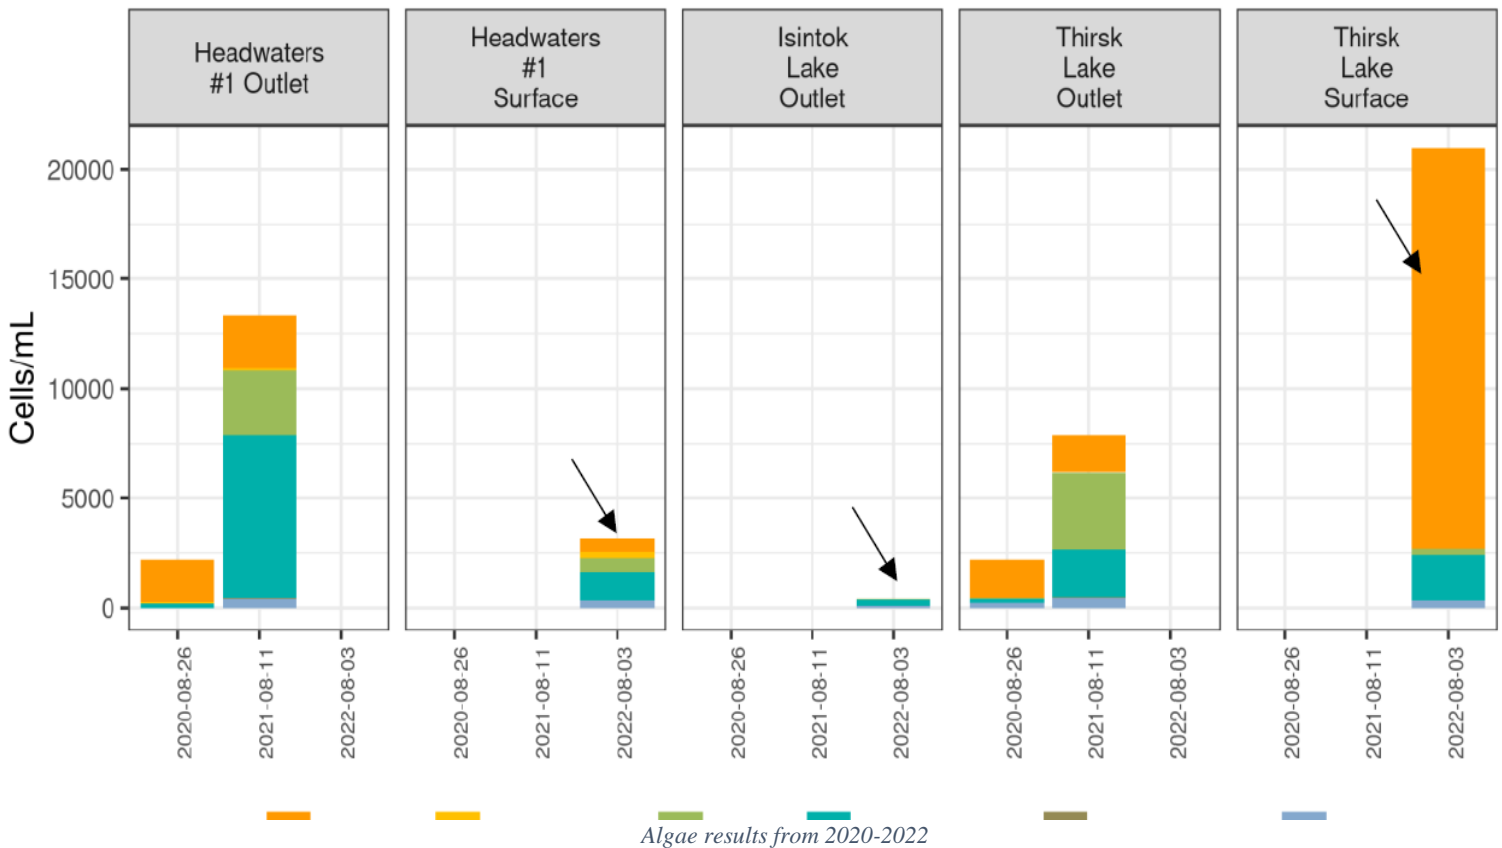
### August 6<sup>th</sup> Samples

According to Larratt, the sample submitted from Thirsk had very high algae densities dominated by the diatom *Aulacoseira* sp. with 18170 cells /mL. Cyanobacteria were also present with 2070 cells/mL of mostly *Anacystis* sp. Cyanobacteria densities were slightly above the WHO Alert Level 1 threshold (2000 cells/mL). Larratt’s comments based on the densities observed on August 3<sup>rd</sup> suggest that this should not pose a risk for acute cyanotoxicity.

Headwaters #1 sample had moderate algae densities with 3190 total cells/mL that contained cyanobacteria (1310 cells/mL), diatoms (660 cells/mL) and green algae (640 cells/mL). Cyanobacteria densities were below the WHO Alert Level 1 threshold and should not pose a risk for acute cyanotoxicity.

Isintok sample contained very low algae densities of only 420 cells/mL.

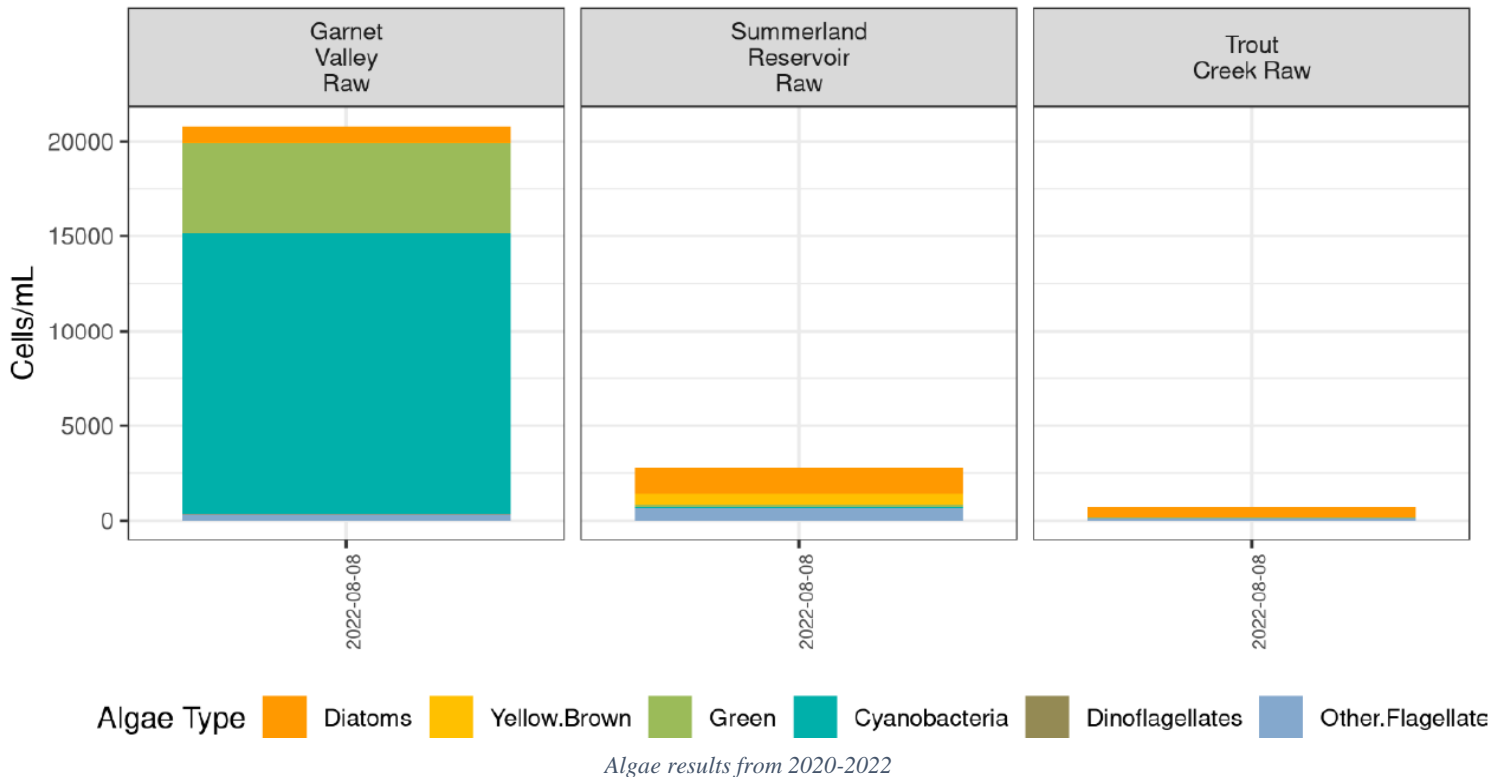
## August 8<sup>th</sup> Samples

The sample from the *Garnett Irrigation Only System* contained very high cyanobacteria, driven by a bloom of *Anacystus* sp. and *Mircocystis* sp known to produce potentially toxic surface blooms. Total cell densities measured 20,790 cells/mL of which 14,830 cells/mL were cyanobacteria. This was the highest cell densities measured in Garnett Valley Reservoir to date. These samples were very high for a raw water sample but lower than expected to lead to acute cyanotoxicity.

The Summerland Reservoir contained a mixture of algae types, dominated by diatoms. Total cell densities measured 2810 cells/mL, with only 60 cells/mL being cyanobacteria. *Aulacoseira* sp. was the most common diatom that can reduce filtration efficiency. No health risks are expected from algae observed in the Summerland Reservoir sample.

The Trout Creek raw sample contained very low algae densities of 710 cells/mL primarily consisting of diatoms. No health risks are expected from algae observed in the Trout Creek Raw sample.
