# FINAL REPORT

## Facility Condition Assessment Summerland Arena & Curling Club Complex

8820 Jubilee Road East,  
Summerland BC, V0H 1Z5

Date: July 13, 2022  
Project No.: 20211925

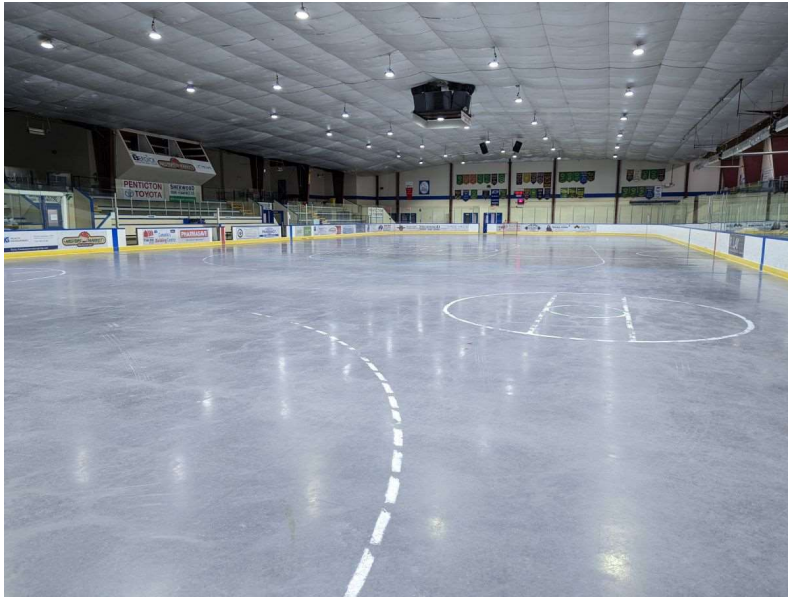
**Photo #S3:** SOC in hockey arena.

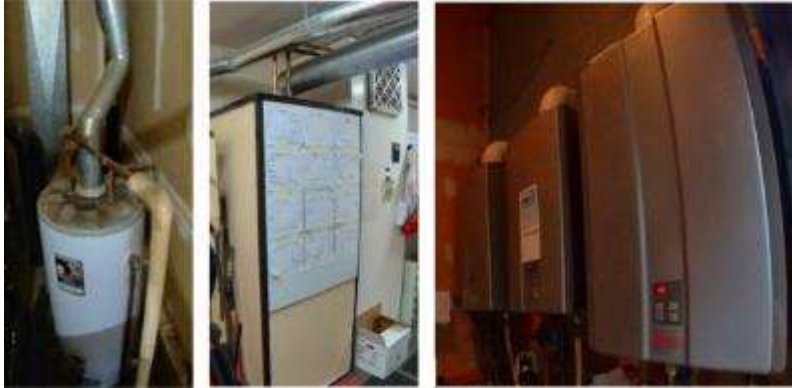
**Photo #M3:** Gas-Fired Domestic Water Heaters (one is completely enclosed in Trailer Change Room).

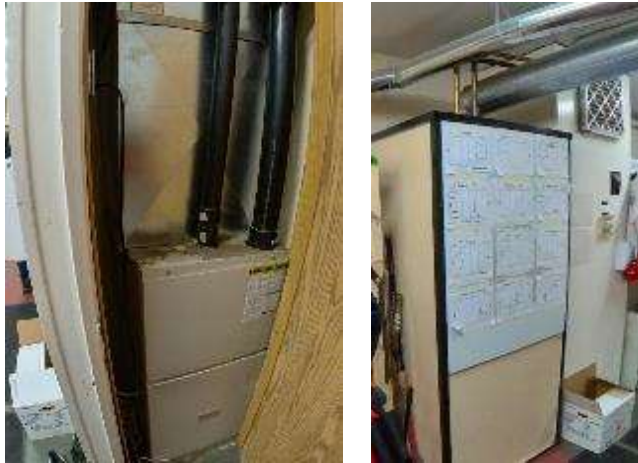
**Photo #M5:** Furnace and It's Enclosure in Trailer Change Room.

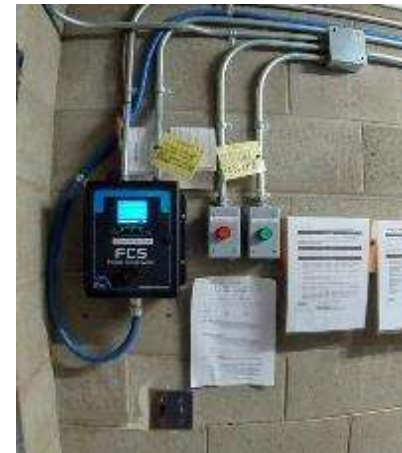
**Photo #M10:** Ammonia Leak detection with Emergency Exhaust Fan Switch.

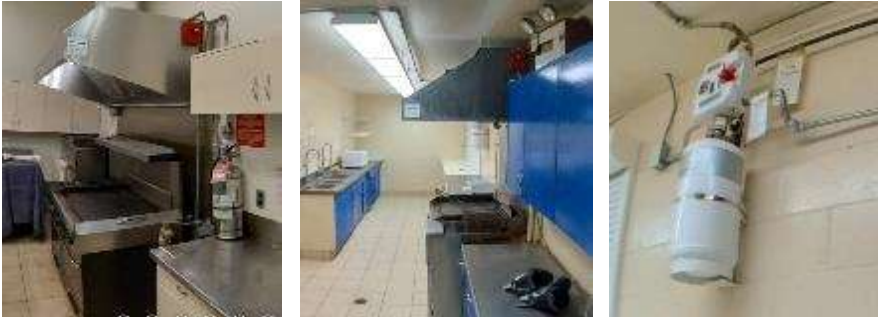
**Photo #M11:** Commercial & Concession Kitchen Hoods with Fire Suppression system (Typical).

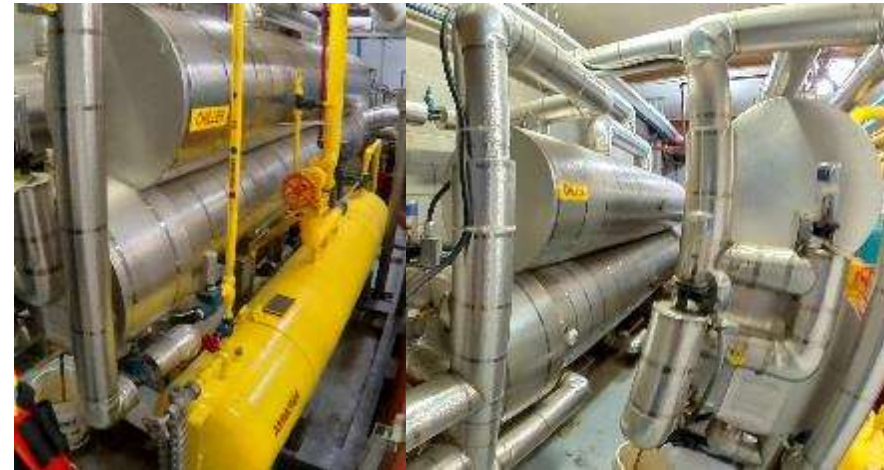
**Photo #M14:** Chillers with High Pressure Receiver (yellow).

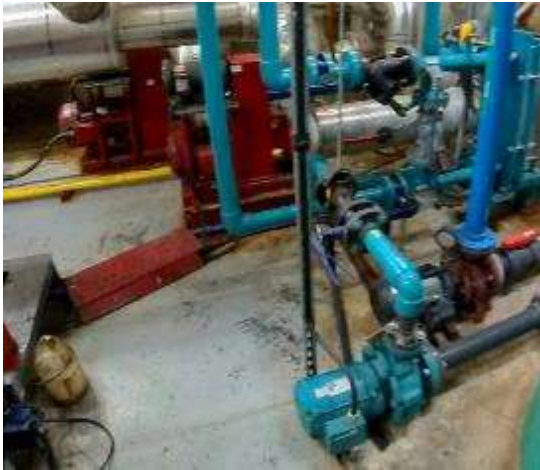
**Photo #M17:** Condenser Water Pumps.

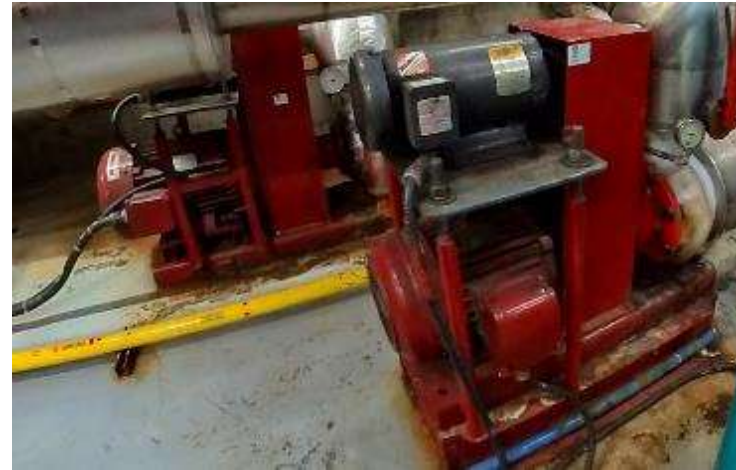
**Photo #M18:** Cold Brine Pumps.

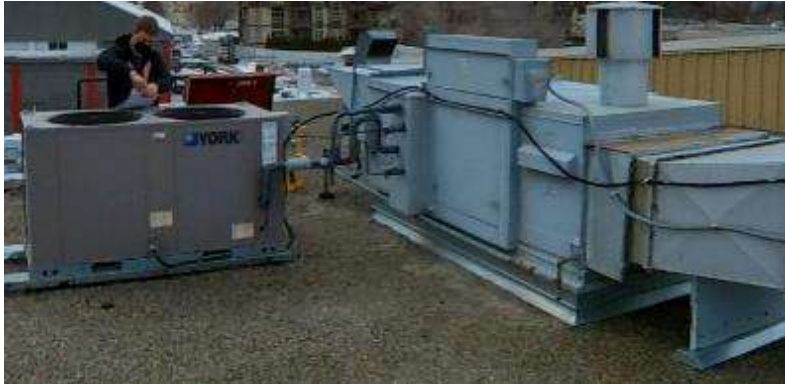
**Photo #M19:** Air Handling Unit AHU-2.

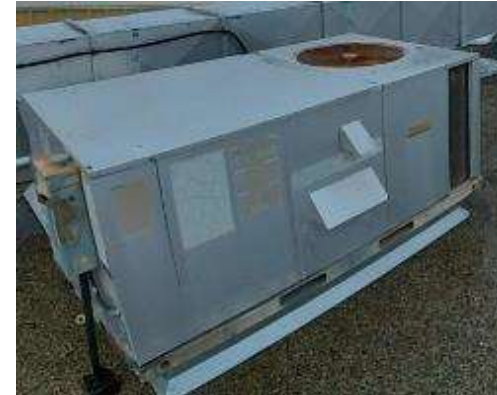
**Photo #M20:** Roof Top Unit RTU-1.

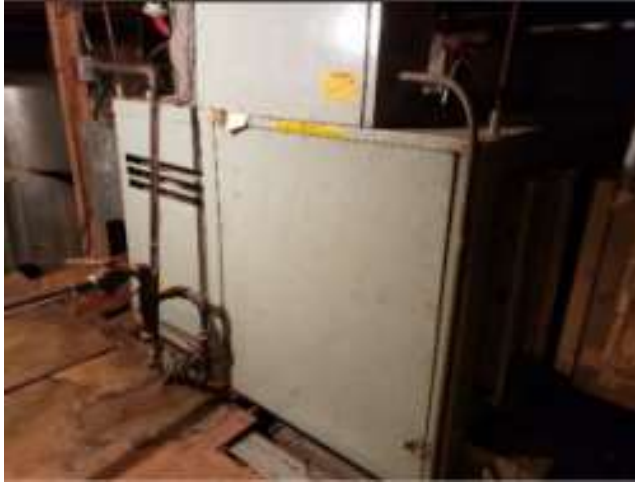
**Photo #M21:** Air Handling Unit AHU-1.

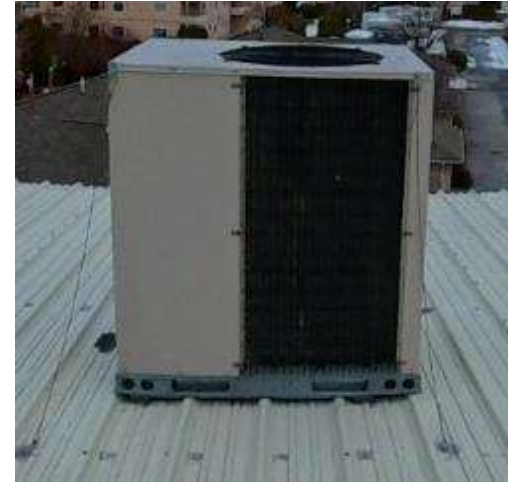
**Photo #M22:** Heat pump for AHU-1.

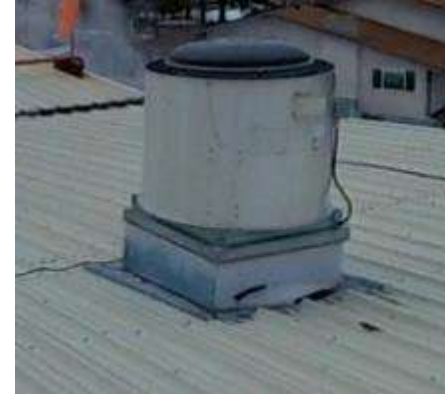
**Photo #M24:** Emergency Ammonia Exhaust Fan.

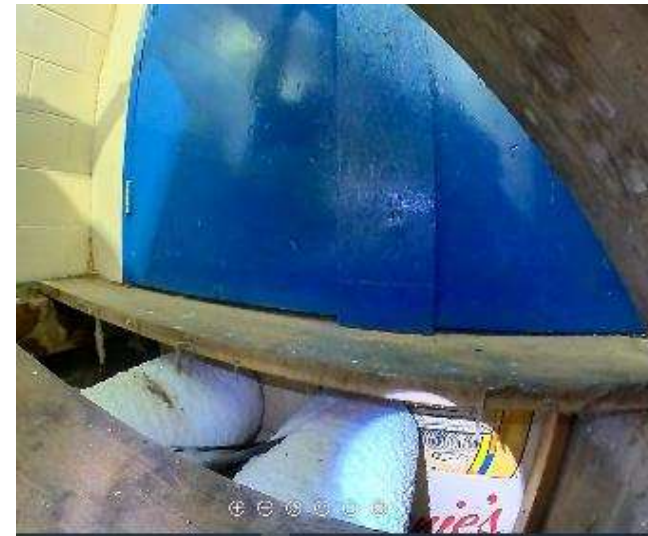
**Photo #M34:** Ammonia pipes Penetration through the wall in Compressor/Ammonia Room are sealed. No concerns.

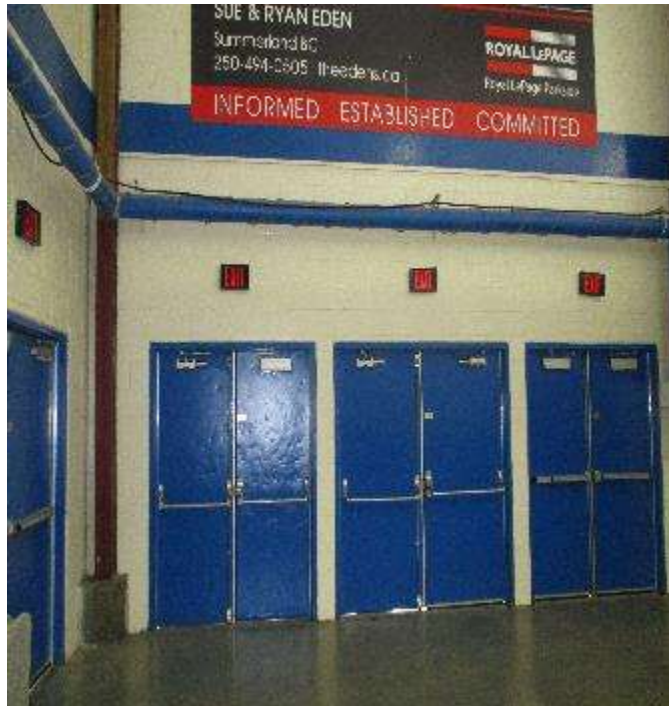
**Photo #E11:** Red letter style exit sign.
