PROPERTY CONDITION ASSESSMENT

Summerland Aquatic and Fitness Centre

13205 Kelly Avenue
Summerland, BC, V0H 1Z0

Project No.: 155618238

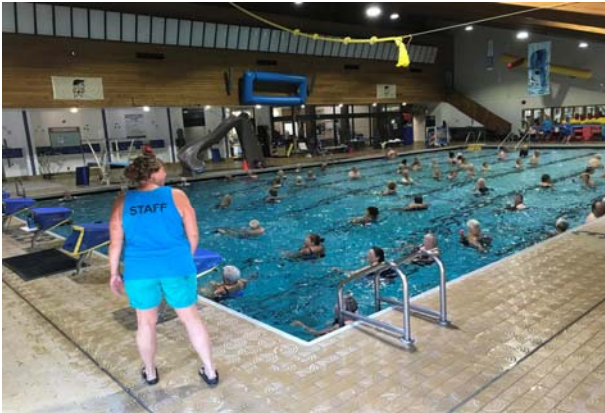
Photo: A1
View of Pool use in high demand.

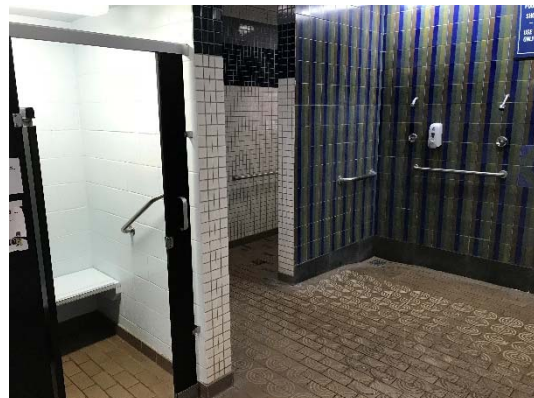
Photo A24
View of grab bars installed in change rooms.

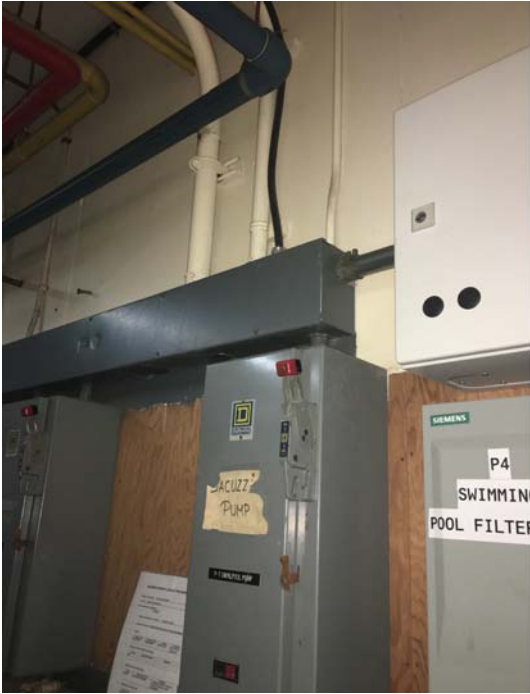
Photo E6
Splitter 1

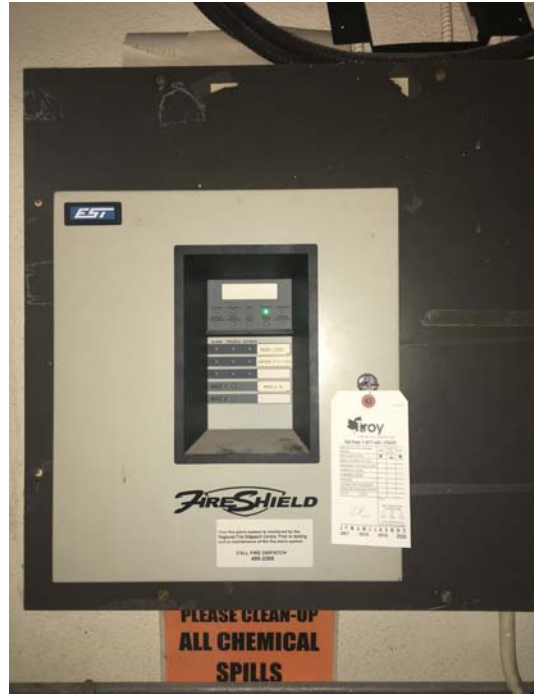
Photo E11
FA Panel

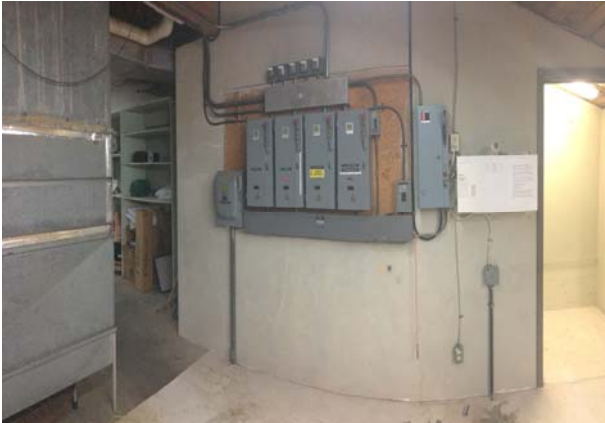
Photo E14
Splitter 2

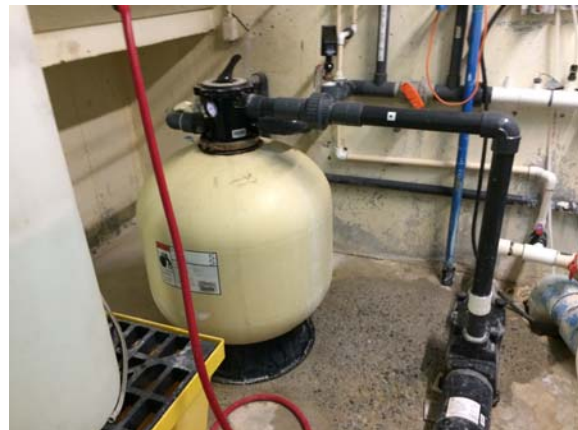
Photo PSys5
Hot Pool Pump
